THE QUARRY SWIMMING AND FITNESS CENTRE VISUAL APPRAISAL CURTINS (DECEMBER 2014)

Quarry Pool

Visual Inspection Report

Curtins Ref: MA1279

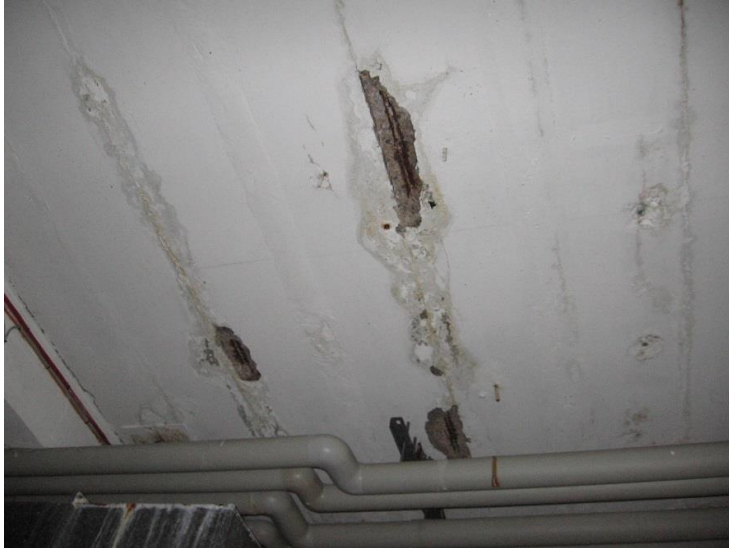
There is evidence of reinforcement corrosion to the soffit of the first floor slab above the central plant space.

Figure 1 □ Spalling of concrete soffit as a result of reinforcement corrosion.

The likely cause of this is in adequate cover to the reinforcement, for the environmental conditions associated with the space. This is common in buildings of this age, where early use of reinforce concrete lacked the quality of workmanship required for long term durability.

There are some signs of corrosions to soffit reinforcement to the first floor slab. This is a common defect of a building of this type and age and can be repaired however this should be done promptly to avoid more significant problems developing.

- A detailed intrusive survey would need to be carried out to determine the extent of any reinforcement corrosion to the slabs, and a detailed specification prepared for the concrete repair works.
- A detailed intrusive survey would need to be carried out to determine the extent of any steel member corrosion and a detailed specification prepared for localised repair and the implementation of cathodic protection.
- All rainwater goods will need to be replaced and localised repairs made to the damaged facades.

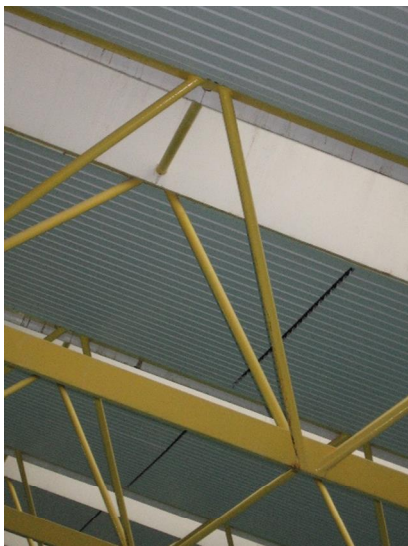
It appears that the roof over the original pool hall has been replaced, however there is some evidence of localised corrosion of the welded joints within the truss. The likely cause is failure of the paint protection system and should be rectified as part of the ongoing maintenance regime for the building.

Figure 2 □ Exposed steel trusses over pool hall with localised corrosion to nodes.

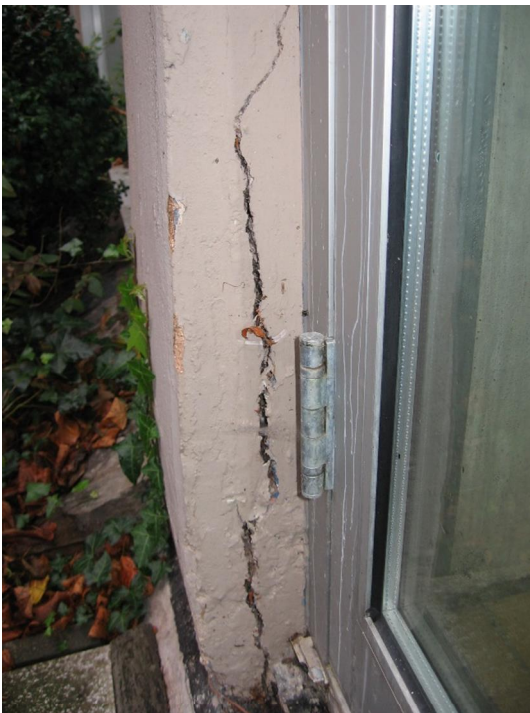
The external elevation is showing some signs of degradation. Vertical cracks were noted in the exposed concrete columns to the rear, which is likely to be caused by inadequate protection to the steel stanchion resulting in corrosion of the steel work. This needs to be addressed as the corrosion will be progressive and could develop into a structural instability.

Figure 3 □ Vertical crack to concrete column on rear elevation

There are some signs of corrosion to the steel columns on the building façade, which is common for buildings of this age and construction. Localised repairs are likely to be required and a cathodic steel protection system installed to control any further corrosion. Major refurbishment to the building should consider a new façade system which provides better protection to the steel frame.

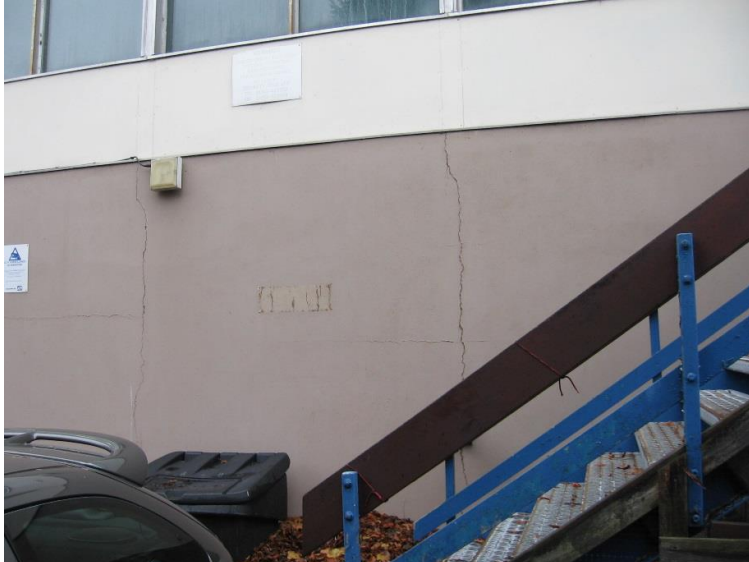
Vertical cracking was also noted in the external render and this is likely to be caused by either self-formed movement joints in the masonry or corrosion of steel stanchions as a result of inadequate protection from the exposure conditions.

Figure 4 □ Vertical crack to concrete column on rear elevation

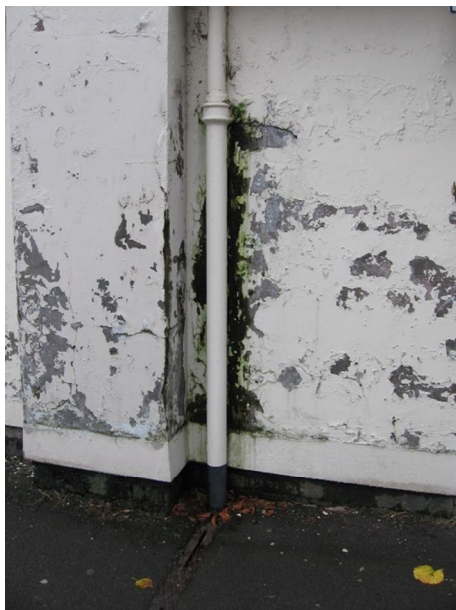
The rainwater goods which drain the roof are in poor condition and water is overflowing from outlets and down pipes. This has caused degradation to the external masonry with localised staining, mould growth and damage to the render. This is progressive and should be rectified as part of the building maintenance strategy, as long term effects could result in structural instability of the building.

Figure 5 □ Façade damage caused by faulty rain water goods.
