**Amateur Swimming Association
Swimming Pool
Visual Condition Survey**

1. Swimming Pool Name: Quarry Swimming Pool
2. Swimming Pool Address: Priory Road, Shrewsbury, SY1 1RU
3. Swimming Pool Owner: Shropshire Council
4. Swimming Pool Operator: Serco Leisure
5. Visual Survey Inspection Date: 5.8.16
6. Brief description of facility: The building houses multiple swimming pools with Ancillary changing rooms, reception vending area, multiple cafés and spa/sauna/steam room. Service plant room and office accommodation. There are 3 swimming pools: 33m Pool with 6 lanes and a 51 metre flume, this pool also has 3 diving boards which are no longer in use and a spectator gallery. There is also a 25m pool, an 18m pool and a 10m pool.
7. Year of original build: 1880-(Main Quarry Pool added in 1971)
8. Gross area of Building: Approximately 4460m²
9. Number of floors: Four Floors
10. Operational hours per week: n/a
11. Major Renovation and Refurbishment History:

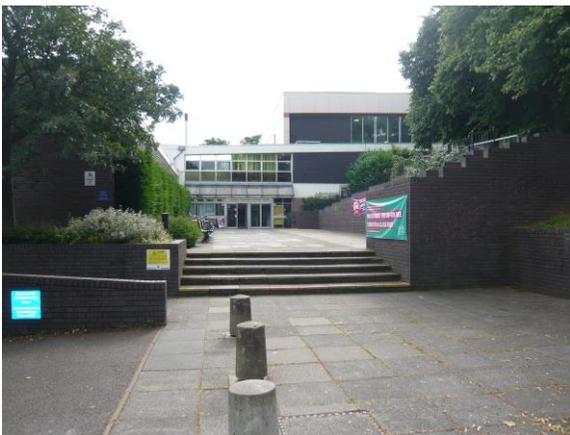
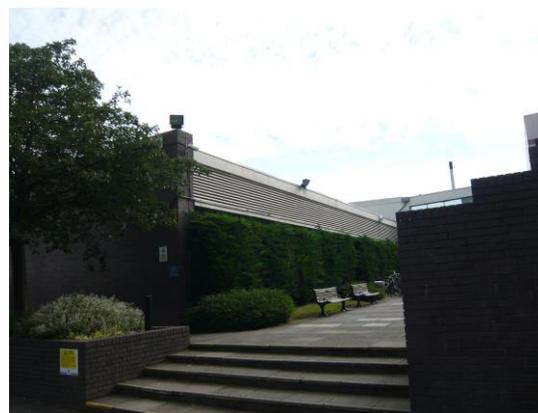
18. Pavements, Car Parks and other external access routes (concrete, asphalt, other) (S)

The south-west entrance to the facility is paved with traditional paving slabs with an approach

through an illuminated landscaped area from the main thoroughfare. The immediate approach to the entrance is by paving slab steps with an adjacent disability ramp approach. This area is in good condition.

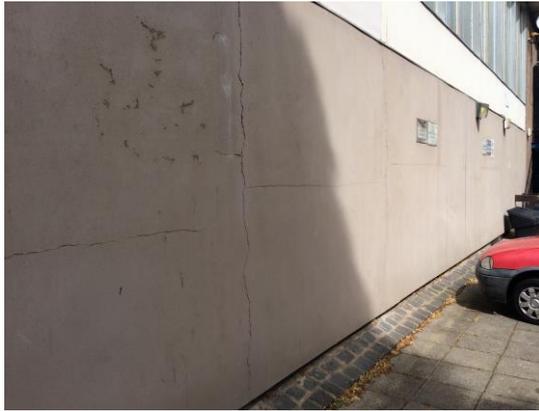
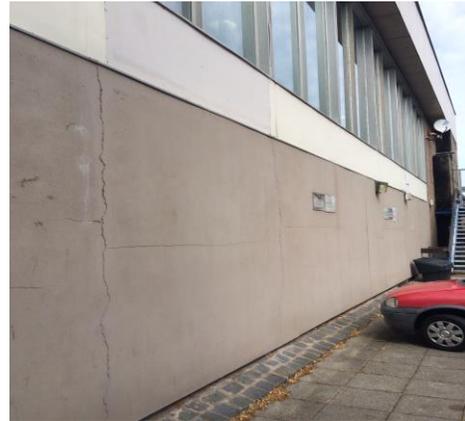
- Masonry
 - Concrete fascias
 - Panelled cladding
- b) Evidence of structural concerns with support system (columns/base plates/connections)
None observed
- c) Structural cracks
- d) Rot/decay/corrosion
Non observed
- e) Condition of external cladding **(U)**
External cladding is generally good on all sides of the building, there is some cracking on the rear of the building which appears to be due to the lack of and misalignment of expansion joints.

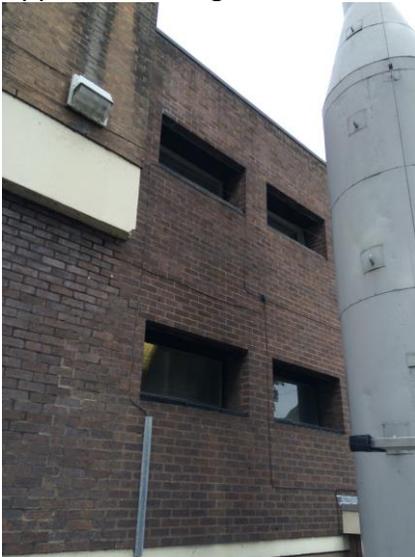
22. Chimneys/Flues **(S)**

Appear to be in good condition with no signs of deterioration.

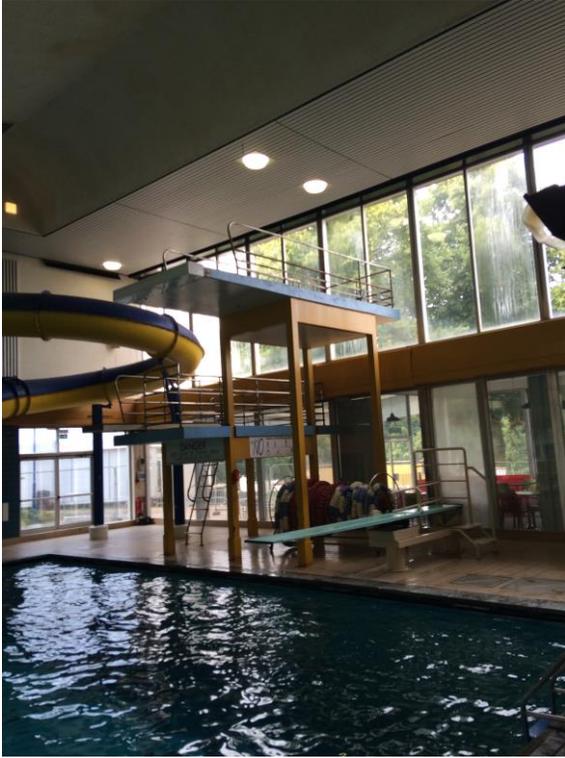
27. Windows (external & internal) (S)

All windows are of an aluminium clip frame type with double glazed units. Most of these double glazed units the seals have now failed and are in need of replacement, these are inadequate for most public facilities and especially for a high energy use swimming pool.

Energy efficiency – single, double , triple glazing, tinted
Double glazed (Seals gone). Unsatisfactory.

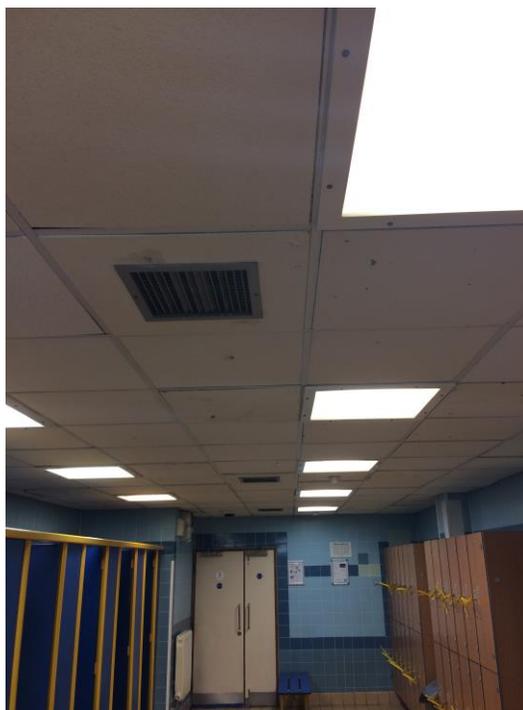
36. Interior Lighting System and ceilings**(S)**

Types of interior lighting systems
Sodium light fittings in the pool hall mainly accessible from the ceiling void.
Condition of interior lighting fixtures
Reasonable
Energy Savings functionality
Reasonable
Overall condition of internal lighting system
Satisfactory
Emergency Lighting System
Satisfactory
Interior ceilings
Apart from the pool hall all ceilings are either plaster finish or ceiling tiles in reasonable condition.
Some tile damage.

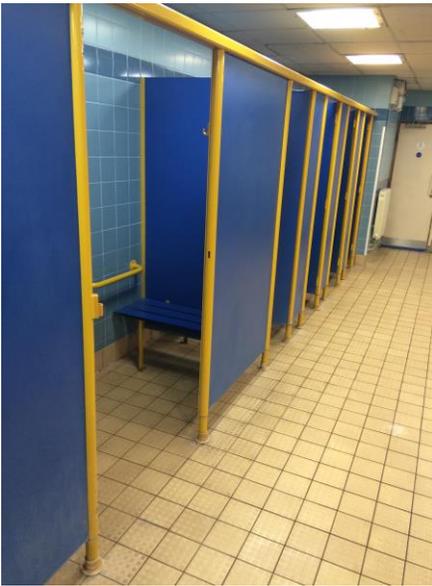
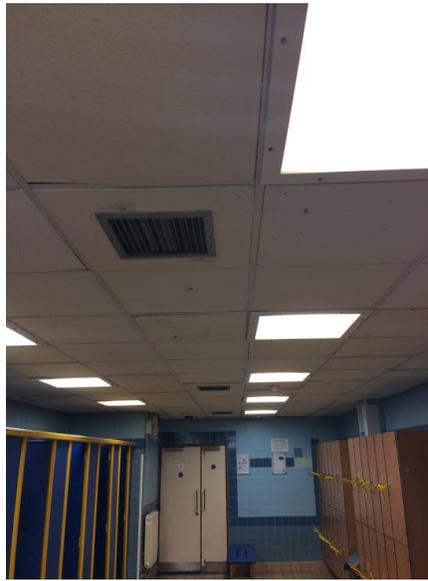
43. Changing Rooms **(U)**

All three areas are similar in that they contain open bench changing, some cubicle changing for increased privacy (more in the female changing room than in the men's), clothing lockers, wet side toilets and showers. Views shown are from the male changing room but are indicative of the other changing areas.

The changing area is generally run down and tired in appearance. The fixtures and fittings are old and the colour scheme bland.

The changing room deck quarry tiles are robust but old and unattractive.

The walls and ceilings within the changing rooms are robust. The walls are tiled and in some places mismatched tiles have been used to retiling which doesn't render to an attractive appearance.

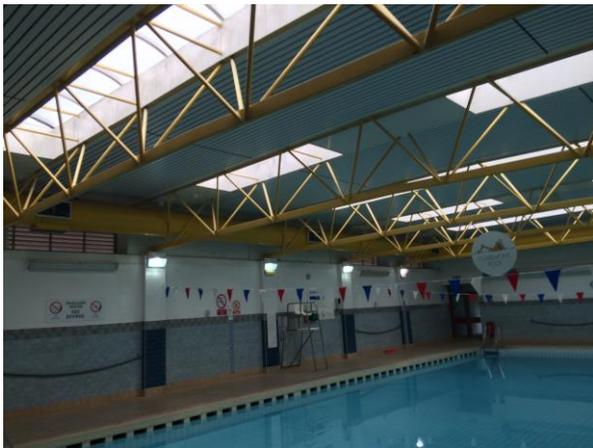
48. Pool deck **(S)**

The pool deck is tiled with robust quarry tiles, which were the standard flooring of pool decks in the 1960's and 70's. They are serviceable and reliable but lack the attractiveness of modern ceramic tiles.

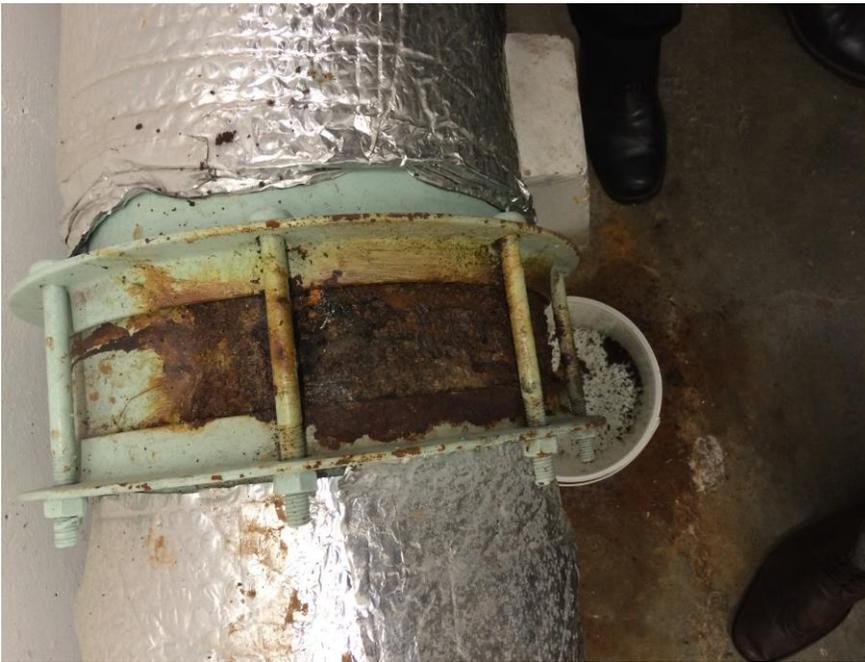
56. Pool Circulation System **(S)**

The pool circulation system is achieved by inlets throughout the pool and outlets at scum trough approx and at bottom outlets. It is a safe system and achieves good turnover and water quality. Integral pipe work is mainly exposed in the undercroft and at ground floor in the plant room area this compromises a variety of both existing cast and replacement plastic and is in reasonable condition.

No internal inspection of the pipework has been carried out however the filters were recently inspected with the internals reported by the operator to be of good quality. There was a leak detected evident below.

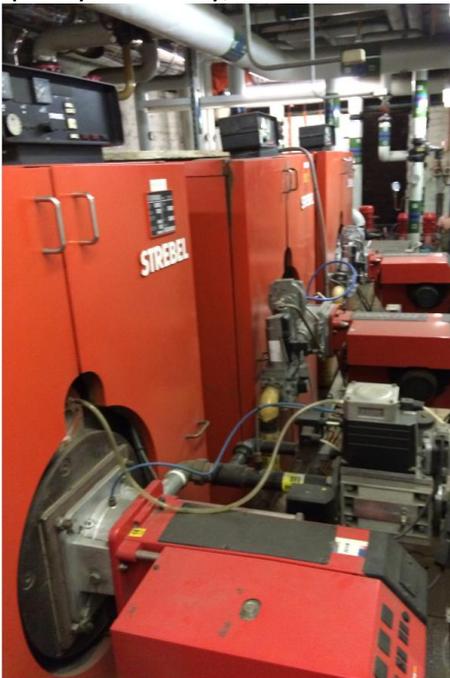
All the centre heating provision is by a primary hot water circulation system serviced by three strebel gas fired boilers that have relatively new burner heads and are in good condition for their age. Although they are not as energy efficient as newer boilers they are moderated by an automatic operating sequencer, which improves their efficiency and they remain serviceable.

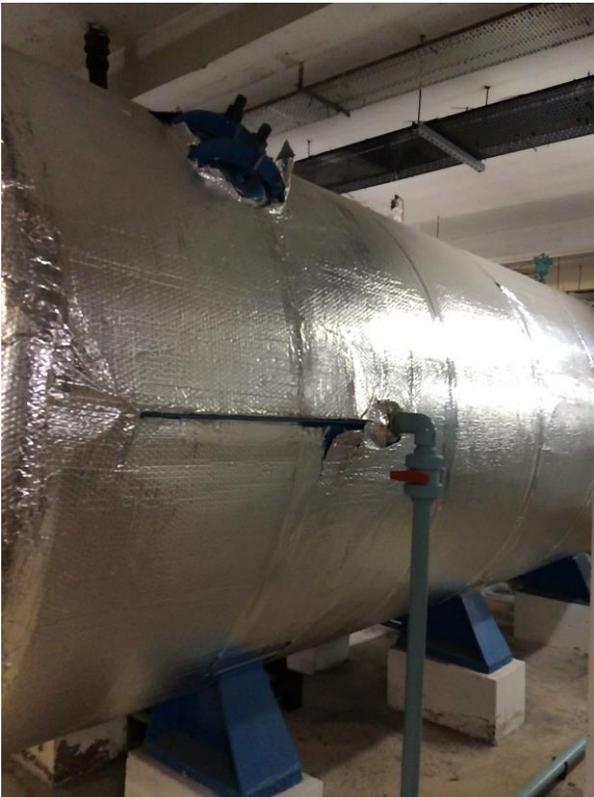
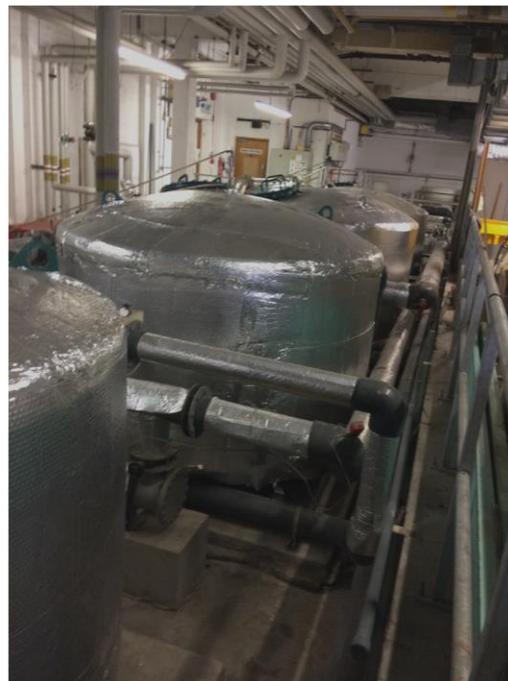
61. Filtration System (S)

The pool water is filtrated through two large horizontal filters that are clearly the original filters. They appear to have been well maintained and the exterior shell shows no signs of significant deterioration, although the frequent paint coats may mask such. Filters received a recent media change and inspection which identified no signs of severe deterioration. The design of horizontal filters is inefficient and usually only the front third of each filter is effective in filtrating. Nevertheless the system is working and water quality is satisfactory and there is no reason to consider removing these filters until it is absolutely necessary. If this pool remains operational they will have to be changed within the next ten years. They were constructed on site and the plant room built around them and will have to be cut up on site.
