SHROPSHIRE COUNCIL

Quarry Swimming & Fitness Centre

Building Survey Report

November 2014

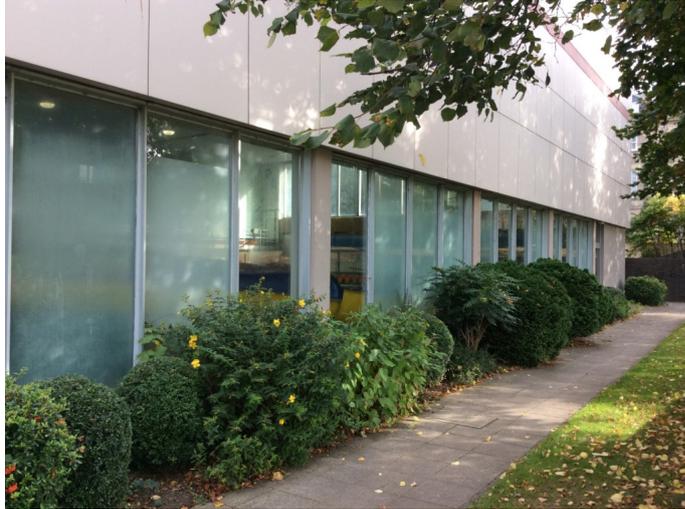
- 5.14 The glazing panels to the full height frames have failed allowing moisture and condensation to form between the internal and external skins. In addition, gaskets have deteriorated or are missing, being replaced with a silicone seal that does not provide adequate protection. Cover strips and trims are also missing or have been mechanically damaged during maintenance works and general corrosion is occurring to isolated locations. These panels are considered to be in a poor condition and should be replaced with a more modern energy efficient product.

Photograph 1: General view of defective glazing to poolside elevation.

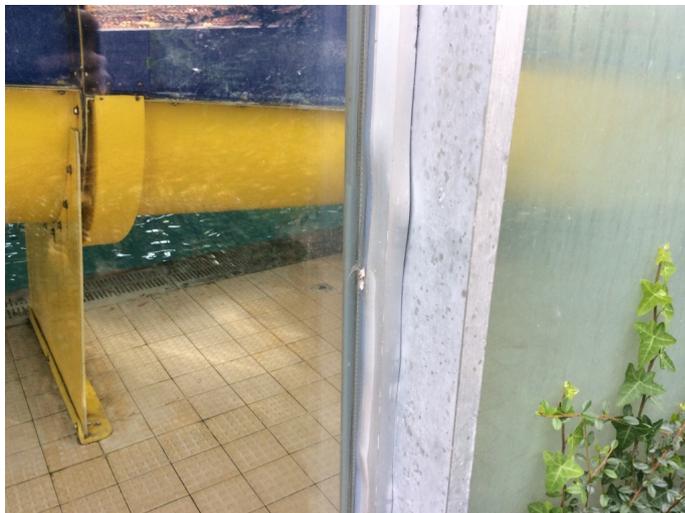
Photograph 2: Damage gasket cover trim to poolside glazing

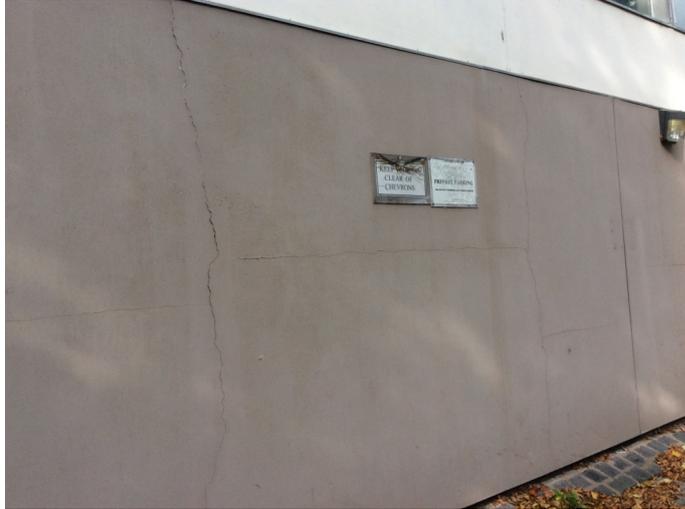
- 5.6 The render throughout the low level areas is in poor condition, cracking is prevalent throughout and it is apparent that significant amounts have debonded from the background substrate. Low level water damage and saturated render is also evident which will be affecting the internal finishes and environment. Any loose / debonded plaster will continue to deteriorate and any trapped water behind may cause freeze / thaw action that will accelerate the breakdown. Again isolated repairs will be ineffective and all such finishes will require removal and replacement.

Photograph 3: General view of cracked and damaged render finishes

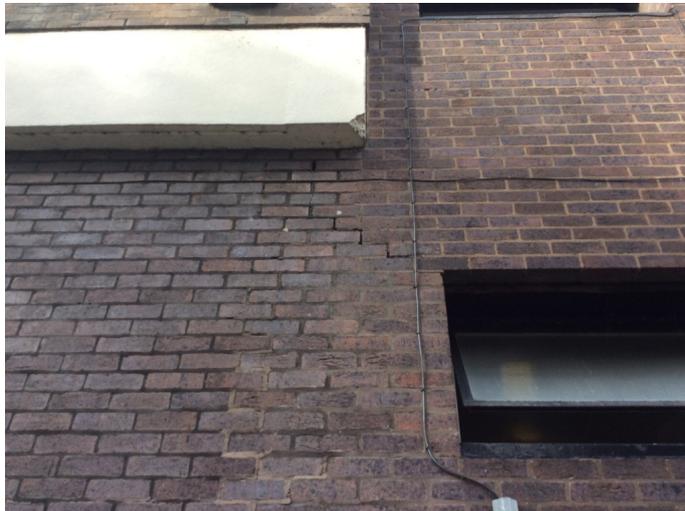
Photograph 4: Stepped cracking

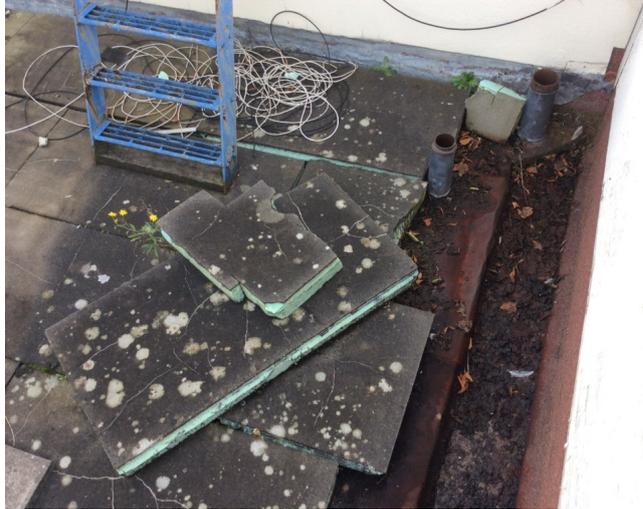
- 4.4 The insulation boards incorporate a tongue and grooved edge and will have been designed to negate wind uplift etc. Our inspection identified that the insulation boards have been subject to movement and have begun to deteriorate and curl. Joints between boards have opened and are considered excessive allowing significant plant growth to occur on the underlying waterproofing layer. This profuse growth and associated debris will cause damage to the coverings, shortening an already limited remaining lifespan. Although a number of areas have been replaced post 1994 the existing insulation has been relayed, and again significant growth has occurred at these points.

Photograph 5: General view across roof showing displaced and damaged insulation

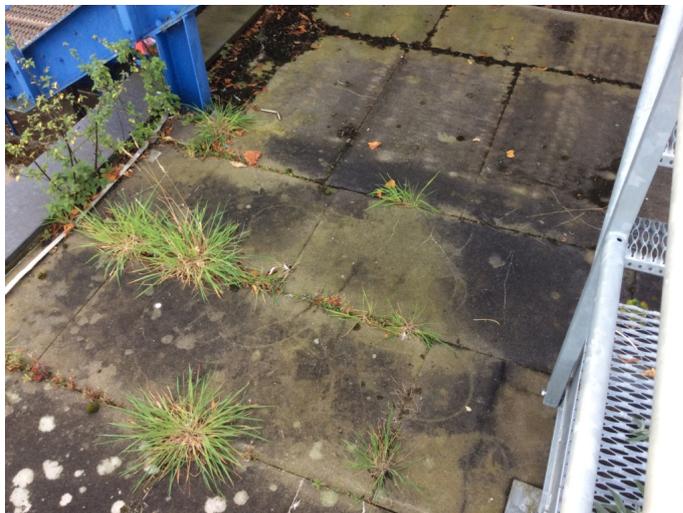
Photograph 6: General view of plant growth across roof

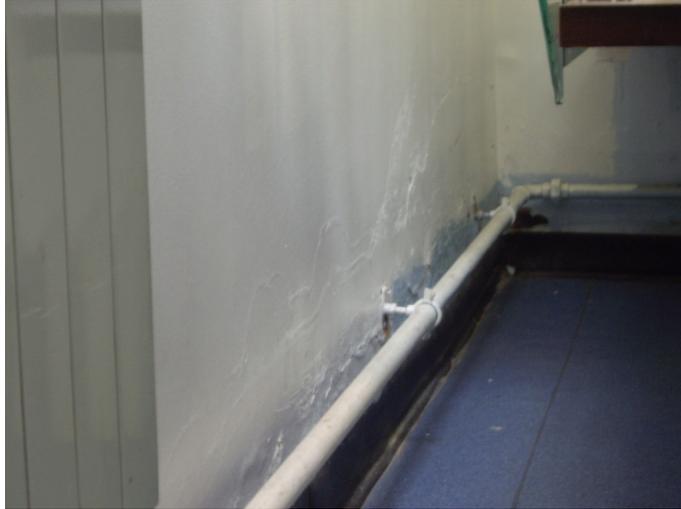
Photograph 7: General view of low level water damage to plastered surfaces

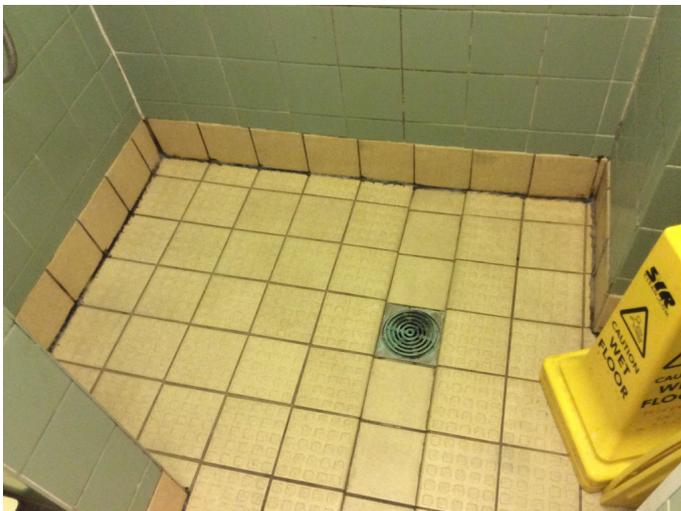
Photograph 8: Typical view of tiled floor finishes

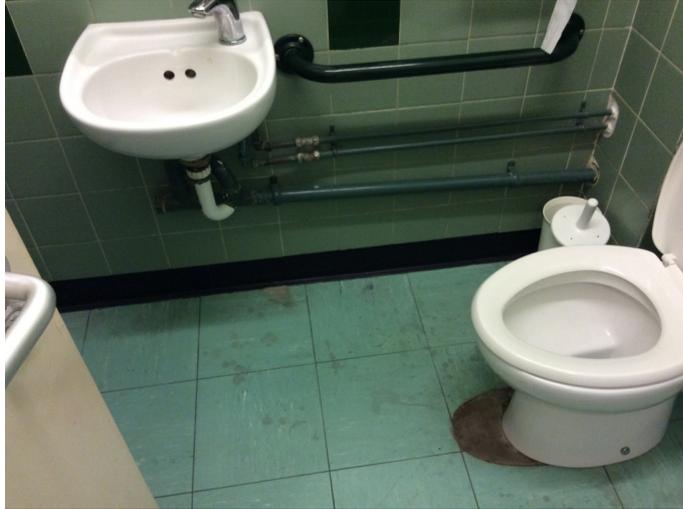
Photograph 9: Damaged / poor vinyl floor finishes

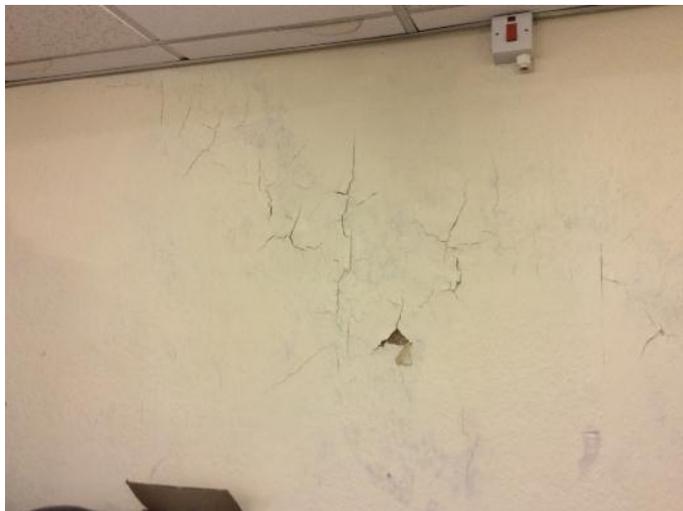
Photograph 10 Damaged plaster surfaces

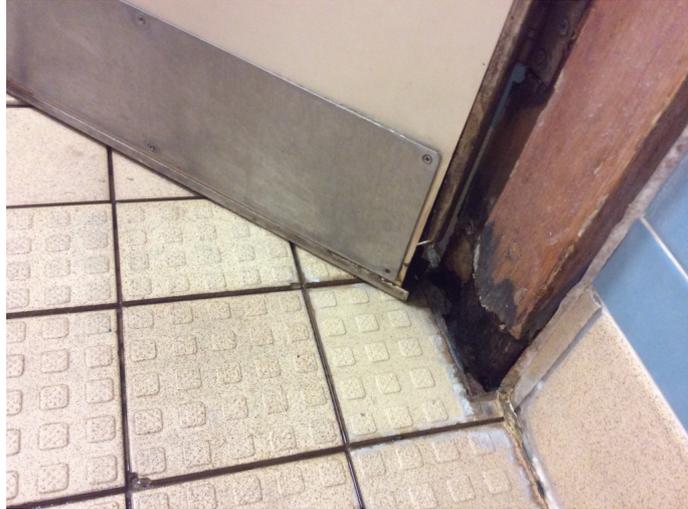
Photograph 11 Typical example of water damage to floor and low level joinery

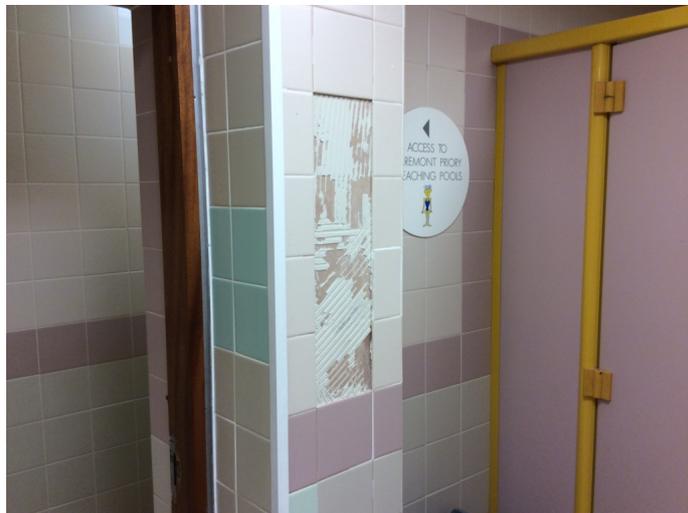
Photograph 12 Missing wall tiles

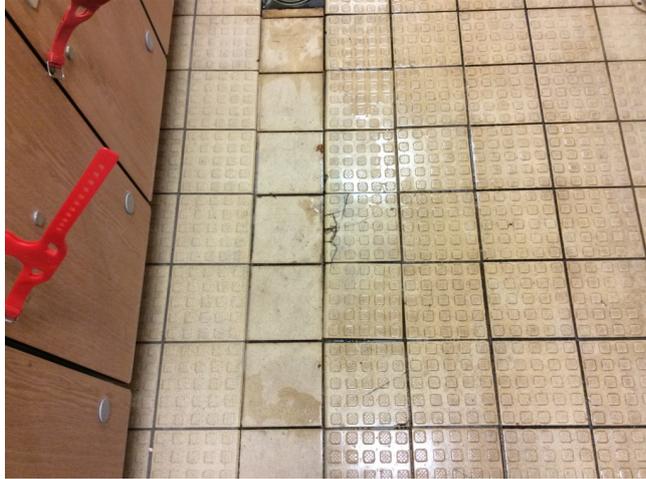
Photograph 13 Typical example of floor finishes

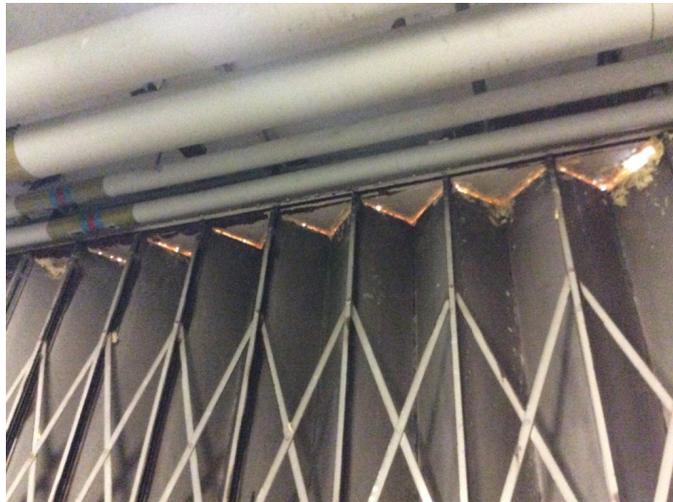
Photograph 14 Concertina door sealed with foam

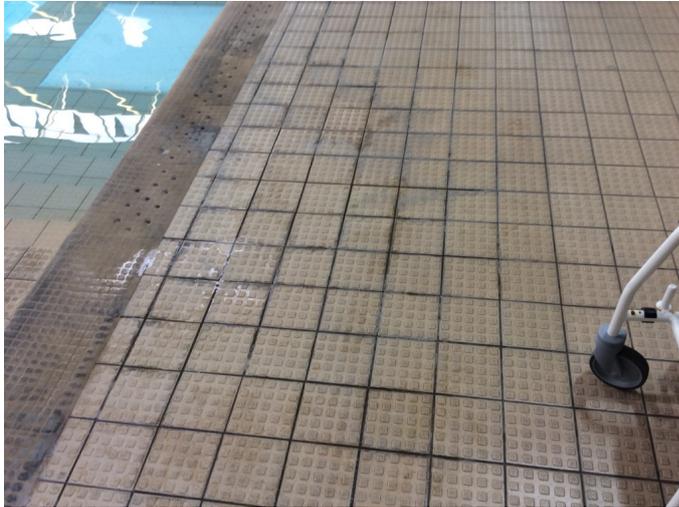
Photograph 15 Typical floor covering condition to pool side

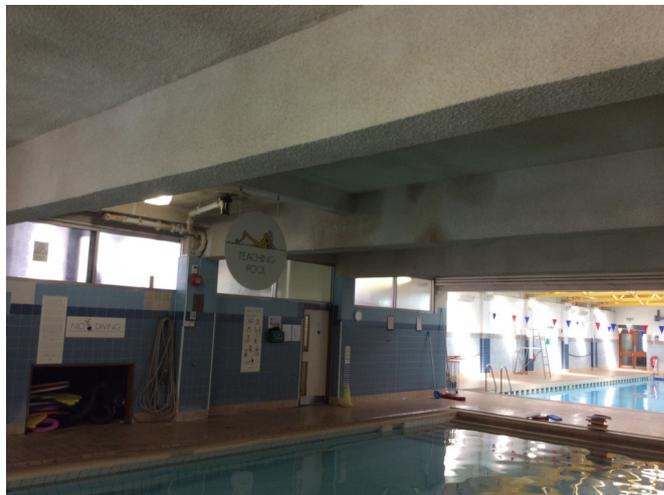
Photograph 16 Staining to ceiling areas

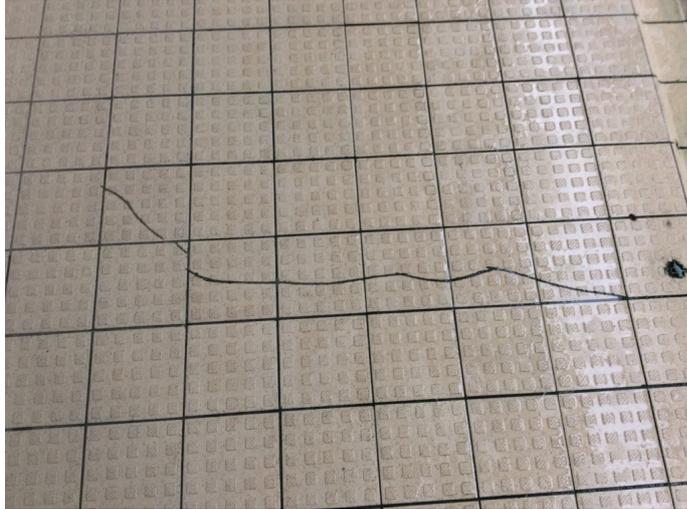
Photograph 17 Cracking within floor coverings

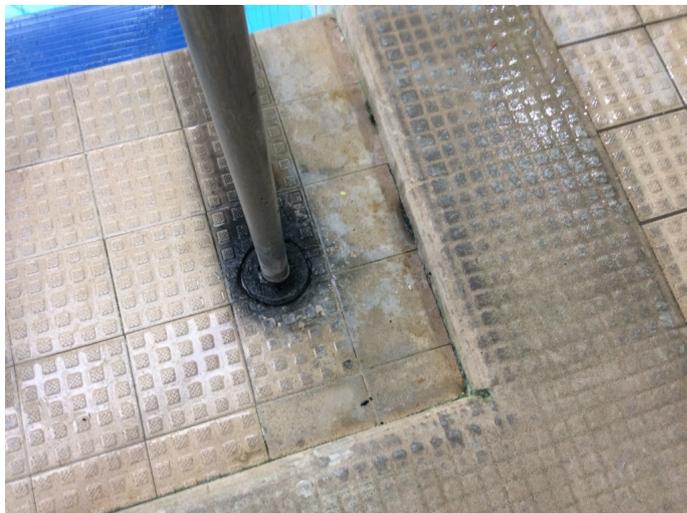
Photograph 18 Corrosion to metal fixings and algae growth

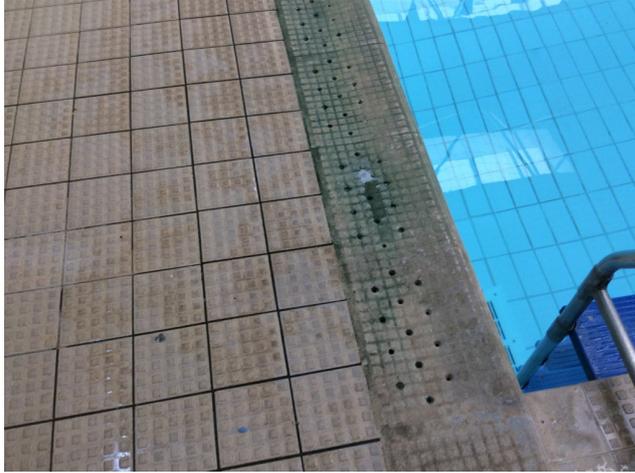
Photograph 19 Typical example of mechanical damage and algae growth to pool side

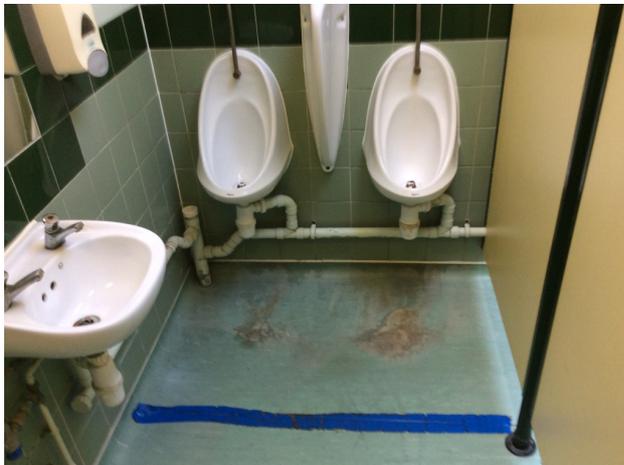
Photograph 20 Typical example of damaged vinyl flooring

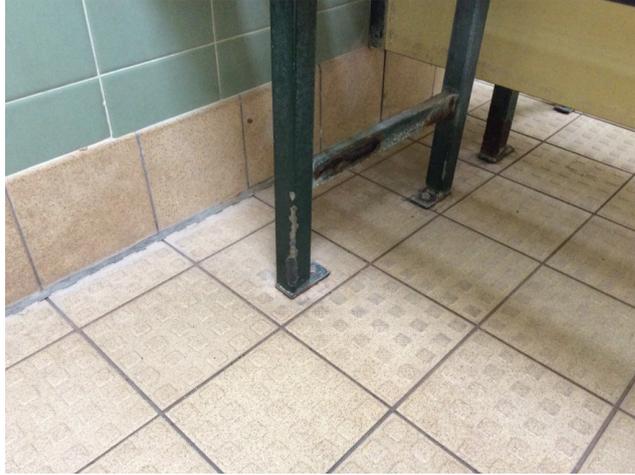
Photograph 21 Typical example of corrosion to fixtures and fittings

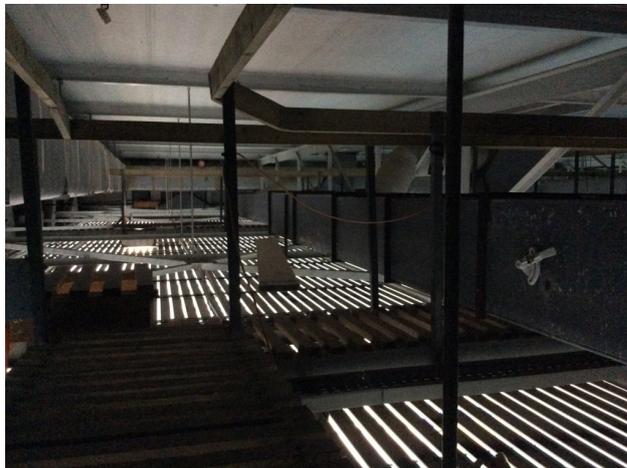
8.13 Access to maintain the ceiling mounted plant and equipment over the upper ground floor pool is via CAT ladder that leads to a timber walkway with ineffective and noncompliant handrails. To access equipment maintenance staff are required to traverse ductwork that intersects the walkway resulting in a high risk of severe / fatal injury. We would therefore recommend that access to these areas is prohibited until such time that a suitable system has been installed.

Photograph 22 High level access walkways and intersecting ductwork
