Whitchurch Swimming Centre

Building Surveyor's Inspection Report

Shropshire Council

9th April 2021

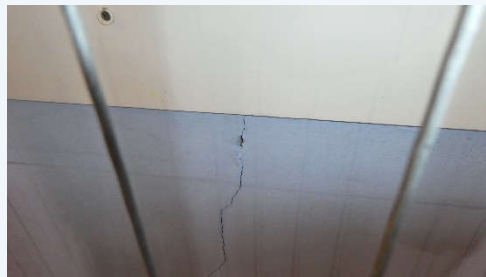
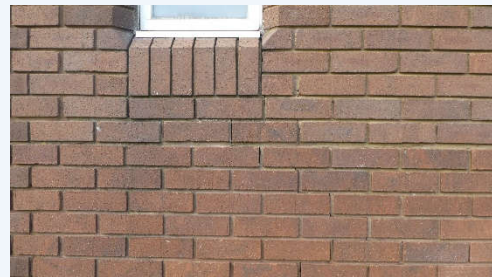
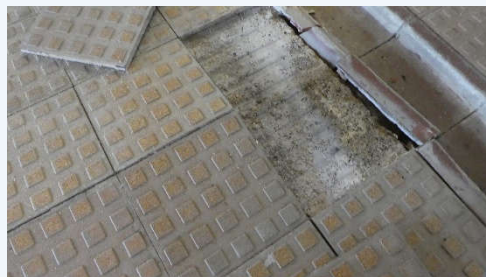
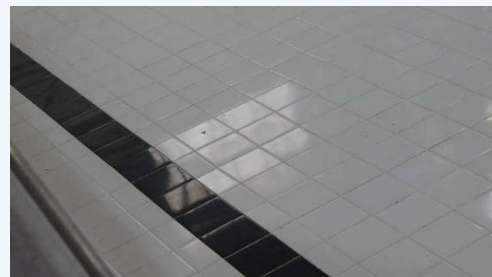
1. Movement and lifting of tiled coverings to the perimeter walkways ■
2. Movement and lifting to tiled coverings within the pool structure ■
3. Stepped internal cracking to external wall of viewing area ■
4. Stepped external cracking to external wall – South East Elevation ■
5. Removal of vegetation to review external wall – North West Elevation ■

- i) Movement is evident within the structure at the change of level position and across a specific section of the building line.

4.0	Further Investigations Required	
4.1	Further Structural Engineer advice and inspection is required to determine severity of issues noted at 1.1.	High

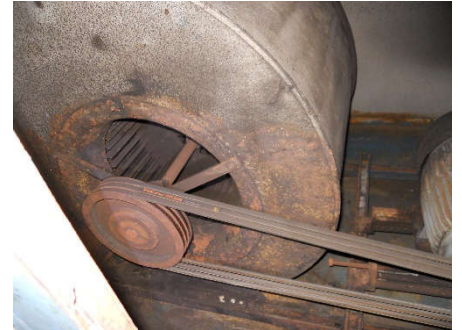
Photo 3 - Air Handling unit, extract fan with surface corrosion.

The air handling unit is circa 1974. Within the extract side of the unit the fan has surface corroded, the cross-over heat exchanger surfaces have corroded. The LTHW heating and frost coils surfaces are corroded. The extract ductwork has surface corrosion and begrimed. All of which will require replacement and cleaning at a cost of circa £165,000.

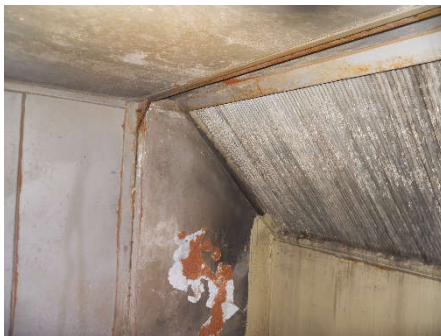
Photo 4 - Air handling unit, plate type heat exchanger with surface corrosion.

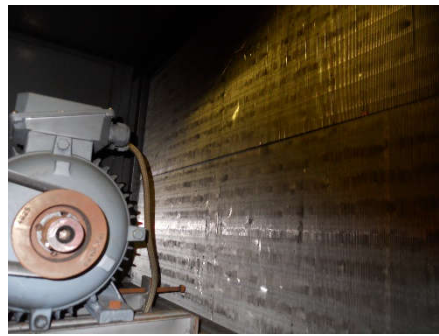
Photo 5 - Air handling unit, main heater battery with surface corrosion.

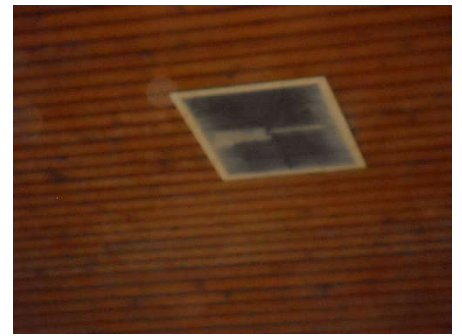
Photo 6 - Pool extract grille and ducts above, begrimed.

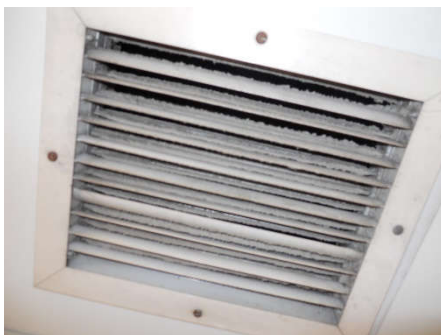
Photo 7 - Changing room extract grille and duct behind, begrimed.

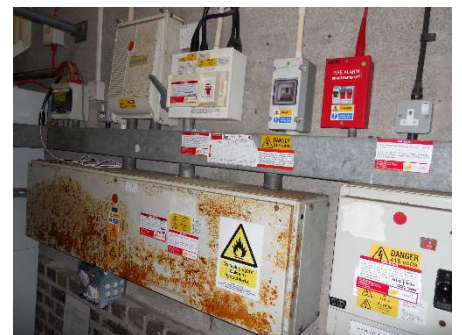
Photo 9 - Electrical bus bar with surface corrosion to enclosure.

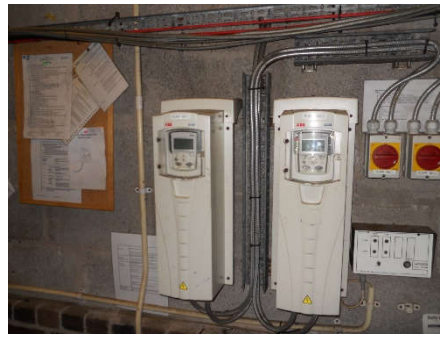
Photo 11 - ABB variable frequency inverter drives.

2.5	2No ABB HVAC variable frequency drive units are obsolete.	High
2.6	Air handling unit is circa 1974 and is corroded and requires replacement. Supply and extract ductwork similar.	High

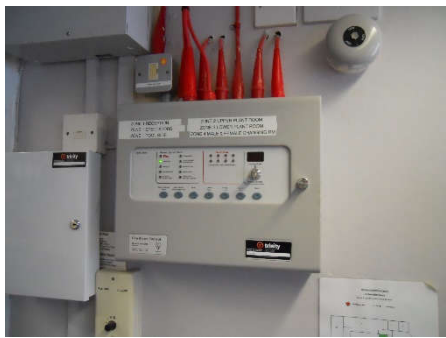
Photo 16 - Fire alarm panel.

2.7	200 mm sump outlet from corner of the pool is in poor condition.	High
2.8	Fire alarm and security panels require replacing.	High
2.9	Showering facilities require replacement.	High

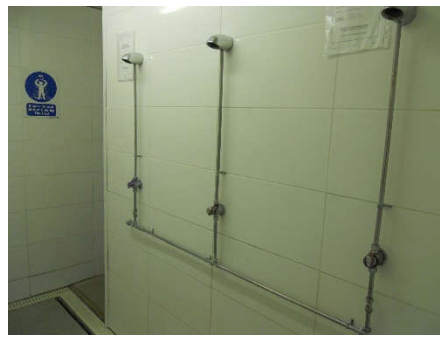
Photo 20 - Shower heads and control valves.

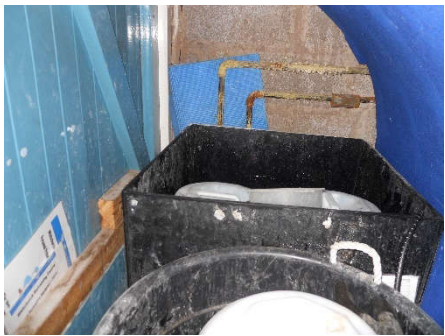
Photo 25 - Acid dosing tank and pump.

2.4	The acid storage unit and pump should be replaced with a unit with a barrier to prevent spills to the un-stabilised chlorine granules, which is within a constricted part of the plantroom.	High

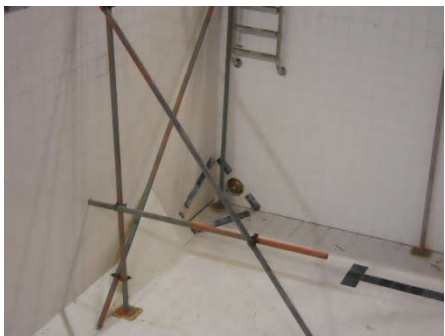
Photo 28 - Pool sump outlet, plugged.

The main mechanical installations are aged and incorporate a number of obsolete installations all of which will require renewal. The outlet pipework to the pool has previously had a liner installed and is understood to be leaking. The promenade will therefore require excavation to replace the pipework.
