# Whitchurch Library & Civic Centre

High Street, Whitchurch, SY13 1AX

Technical Overview and Options Appraisal of  
Reinforced Autoclaved Aerated Concrete

Property Services Group – Shropshire Council

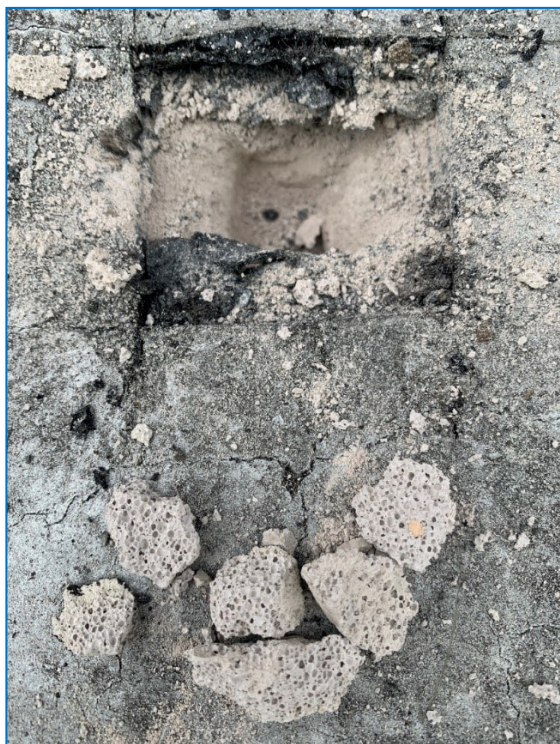
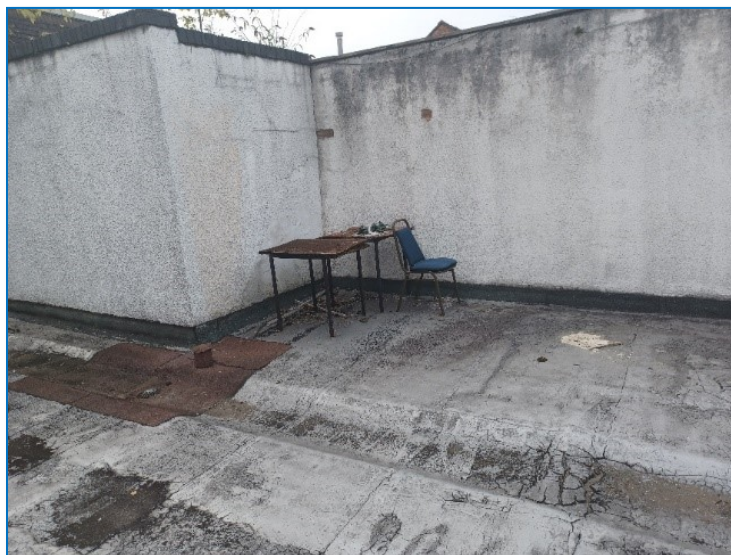
The age of the building is within the “scope range” of current RAAC desktop assessments. Archive microfiche plans of the building were limited in extent and content. Following investigations of RAAC in Shropshire Council buildings and a programmed capital re-roofing scheme to the Library roof (only), the presence of RAAC was detected in the roof area to the rear of the library. A sample of external penetration testing shows the “bubbly concrete” formation as an indicator that RAAC may be likely.

Figure 9 - Sample of roof library roof deck. Source Author

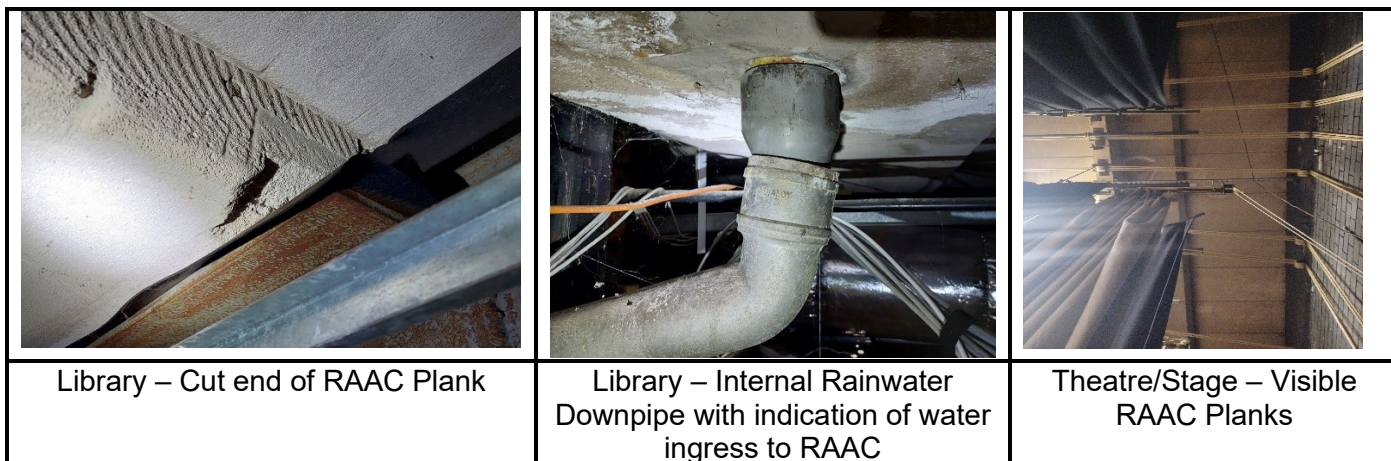
Following this positive identification the initial physical assessment was extended to the Civic Centre, though this was limited due to the initial inaccessible six-metre height of the main theatre area, fixed/suspended ceilings and also potential presence of Asbestos Containing Material (ACM). The condition of the RAAC planks observed in the library/registrar area where of general concern with evidence of water ingress, historic modifications of planks, reduced end bearing widths and minor cracking to walls in rear non-public areas. See **Figure 10** for examples.

Figure 10 - Initial RAAC physical inspection

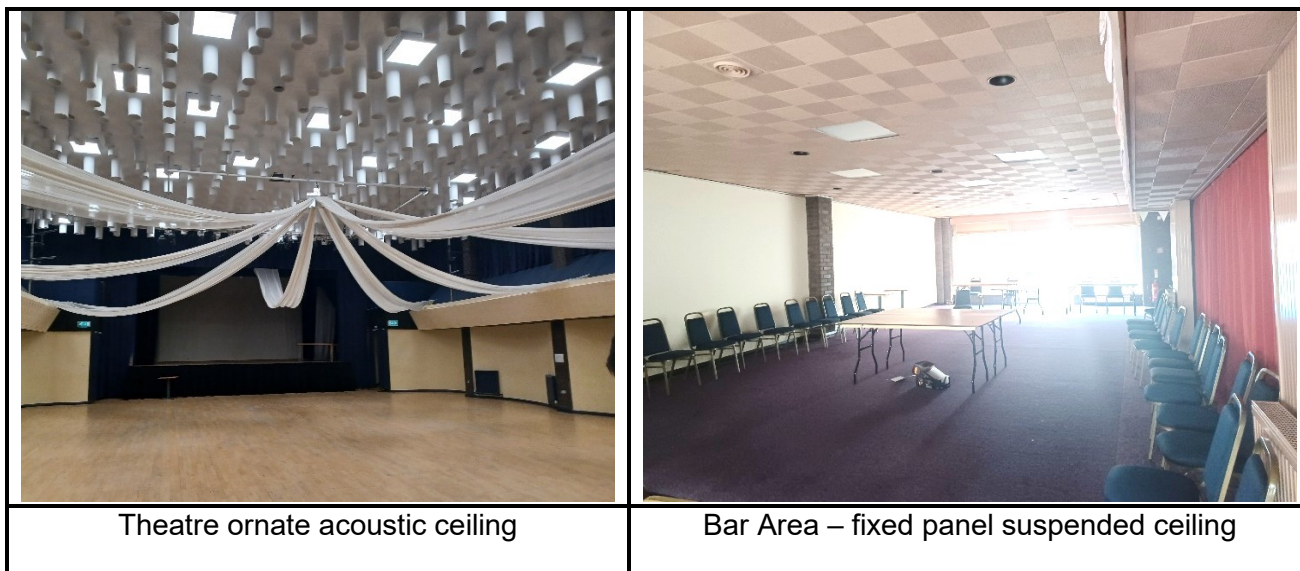
Figure 11 indicates the inaccessible/fixed ceilings preventing access.

Figure 11 - Civic Centre - fixed/concealed ceiling example. Source Author

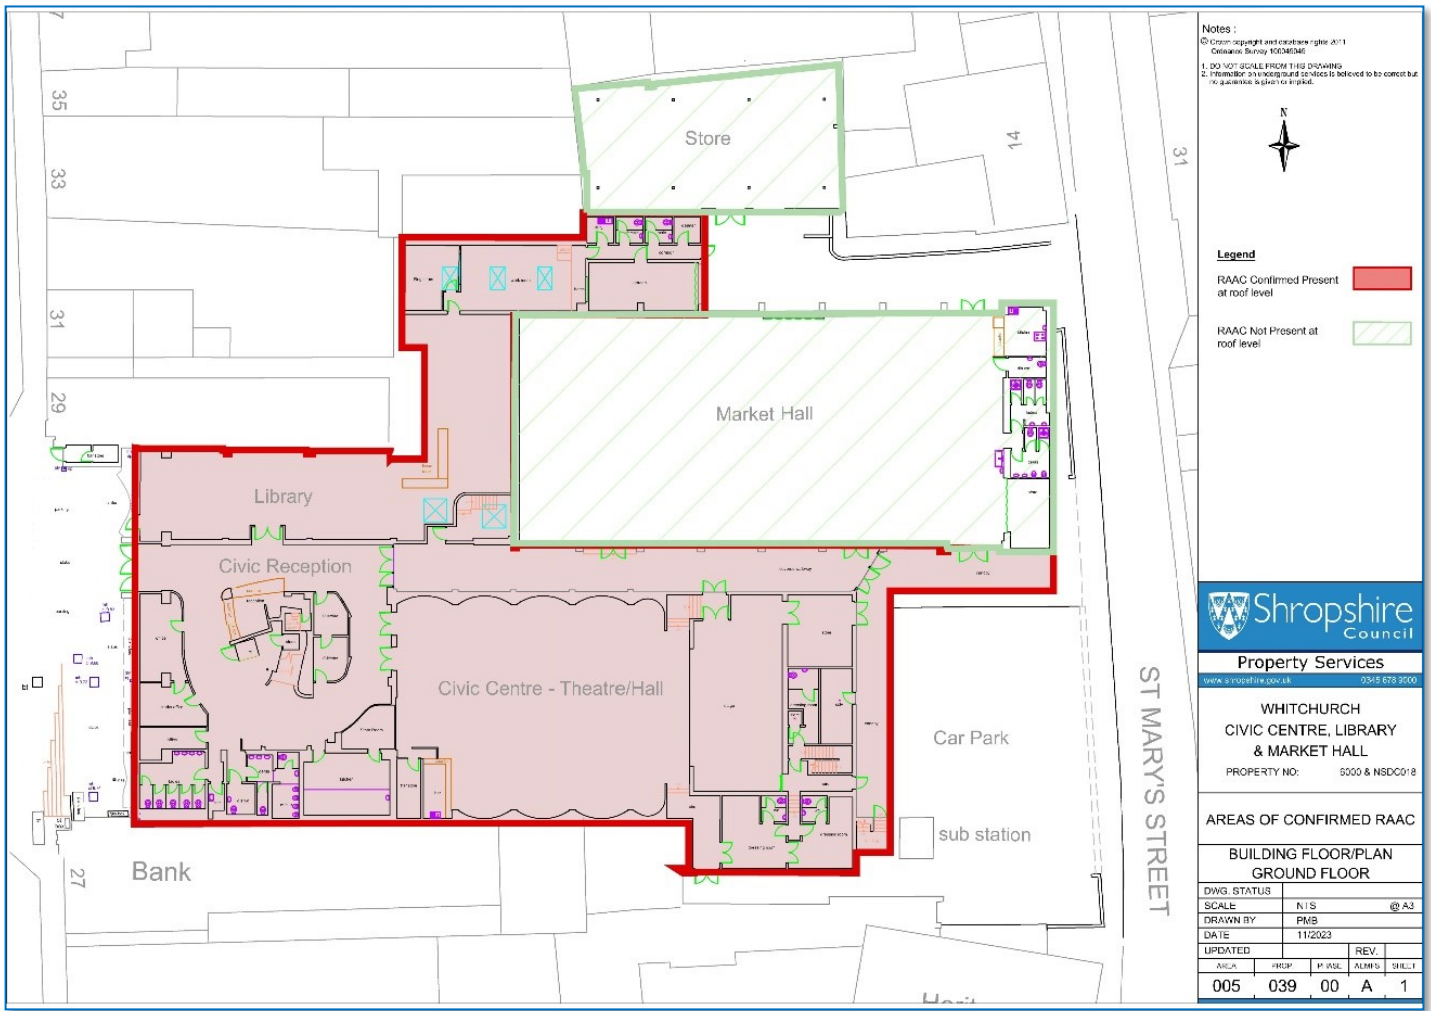
Figure 12 - Whitchurch Library & Civic Centre – Ground floor areas of confirmed RAAC at roof level.

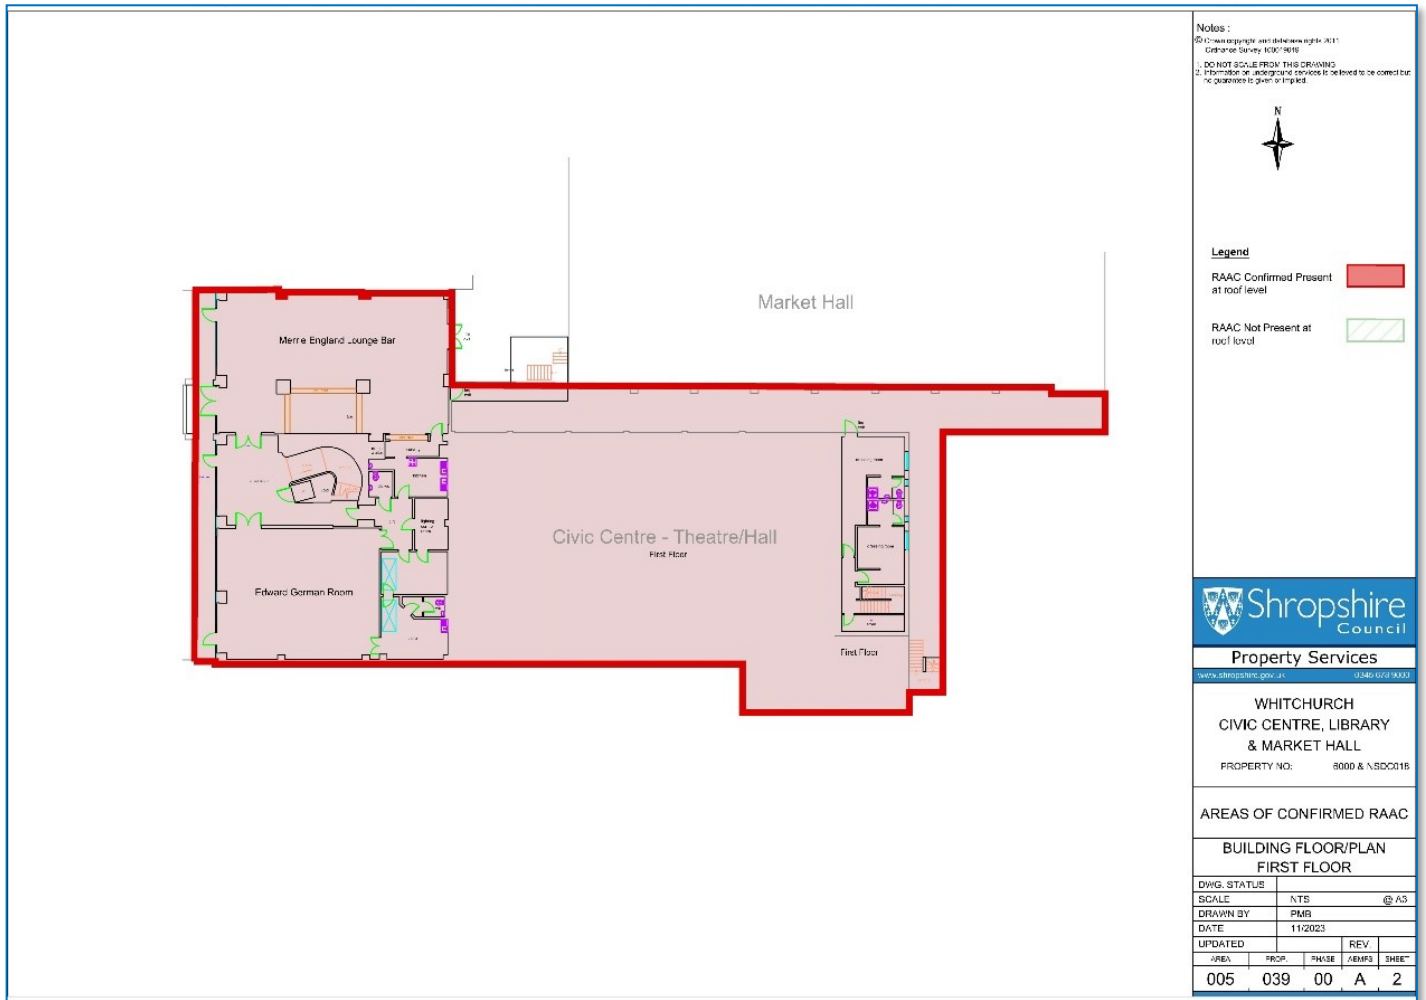
Figure 13 - Whitchurch Library & Civic Centre - First Floor areas of confirmed RAAC at roof level

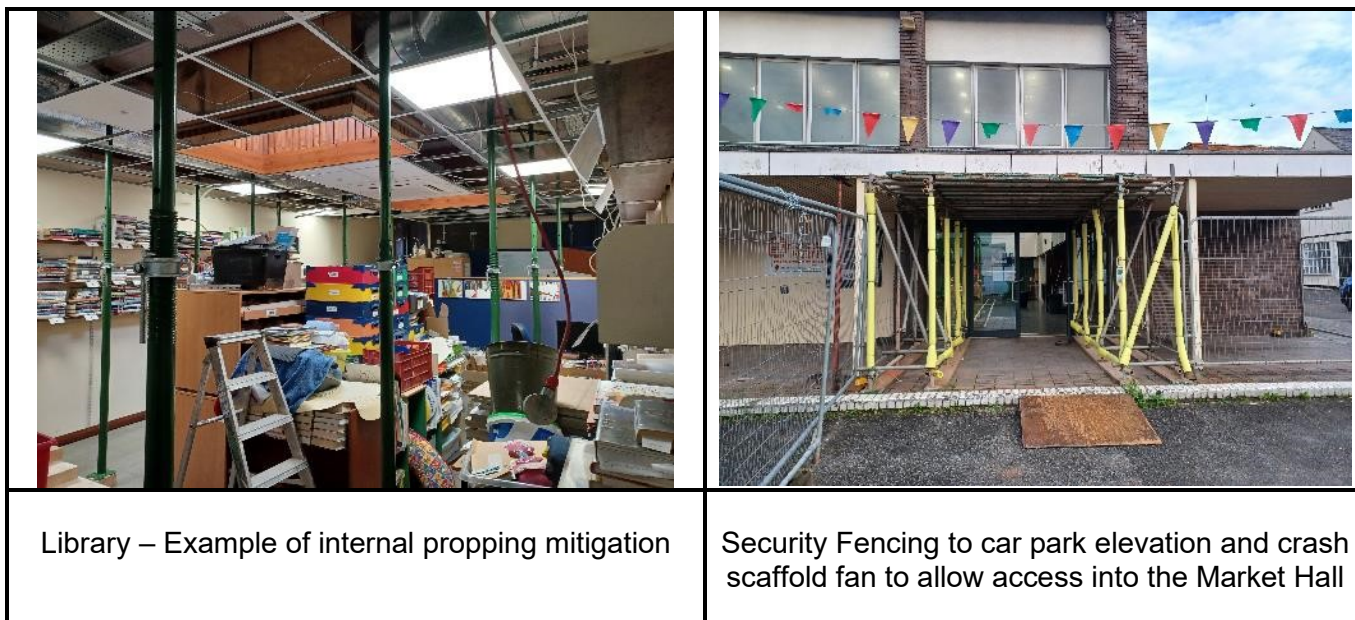
During further visual assessment additional defects were observed requiring a significant amount of additional propping and installed at close centre spacing by the Structural Engineer. As per industry guidance and Structural Engineer observations informed the Council's decision to vacate the Library/Registrars with immediate effect on a safety-first risk assessment approach. See **Figure 14**. Additionally, the building was limited in access and security fencing placed to the rear areas with a calculated crash deck fan constructed to the Market Hall car park public access route.

Library – Example of internal propping mitigation

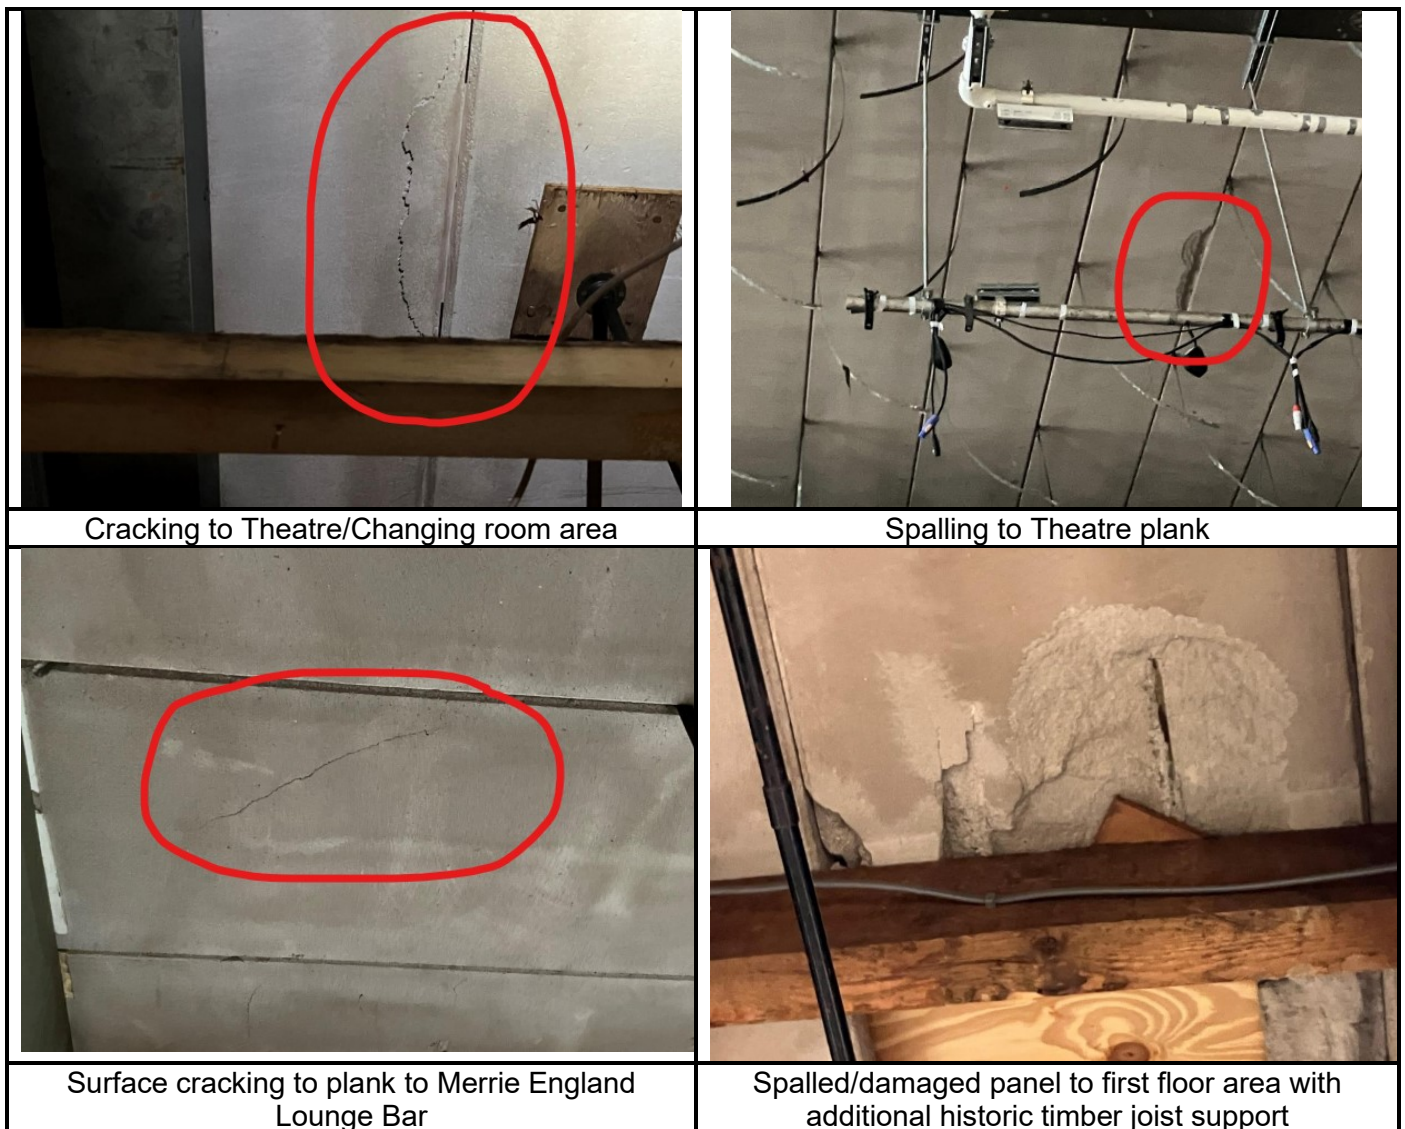
The RAAC planks to ground floor and first floor roof areas are supported largely by I steel beams, with castellated steel beams to the main theatre area. Noticeable movement of the Library roof was observed. However some areas, such as the changing rooms/external walkway appear to differ with support from timber joists which do not contain strutting/noggins to provide lateral support and indicated buckling or twist through torsion from structural loads. Surface cracking to various planks was observed throughout the property. See **Figure 15** below.

Figure 15 - Examples of visual inspection cracking and spalling. Source Thomas Consulting (2023).

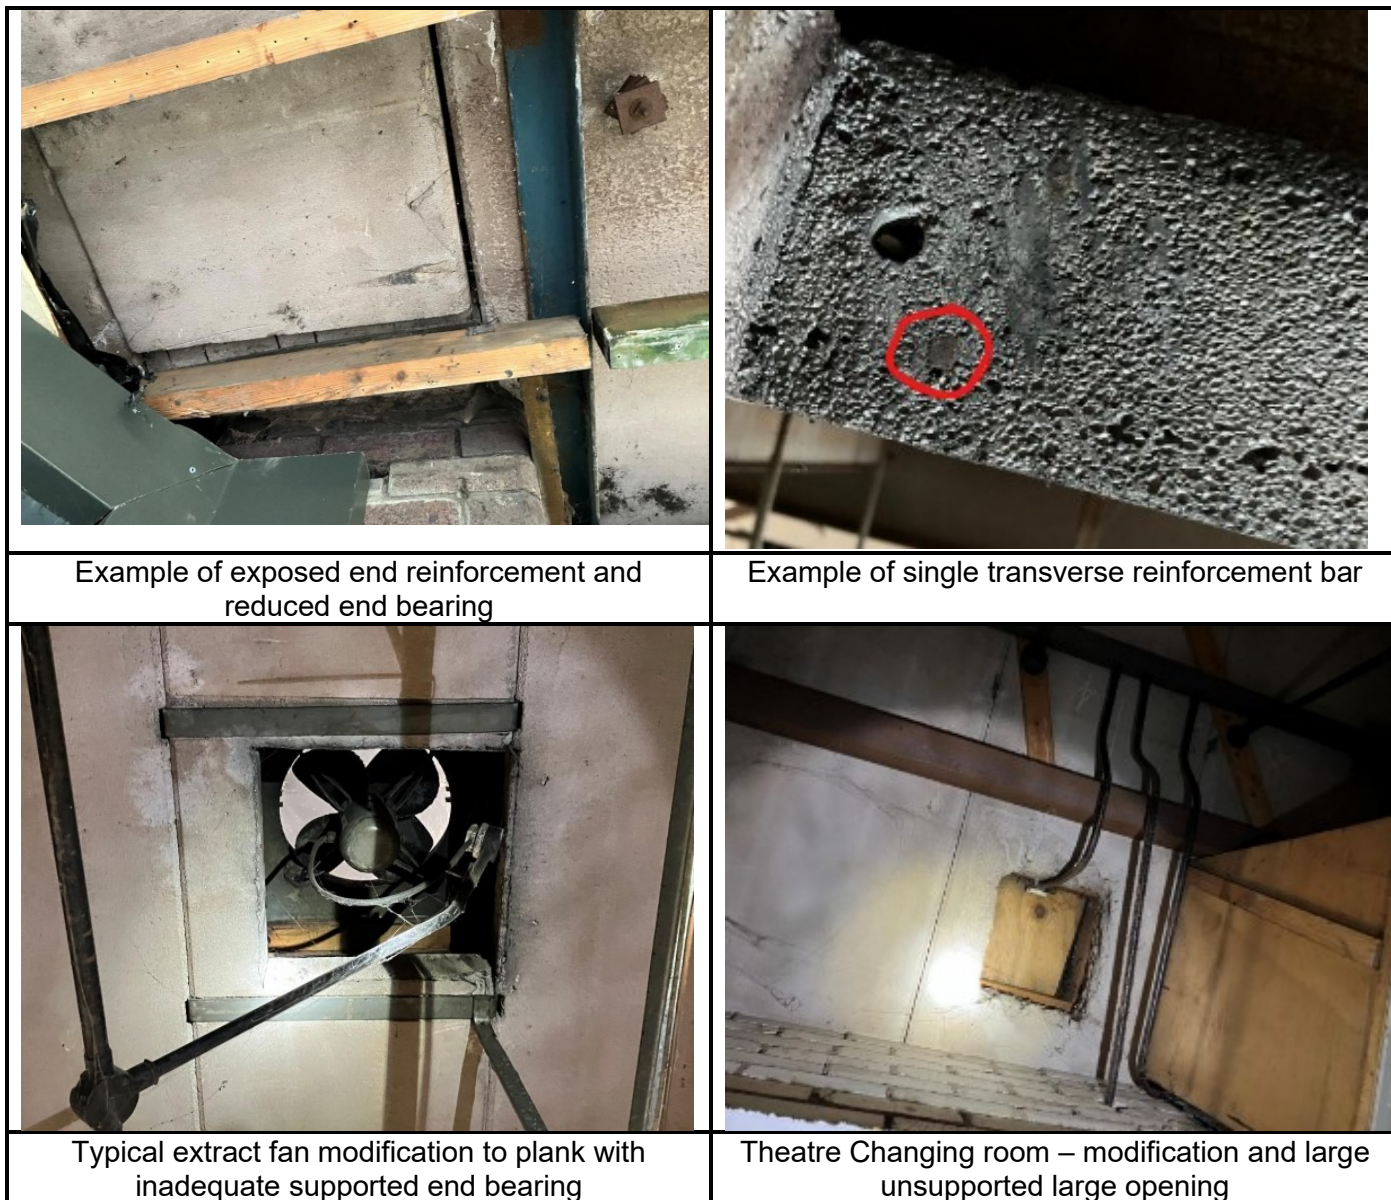
During the period of construction, the bearing design would have been 40mm. However current guidance is a minimum of 75mm. Various locations sampled indicate less than the optimum bearing distance of 75mm with several bearings sharing 100mm wide support (therefore offering only 50mm of bearing). Sampling of planks also revealed only one transverse reinforcement bar as being visible, where additional would be anticipated. The roof lights to the library are not adequately detailed to provide suitable end bearing support to the planks. There are a several historic extract fans cut into planks with inadequate unsupported edges. See **Figure 16**.

**Figure 16 - Examples of modification and penetrations to planks. Source Thomas Consulting (2023).**

Based on the visual observations noted above and the risk category in accordance with Table 1, this would classify the condition and support bearings observed in the Red (critical) category.

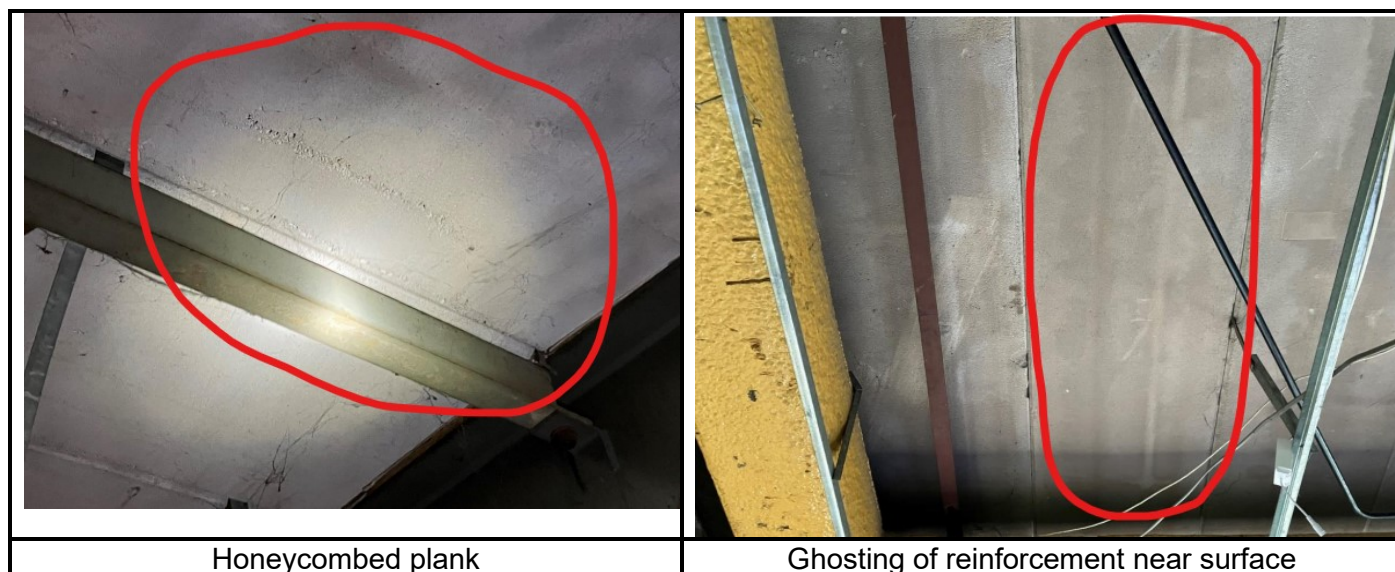
Reinforcement pattern or ghosting is visible to the underside some planks, indicating low coverage of reinforcement within the concrete. A selection of planks in the Theatre illustrates honeycombing and voids within the planks (at the time of manufacture). See **Figure 17** below.

**Figure 17 - Examples of honeycombing and ghosting of reinforcement. Source Thomas Consulting (2023).**

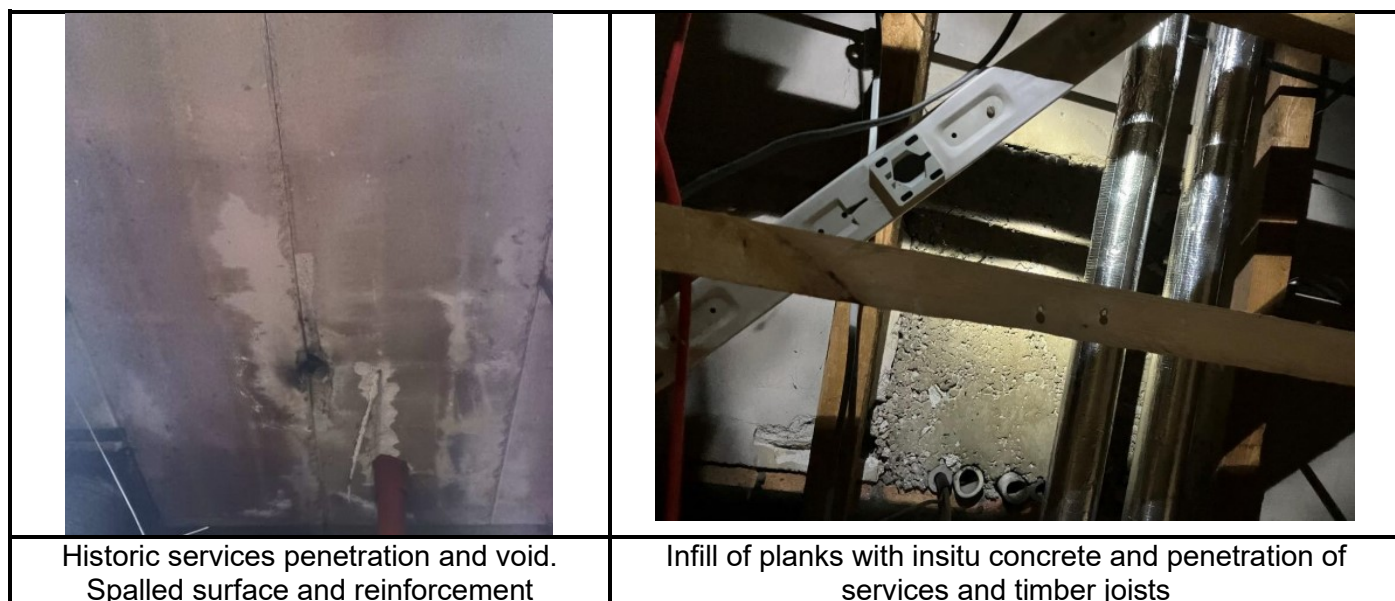
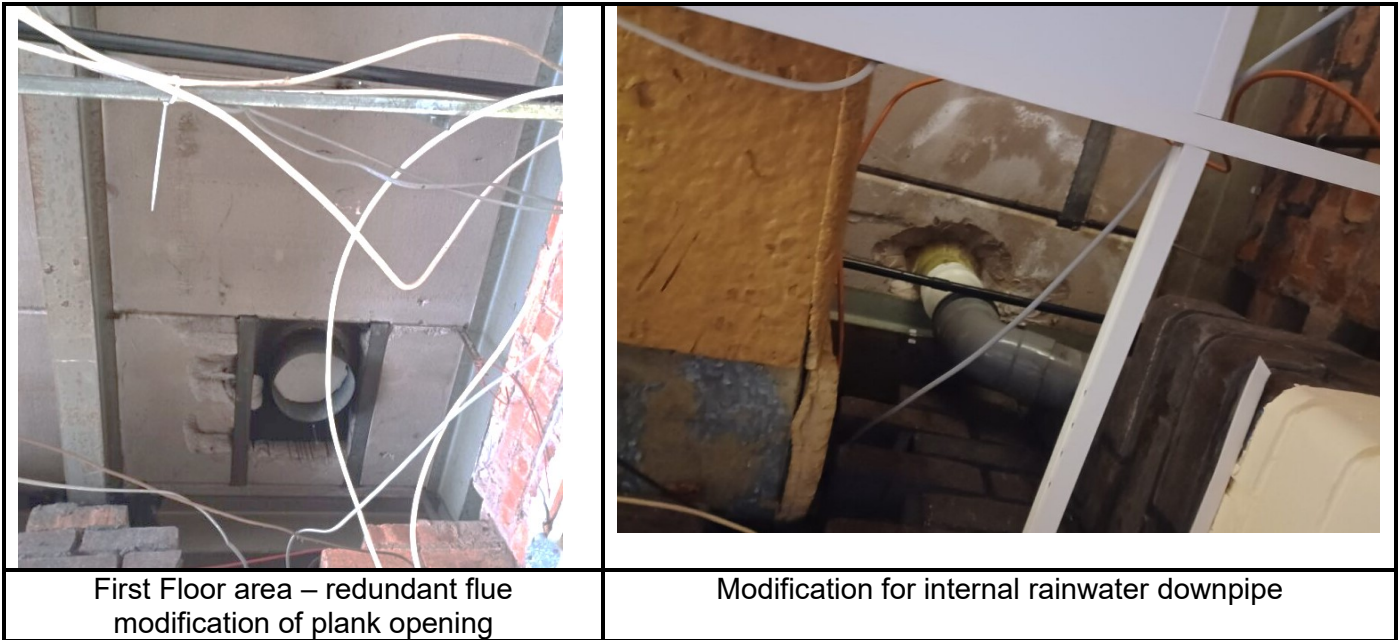
Visual observations of the invasive survey revealed further evidence of historic damaged and modified RAAC planks. This includes general spalled sections but also openings/penetration and fitting of services to RAAC planks throughout the complex. Several areas have original planks being replaced with an insitu cast section. See **Figure 18**.

Figure 18 - Examples of damage and modification of services. Source Thomas Consulting (2023)/PSG (2023).

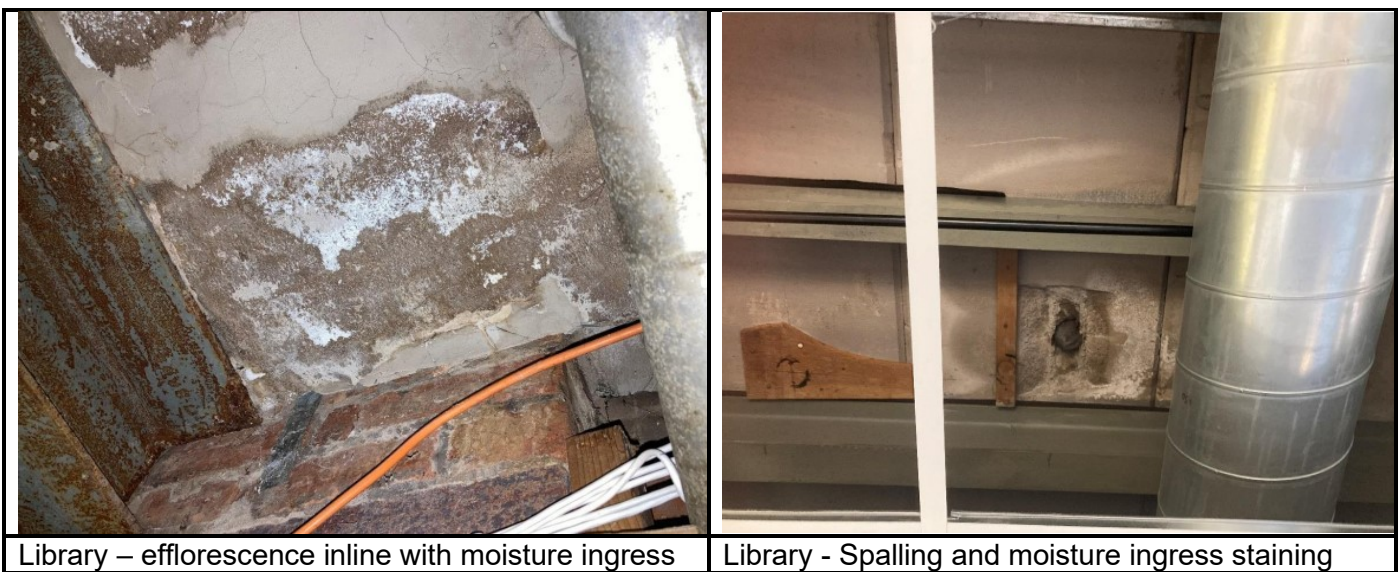
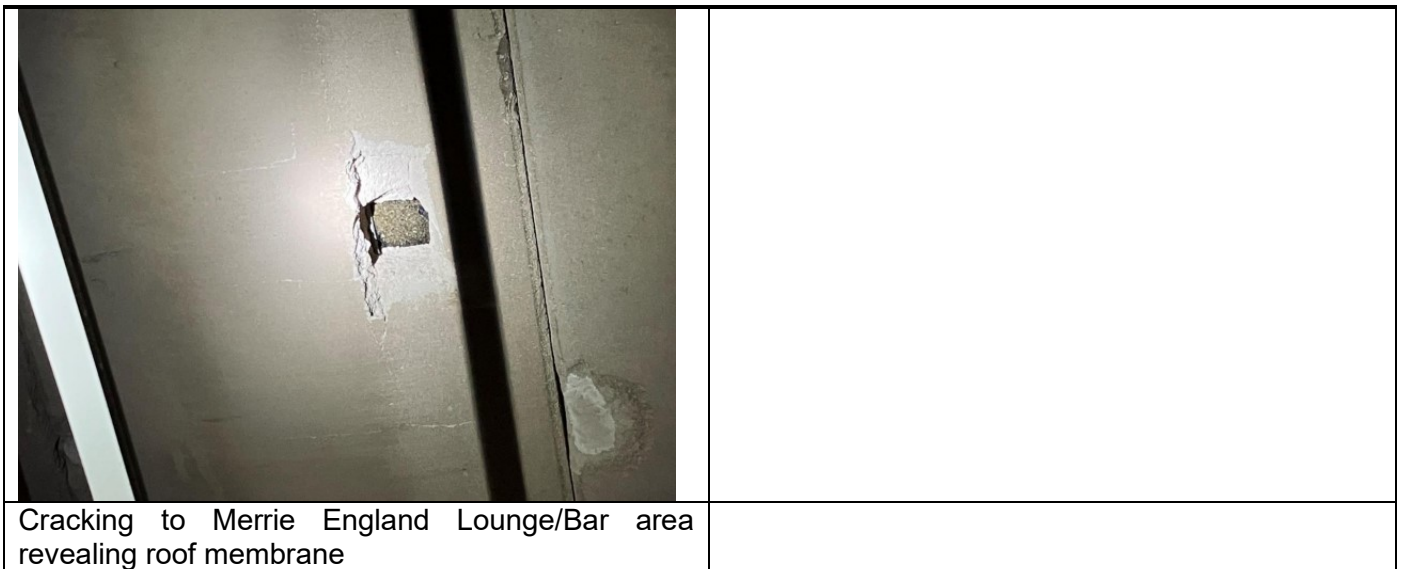
There is evidence of significant moisture ingress to the rear Library area, Registrar’s office, and Theatre roof areas indicated by staining of planks and efflorescence salts to the surface. It was observed of damaged panels to the first floor with missing sections of concrete to planks revealing the underside of the roof membrane. See **Figure 19** below.

Figure 19 – Evidence of moisture ingress and roof exposure. Source Thomas Consulting (2023)

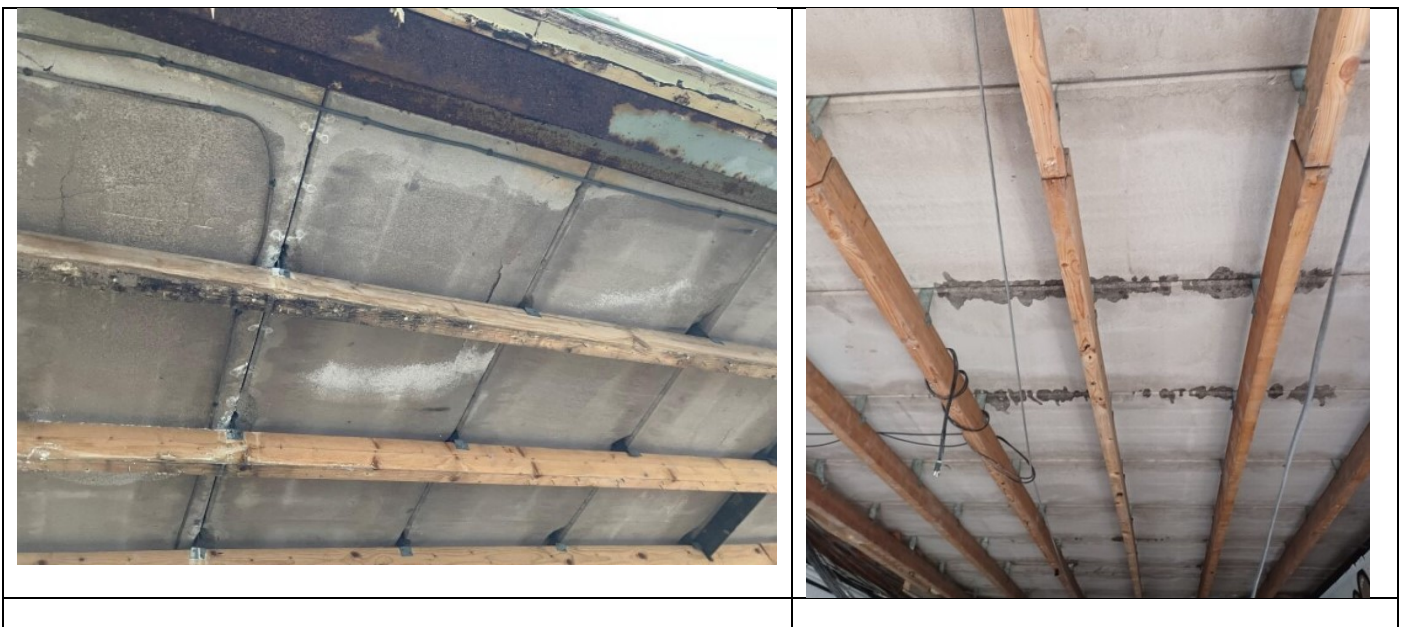
The external walkway indicated extensive moisture ingress with modified and inadequate supported panels in areas with steelwork heavily corroded. Cracking of panels is evident. See **Figure 20**.

Figure 20 - External Walkway - Unsupported modified planks, surface cracking and efflorescence from moisture

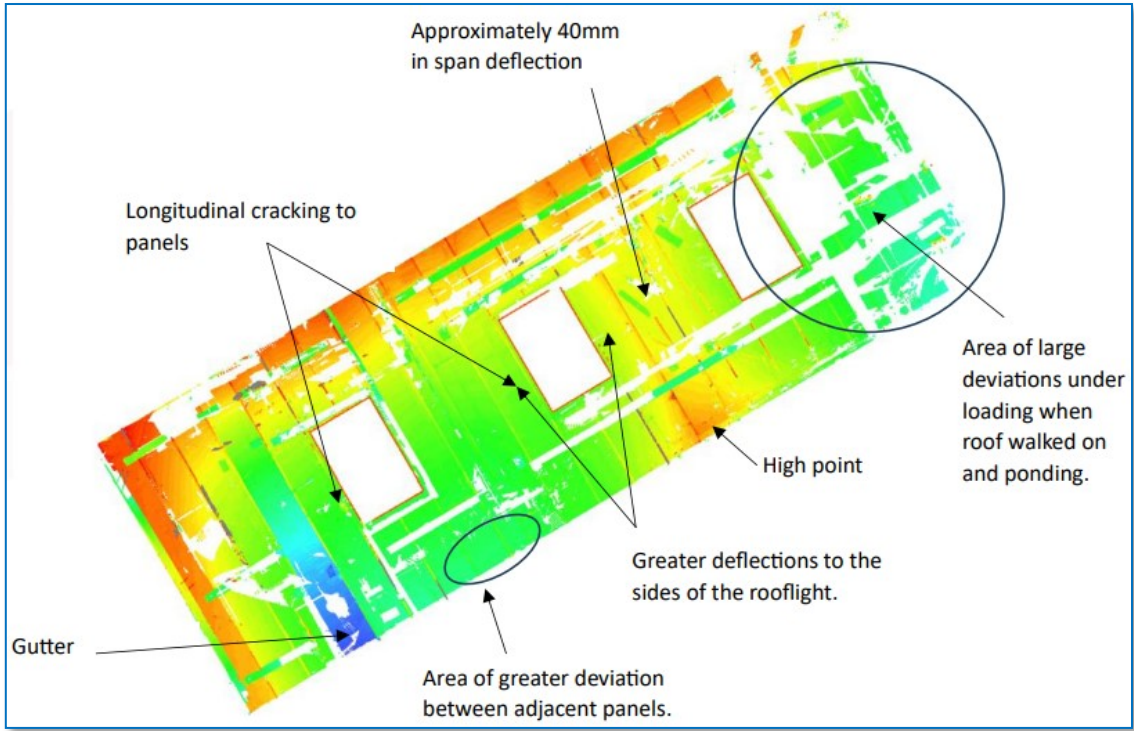
As illustrated in **Figure 22**, the fall of the Library roof is indicated from the external perimeter towards the Library. The deflection test indicates areas of deflection of 40mm and deviation of deflection between panels to various areas of the roof. Areas of inadequately supported openings such as skylights etc and longitudinal cracking also indicate large readings of deflection. This indicates spans in reference to Table 2, of span deflections of span/100. The deflection scan of the Library Garage roof (not shown) is largely uniform without significant deflection.

Figure 22 - Deflection Scan of Library Roof. Source Thomas Consulting, 2023

The deflection inspection concludes all the roofs at the complex based on their scores and relating to the risk category in Table 2 are considered as Red category.

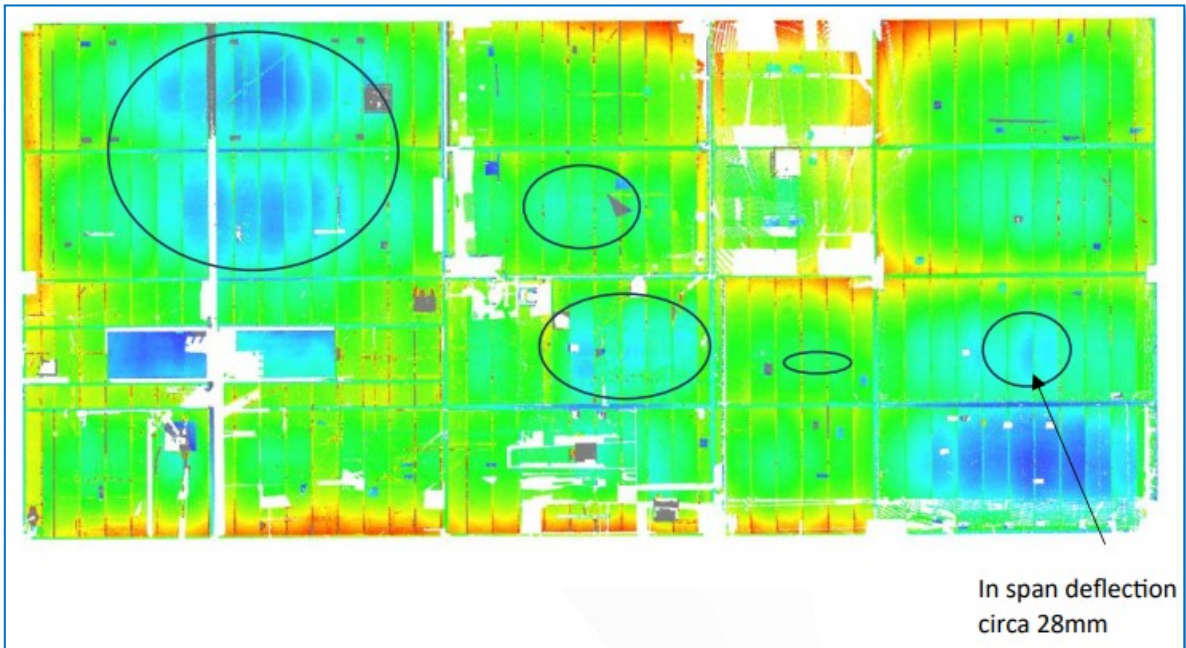
The deflection scan of the Civic Centre first floor Social bar area roofs is shown in the annotated Figure 23, with deflection noted is circa 28mm and span less than span/100.

Figure 23 – Deflection scan of first floor Social/Bar areas. Source Thomas Consulting, 2023

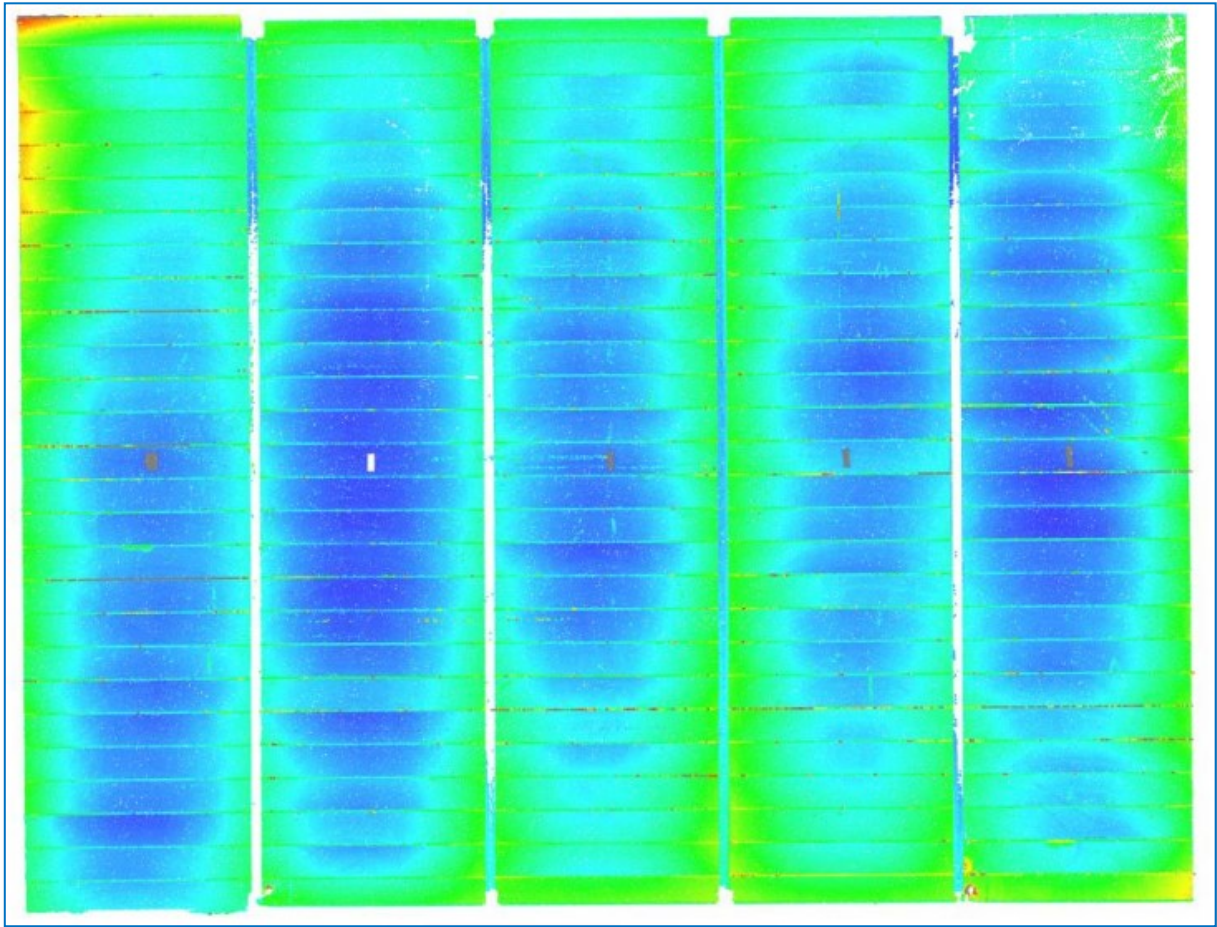
The deflection scan of the Civic Centre Theatre/Changing Room area roofs are shown in **Figure 24**, which indicate typical spans of deflection span/200 to span/250.

Figure 24 - Deflection scan of Theatre/Changing Rooms. Source Thomas Consulting, 2023

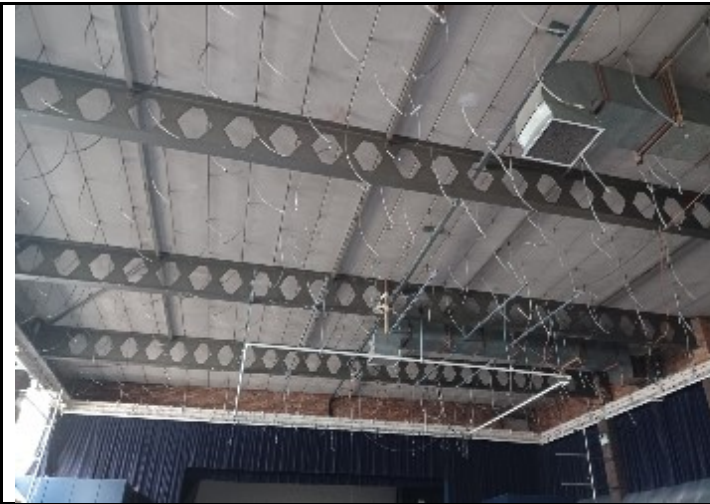
**Theatre - Post ceiling removal – showing castellated beams and fixings to planks.**

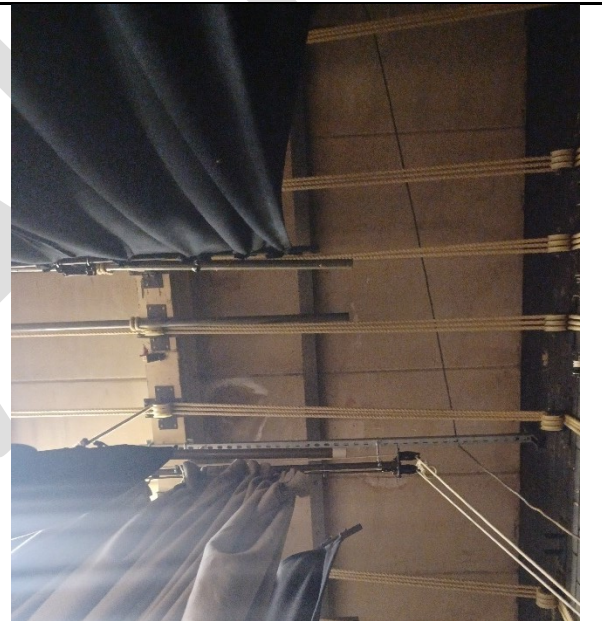
**Theatre Stage area – damage and moisture stained RAAC plank**

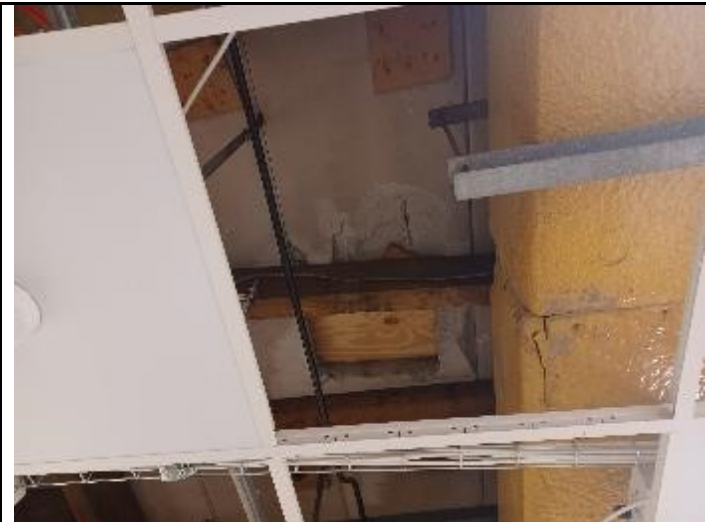
**Cut opening to RAAC Plan and damage to concrete exposing reinforcement bar**

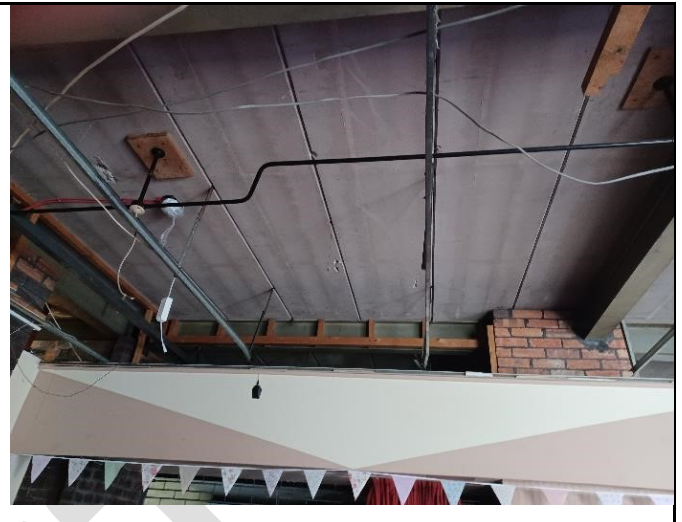
**Social Area ceiling removed and fixing/ghosting to planks**

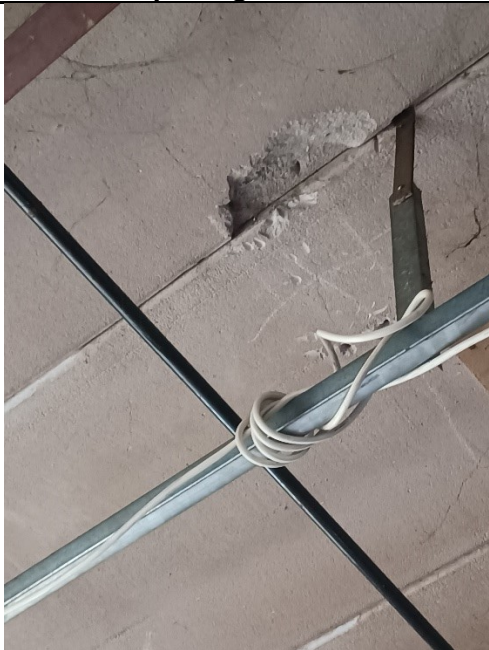
**Damaged to RAAC plank**

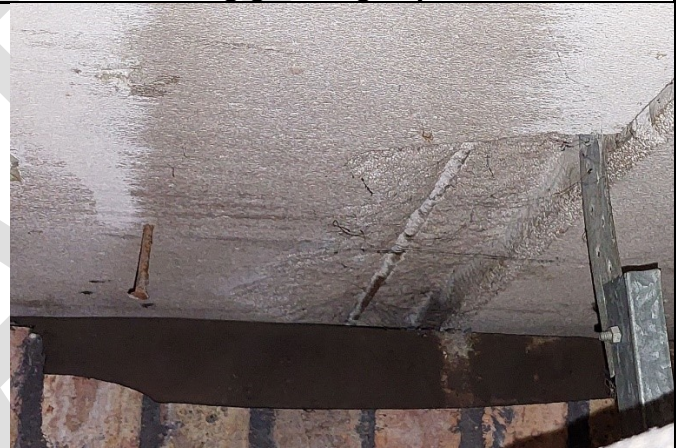
**Damage to concrete cover and exposed reinforcement bar, efflorescence**

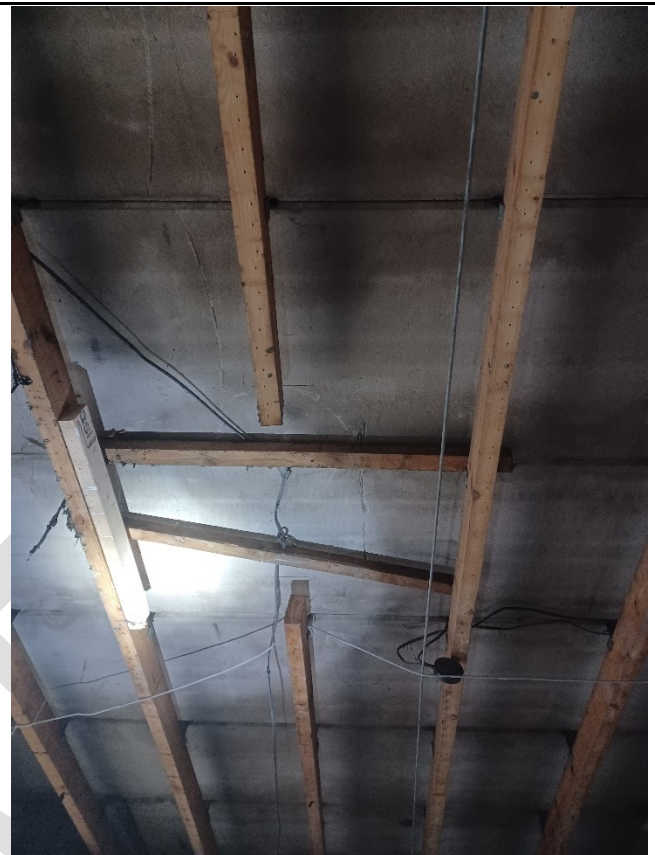
**Timber beams to underside of RAAC planks**

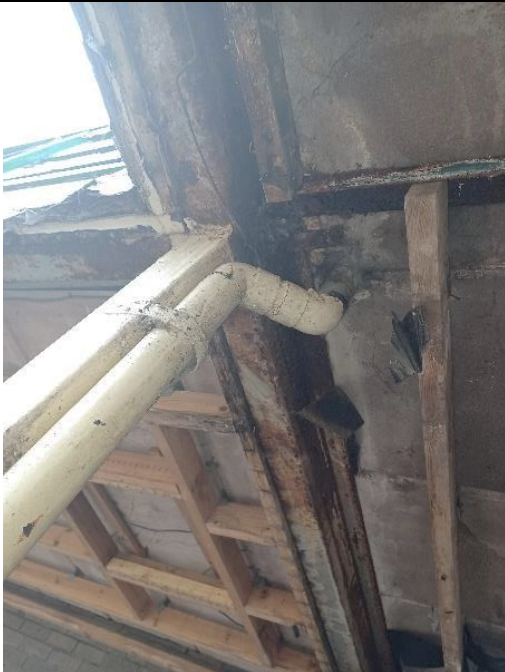
**Covered internal walkway RAAC plank penetration, timber beam support and corrosion to steel work beam. Evidence of moisture ingress.**

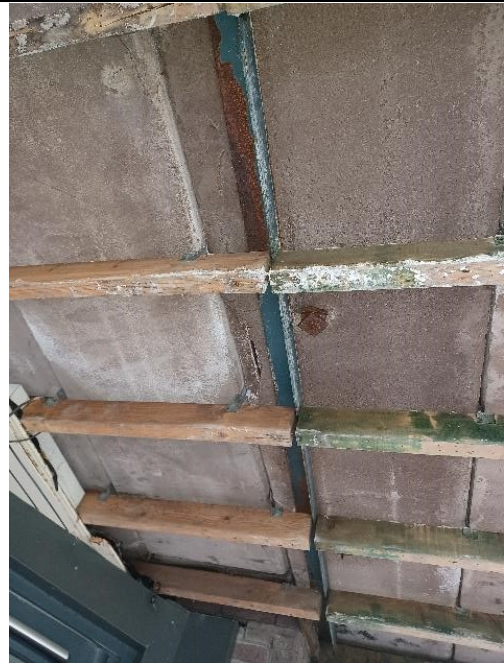
**Covered internal walkway RAAC plank penetration, timber beam support and corrosion to steel work beam. Evidence of moisture ingress.**

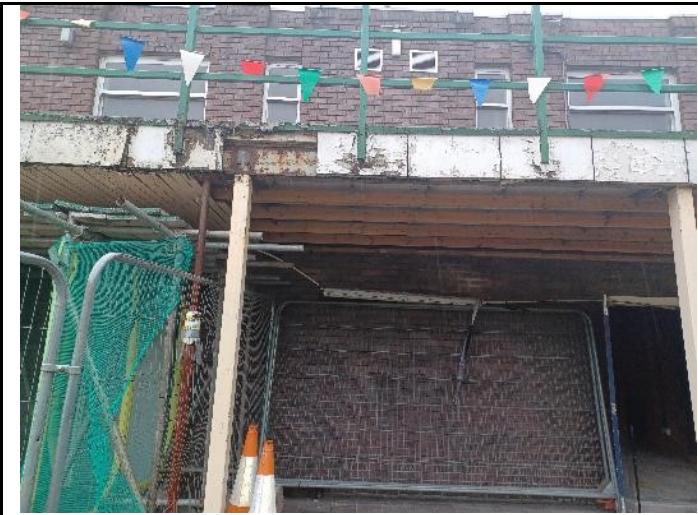
**External canopy, corrosion of steel beam and support propping**
