Annual Inspection

Shropshire Council

Tollgate Road Play Area

Tollgate Road, Ludlow, SY8 1TQ

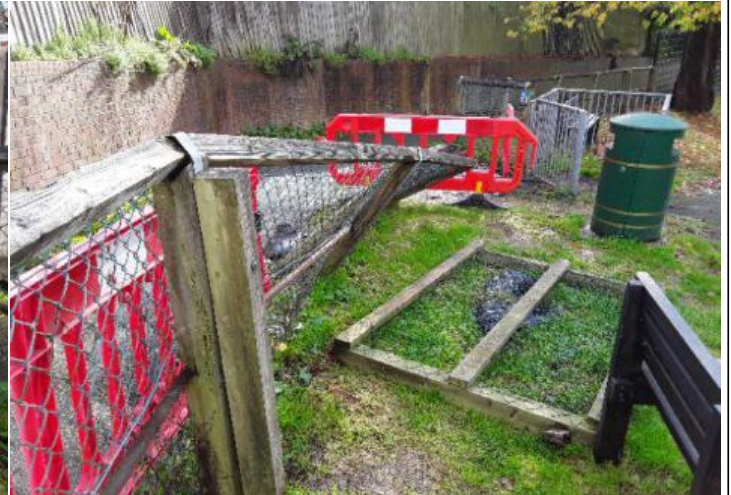
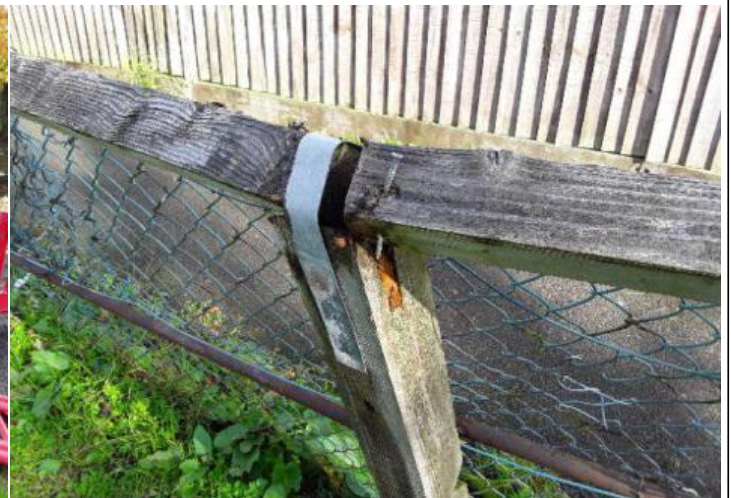
Risk Level: M - Moderate Risk
Surface: N/A

Finding: The fence has severe rot and is damaged exposing projecting fixings and there are unsecured sections of fencing within the play area

Action: Remove all damaged and rotted fencing and secure safety fencing

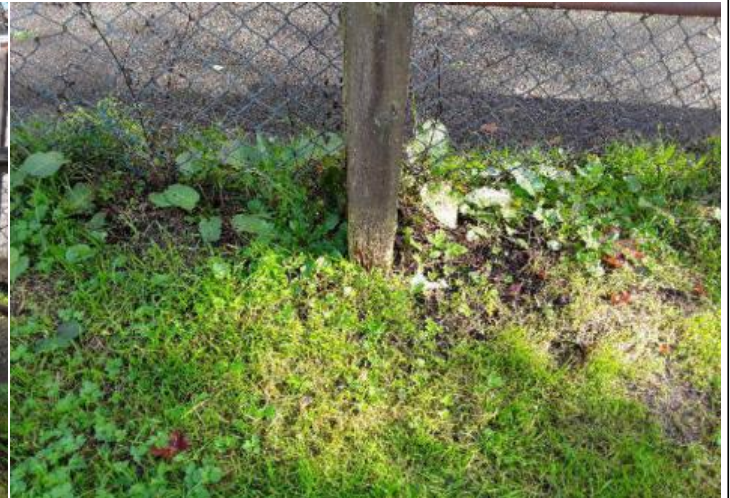
Finding: There is some strimmer / machinery damage apparent on the posts, this can penetrate the preservative applied to the timber and accelerate the rotting process

Action: Monitor for any deterioration (rot) and replace as required

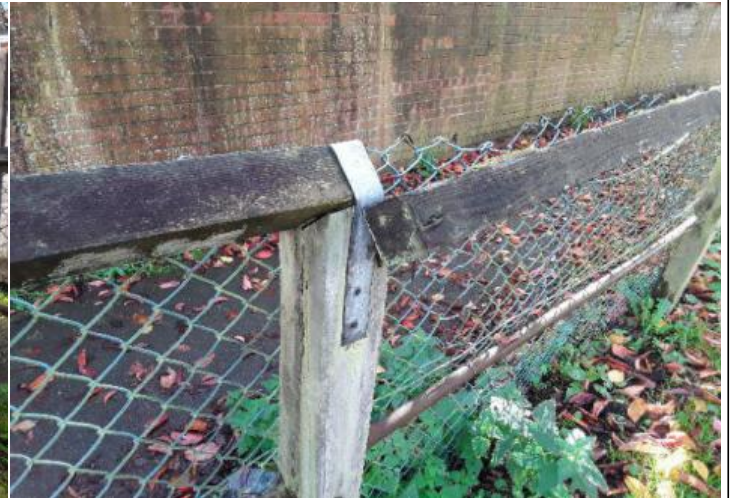
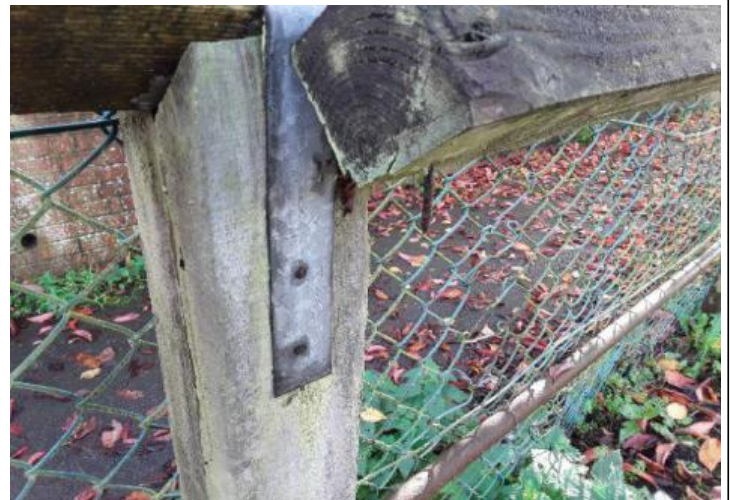
Finding: A number of fixings have worked loose around the fencing
Action: Secure all loose fixings

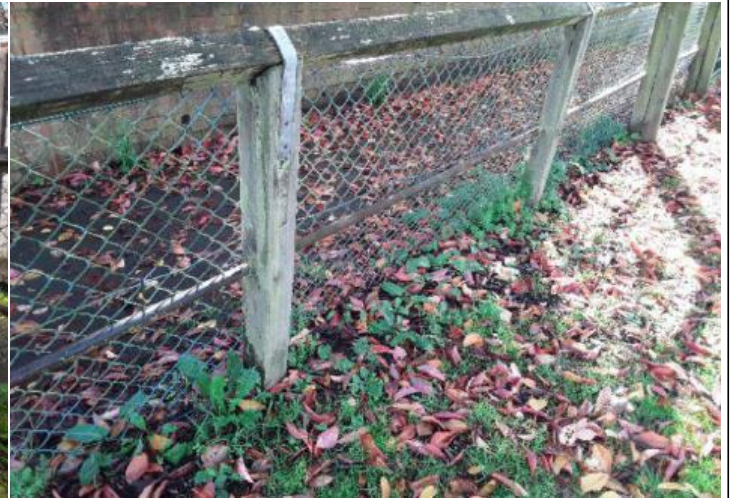
Finding: There are areas or parts of the timber on the structure that have rotted

Action: Replace all affected timbers

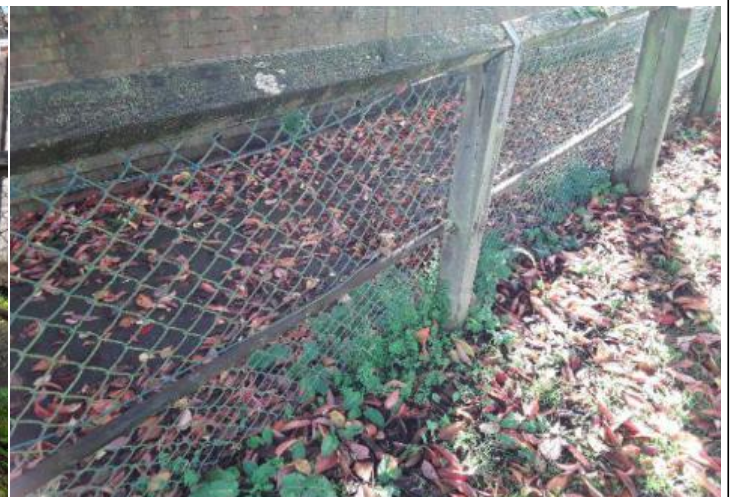
Finding: There is surface corrosion / rust present on the item

Action: Consider treating the item

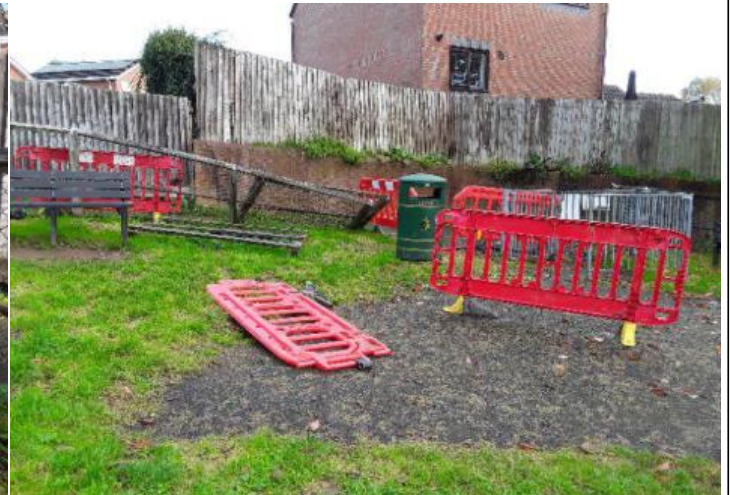
Finding: The area / equipment on site has been isolated from use however the area is still accessible and the means of isolation has either introduced additional hazards that may cause harm in the event of users accessing the area or is insufficient to stop users from accessing the equipment

Action: Provide a more suitable isolation method

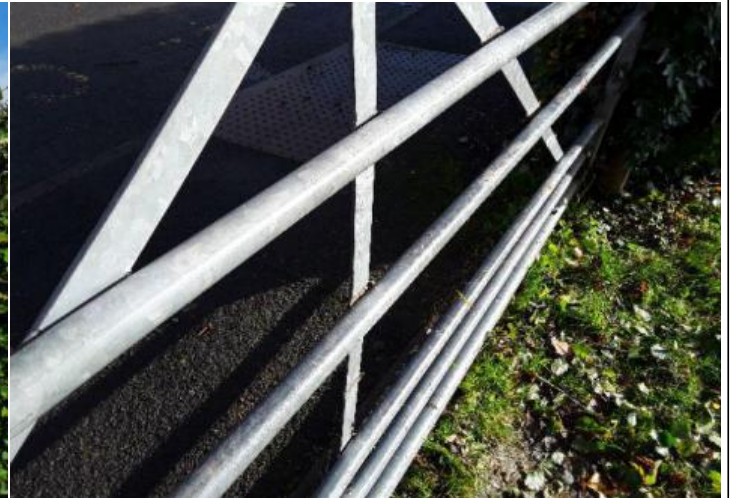
Finding: The weld(s) on this item have failed

Action: Repair item

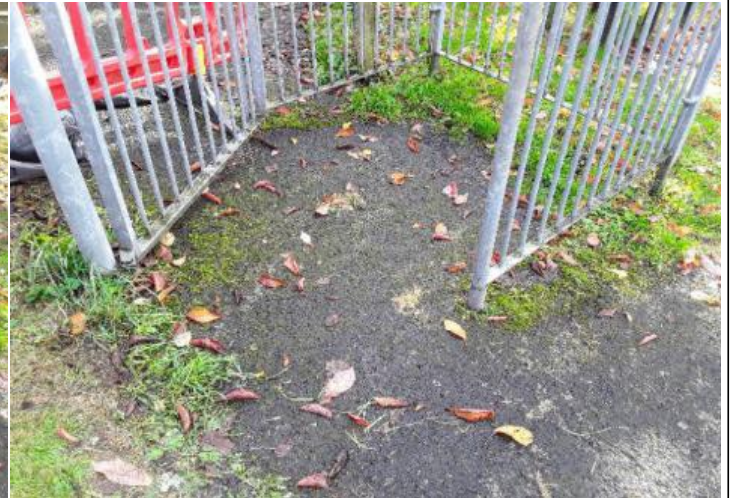
Finding: There is algae, silt or moss growth on the surface resulting in slippery conditions

Action: Clean and treat appropriately

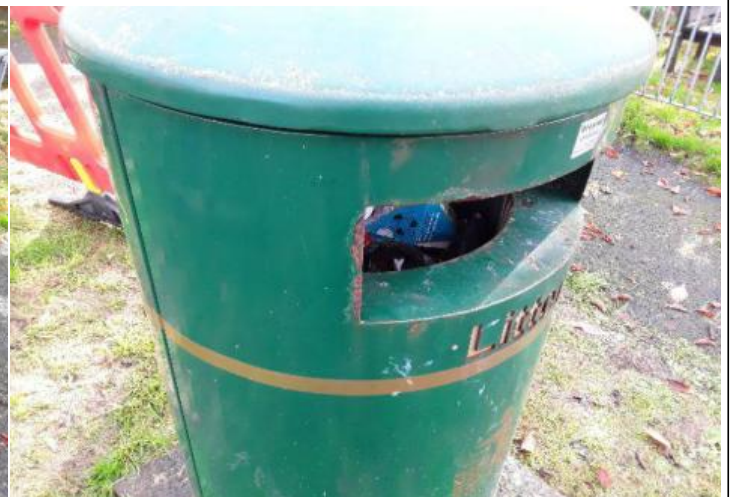
Finding: The paintwork on this item has been damaged or worn exposing the metal underneath which is rusting / corroding

Action: Treat affected areas and repaint

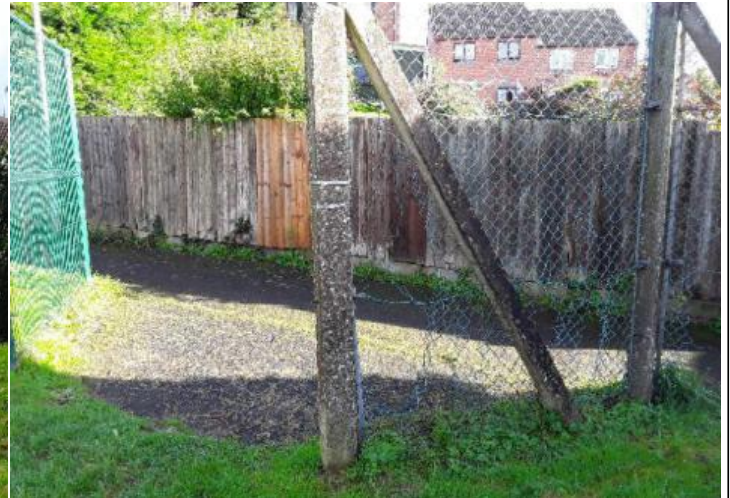
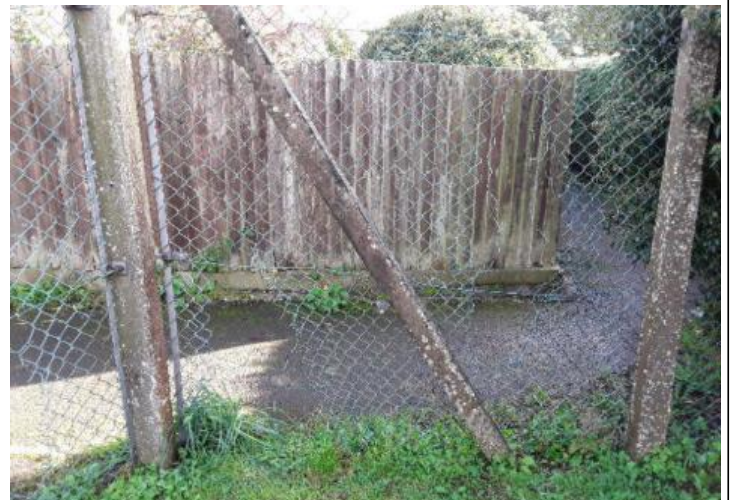
Finding: The fence is severely damaged in places

Action: Repair or replace all affected sections

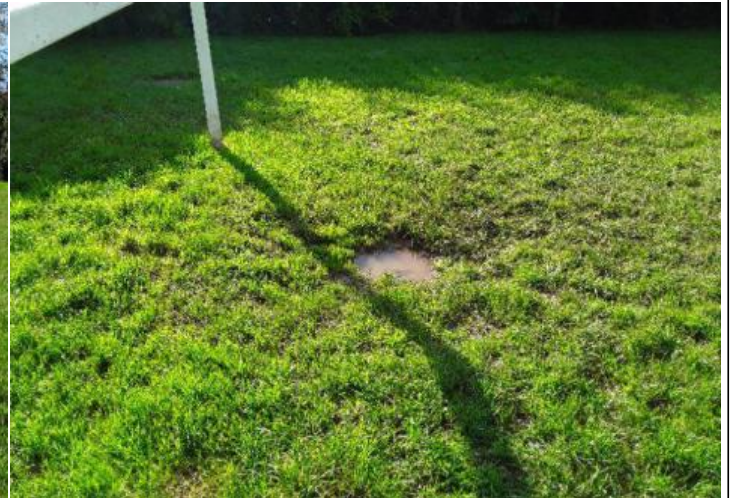
Finding: The surface has eroded in some areas and may be slippery in wet conditions
Action: Reinstate the surface

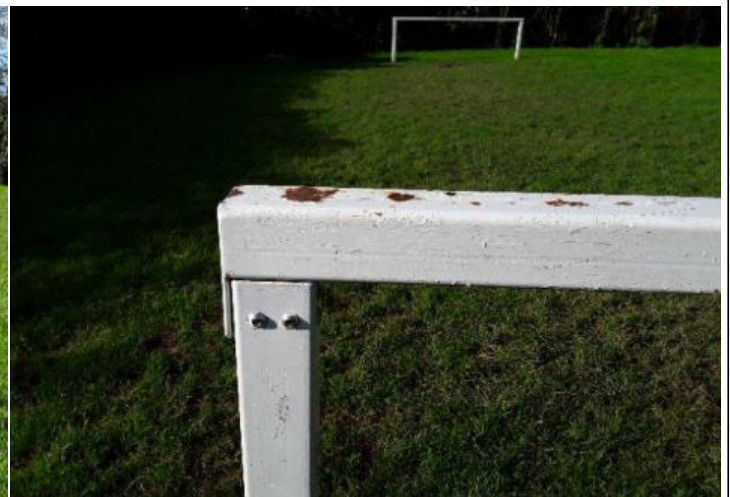
Finding: The paintwork on this item has been damaged or worn exposing the metal underneath which is rusting / corroding
Action: Treat affected areas and repaint

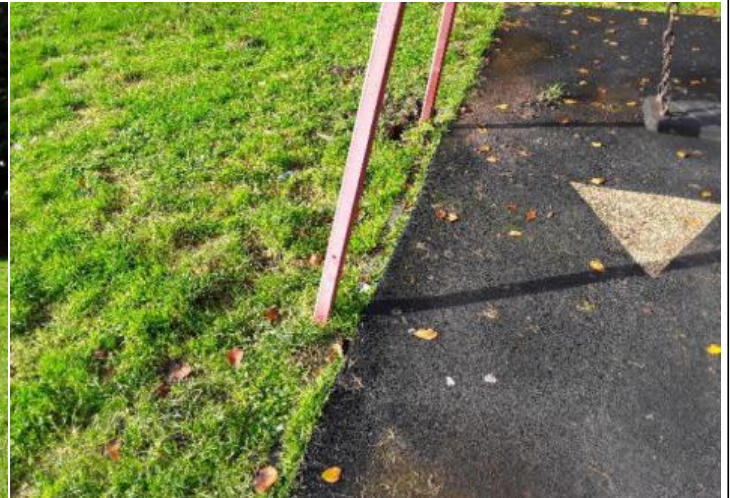
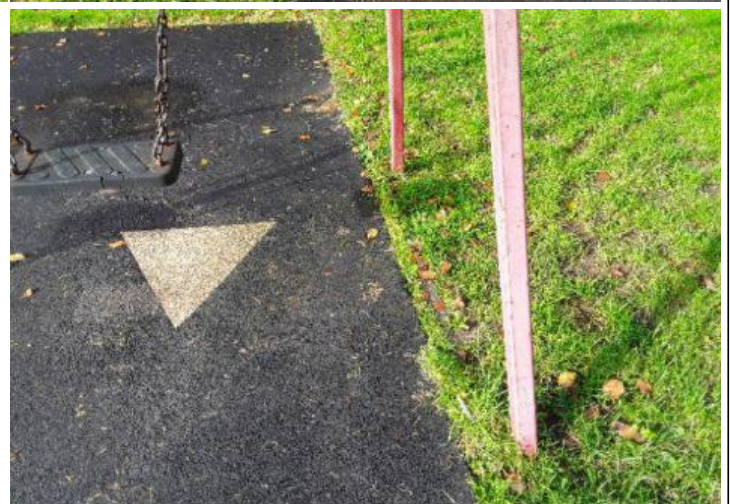
Finding: There are significant gaps (over 30mm) between the surface and the edging or between the joints in the surface; these are large enough for a small foot to enter

Action: Repair surfacing

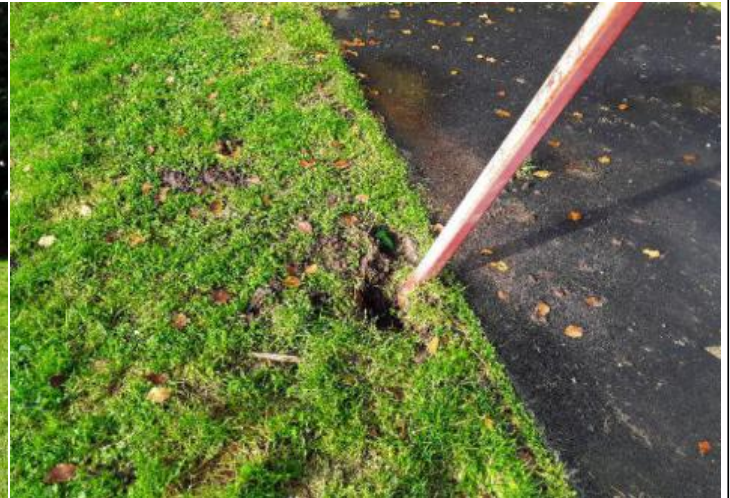
Finding: The surface has subsided in some areas

Action: Monitor for any further deterioration and repair as required

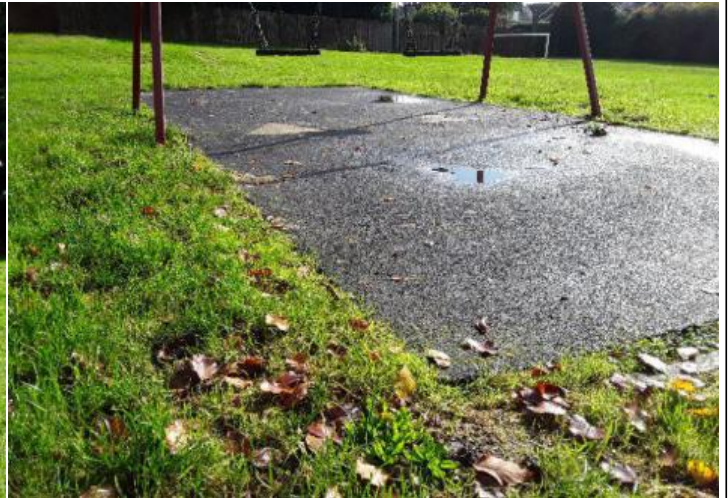
Finding: The surface is lifting at the edges and creating trip points
Action: Repair perimeter of surfacing to remove trip points

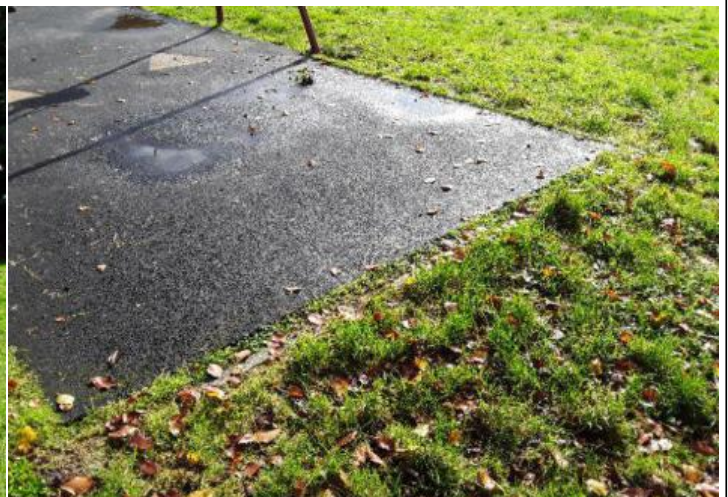
Finding: There are trip hazards at the edges of the surface
Action: Reinstate surrounding surface levels to remove the trip points

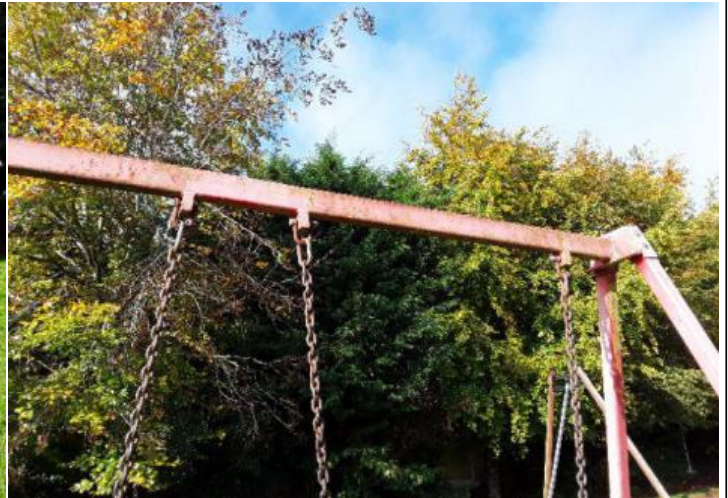
Finding: The paintwork on this item has been damaged or worn exposing the metal underneath which is rusting / corroding

Action: Treat affected areas and repaint

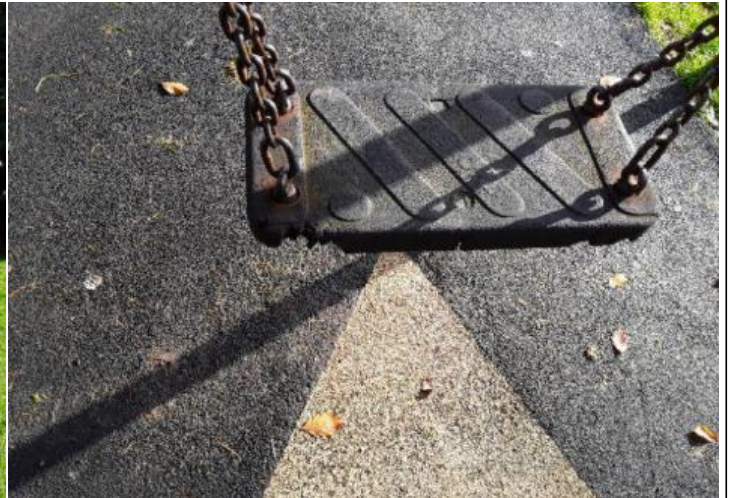
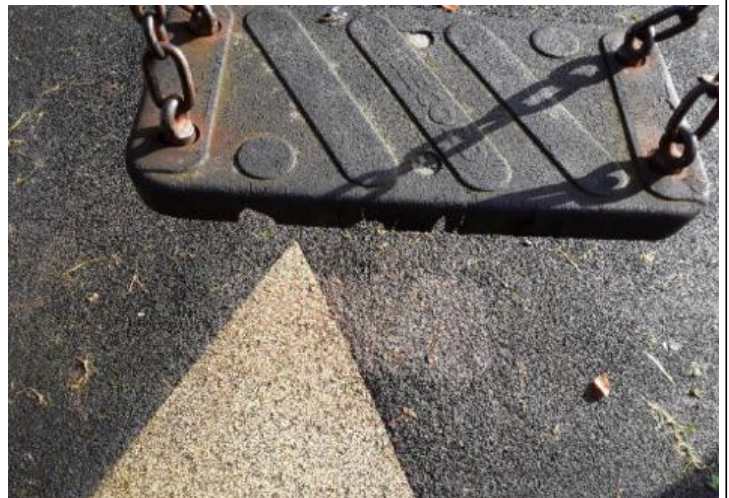
Finding: The seat has minor damage or wear

Action: Monitor for any further deterioration and replace as required

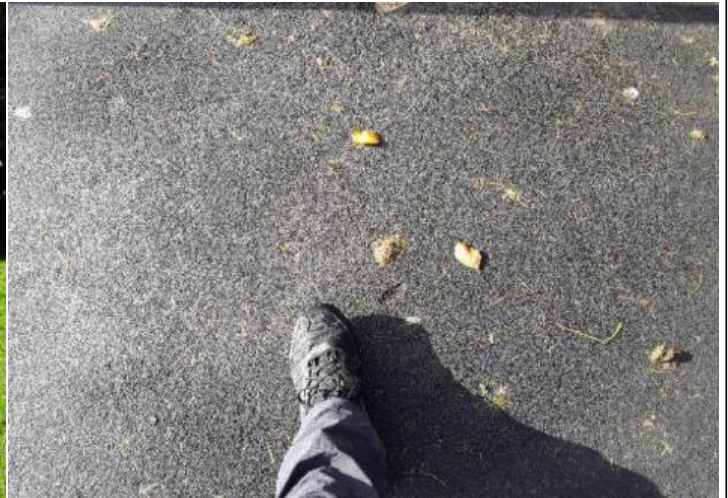
Finding: There is some minor damage to the surface

Action: Monitor for any further deterioration and repair as required

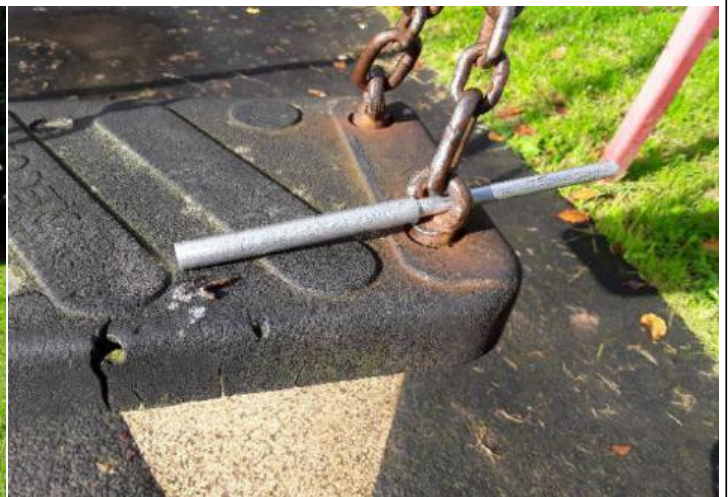
Finding: The connecting links are in excess of 8.6mm and less than 12mm and fail the requirements of BS EN 1176 Part 1; clause 4.2.13, Chains

Action: Monitor use and replace with compliant links at the next maintenance cycle

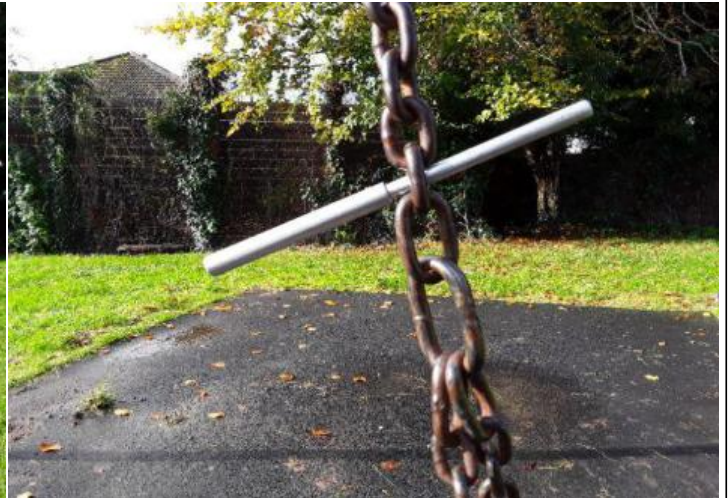
Finding: The chain openings are in excess of 8.6mm and do not meet the recommendations of BS EN 1176 Part 1

Action: Monitor - No remedial work recommended

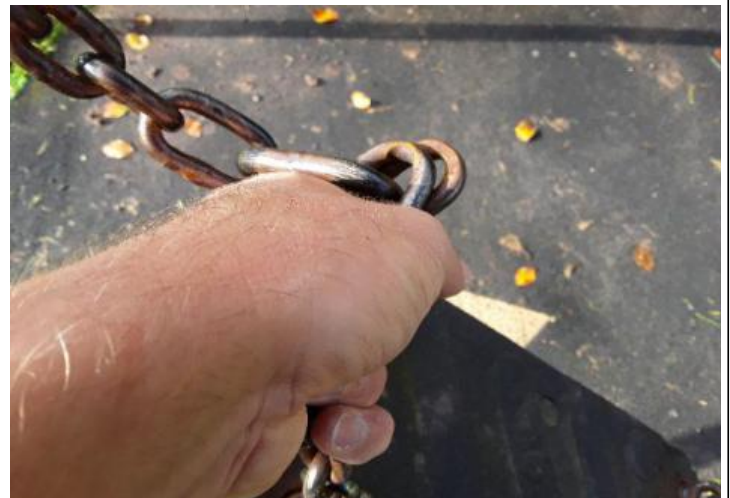
Finding: The chain links are worn in excess of 60% and require renewing

Action: Replace worn chains

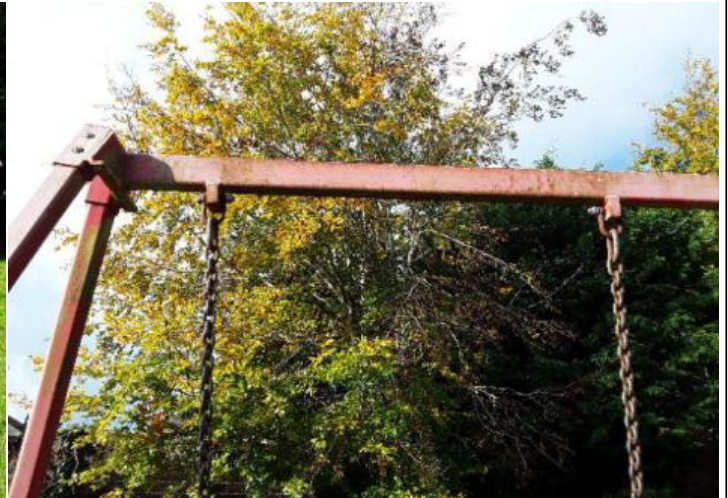
Finding: The shackles are worn in excess of 40% and require renewing

Action: Replace worn shackles

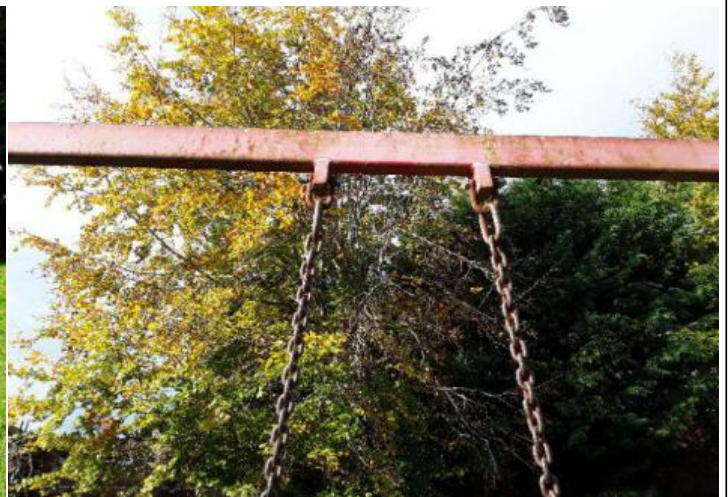
Finding: The bushes are worn or missing

Action: Replace worn or missing bushes

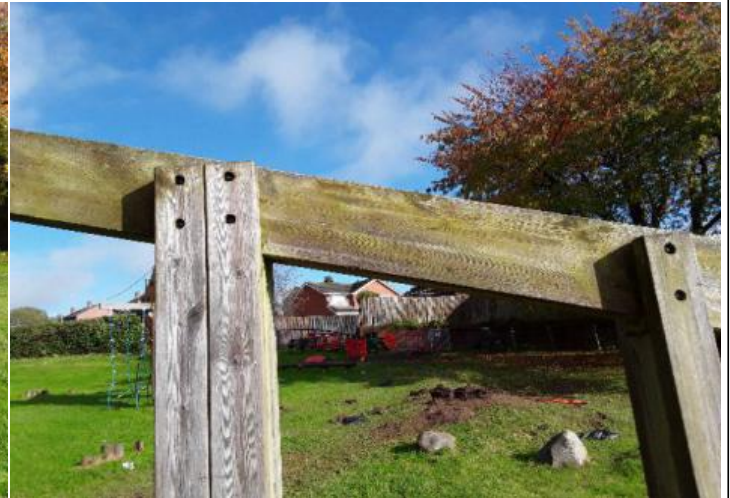
Finding: There is/are bolt cap covers missing or damaged on the item

Action: Replace missing or damaged bolt cap covers

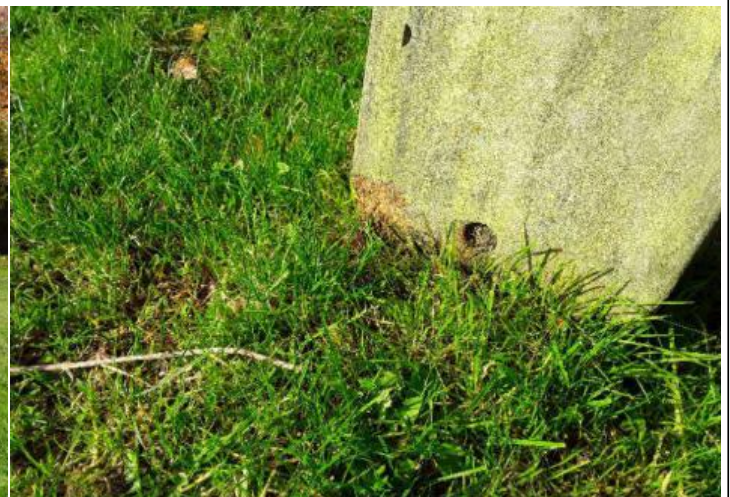
Finding: There is some strimmer / machinery damage apparent on the posts, this can penetrate the preservative applied to the timber and accelerate the rotting process

Action: Monitor for any deterioration (rot) and replace as required

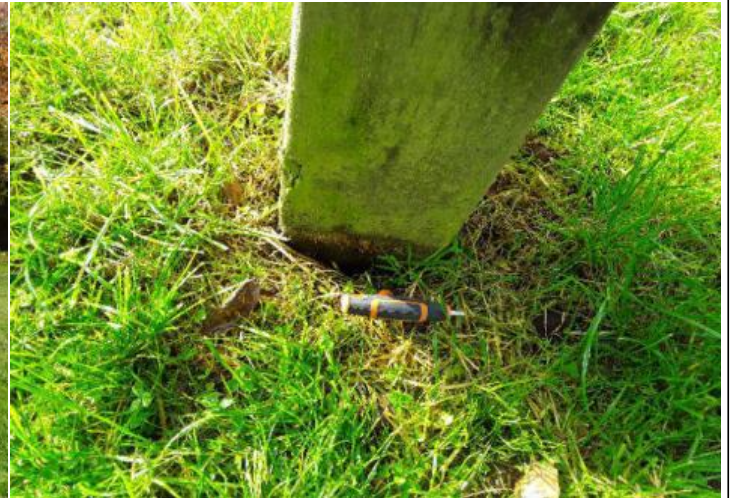
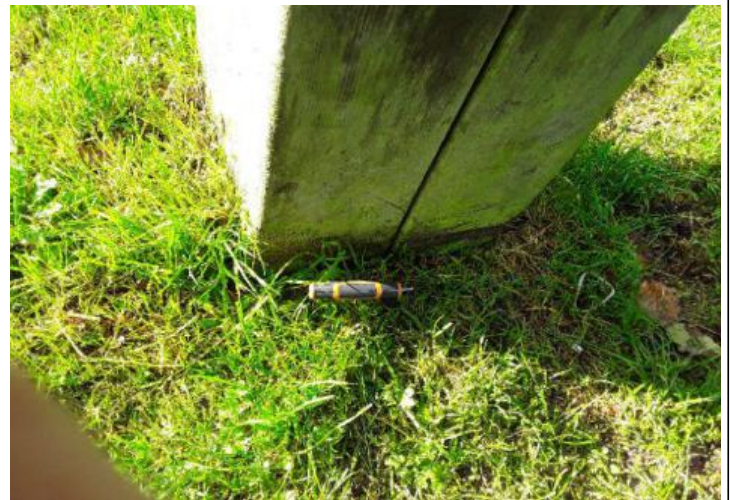
Finding: There is some evidence of rot in the timber posts

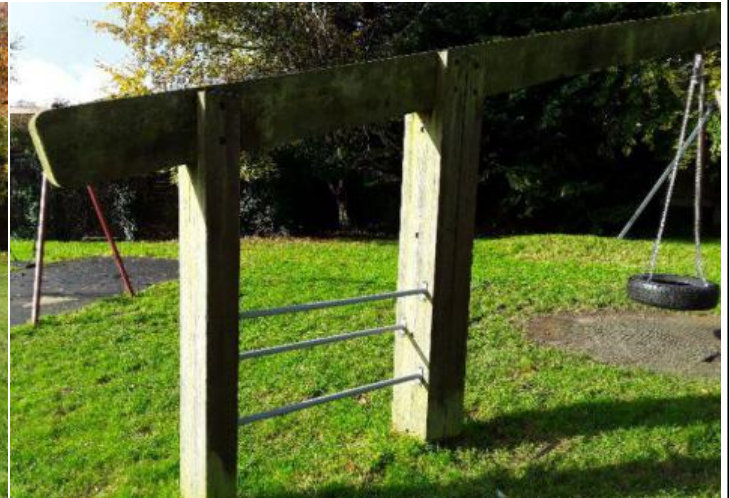
Finding: Due to the dimensions of the timber it was not possible to ascertain the condition of the timber at its core without further testing. We recommend a Resi-PD survey to establish the condition of the timber at its core.

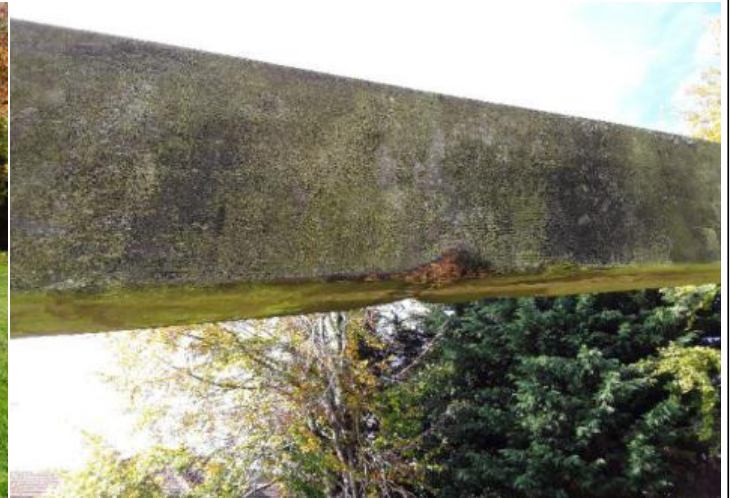
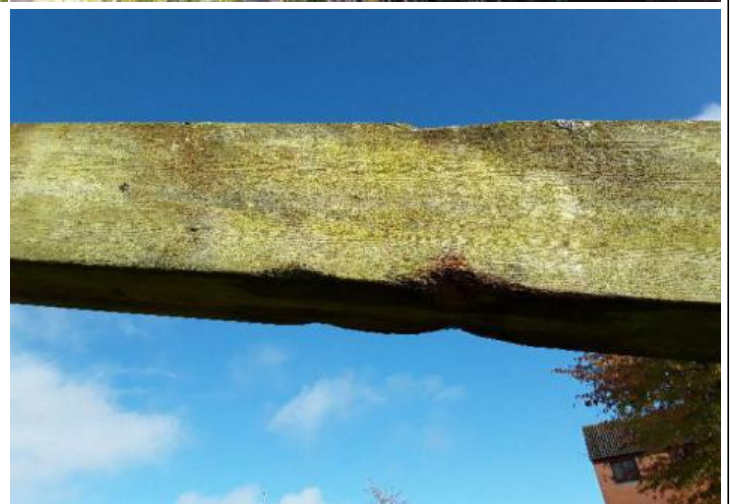
Finding: There is damage apparent on the beam, this can penetrate the preservative applied to the timber and accelerate the rotting process

Action: Replace the damaged beam

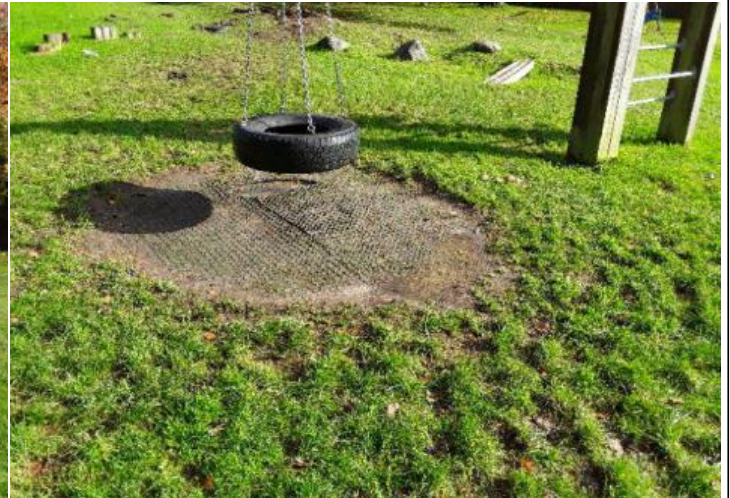
Finding: The grass mats are silted up and the soil is compacted; this may have an effect on the impact absorbing properties of the surface

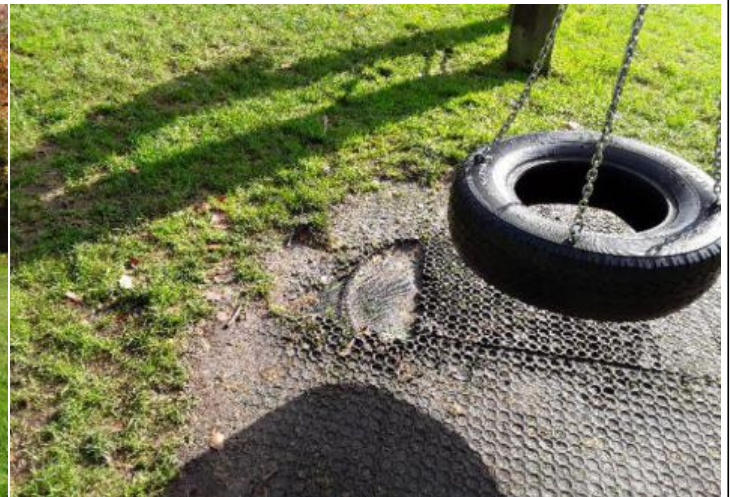
Finding: The surfacing is severely damaged

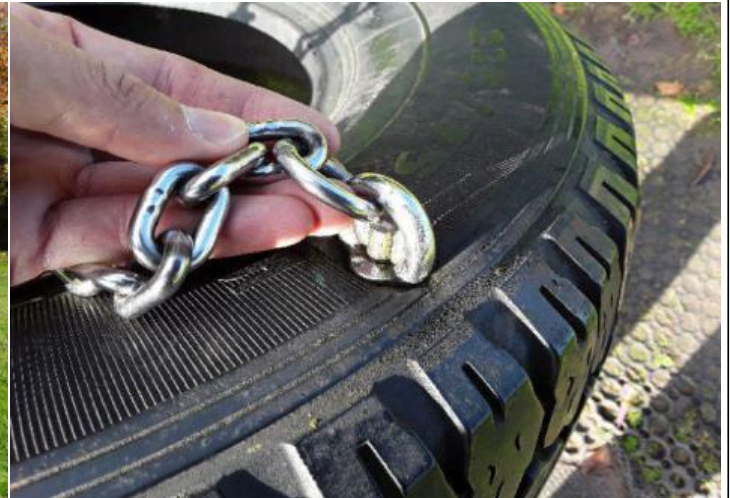
Finding: There is some notable evidence of chain wear

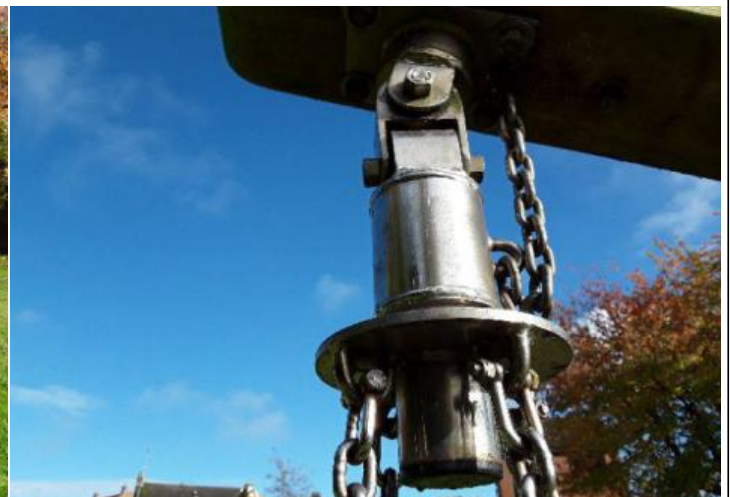
Finding: There is some wear to the suspension joint

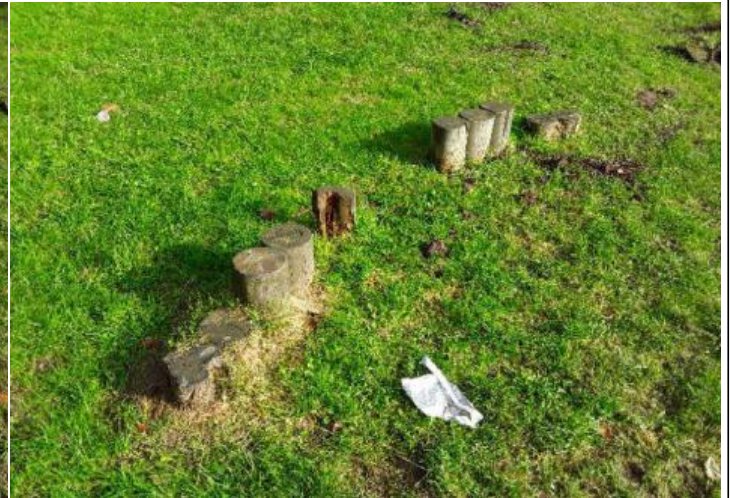
Finding: There are areas or parts of the timber posts that have rotted or are missing

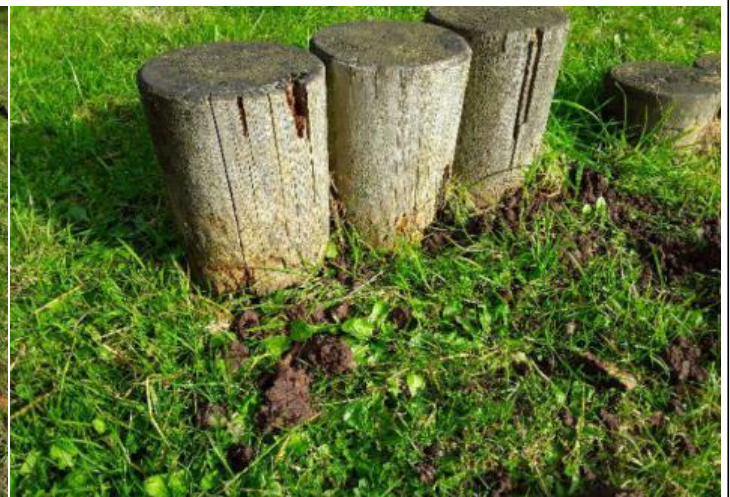
Finding: There is some strimmer / machinery damage apparent on the posts, this can penetrate the preservative applied to the timber and accelerate the rotting process

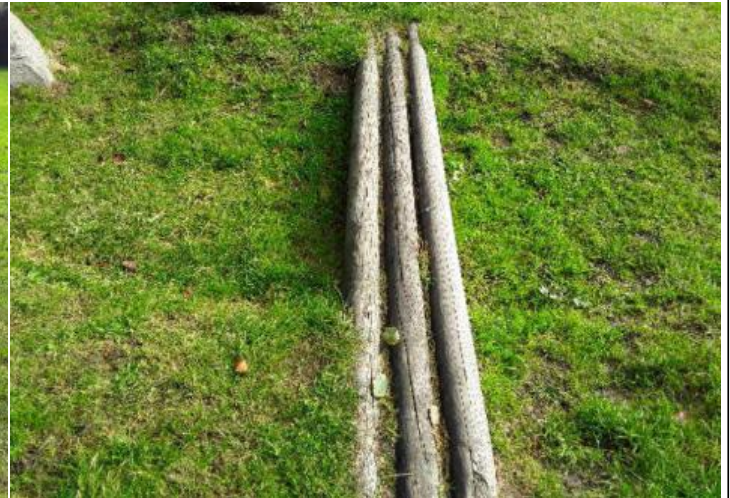
Finding: The timber has a number of splits/shakes or air cracks and this may affect the stability or allow water ingress which will accelerate the rotting process

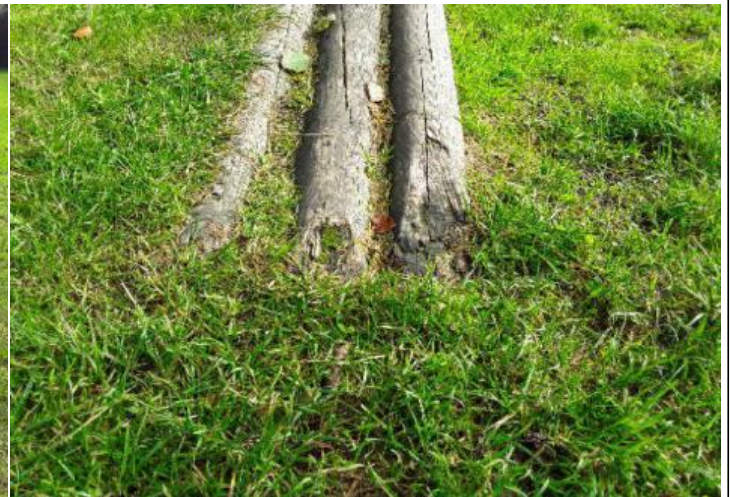
Finding: There are areas or parts of the timber on the structure that have rotted

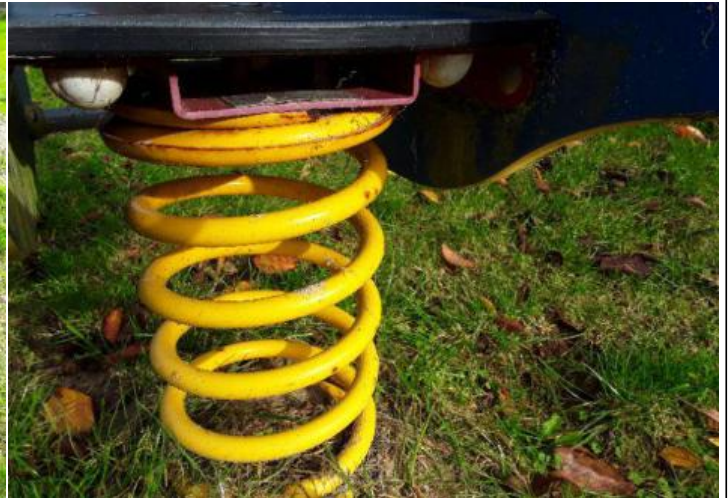
Finding: The paintwork on the spring has been damaged or worn exposing the metal underneath which is rusting
Action: Treat any rusting components and repaint

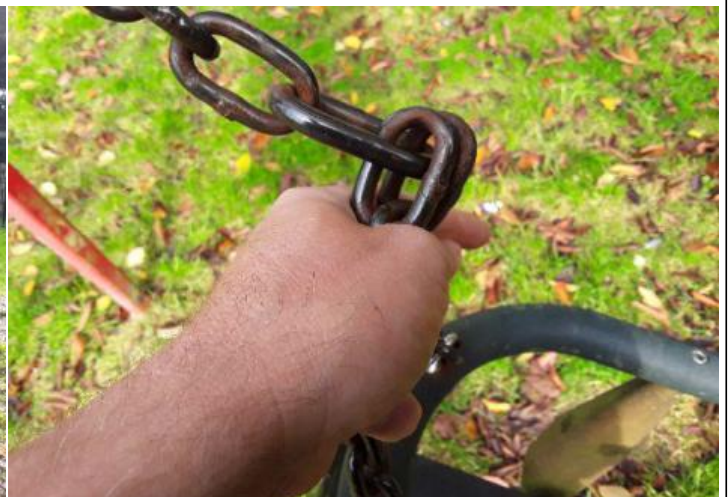
Finding: There is some notable evidence of chain wear
Action: Monitor for any further deterioration and replace when 40% worn

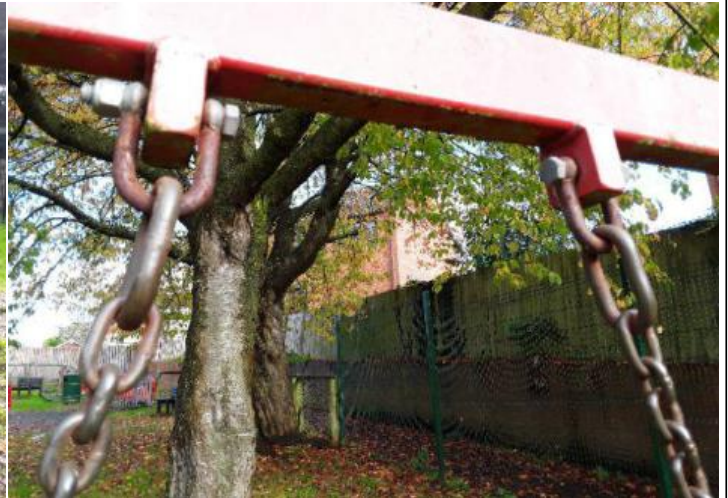
Finding: There is some wear to the shackles

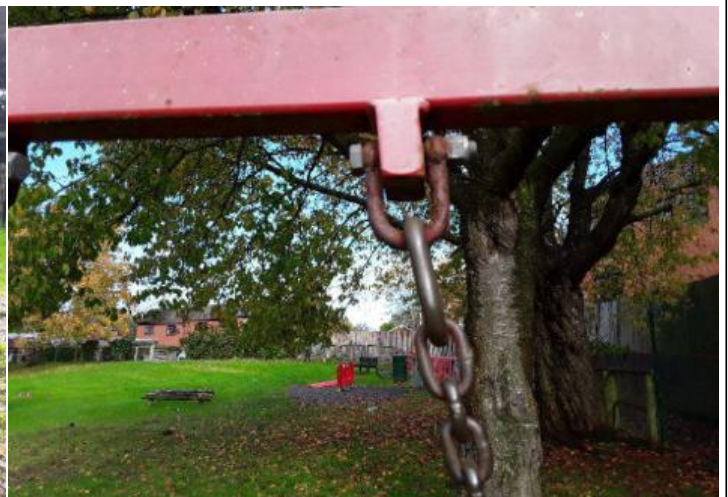
Finding: The bushes are showing signs of wear

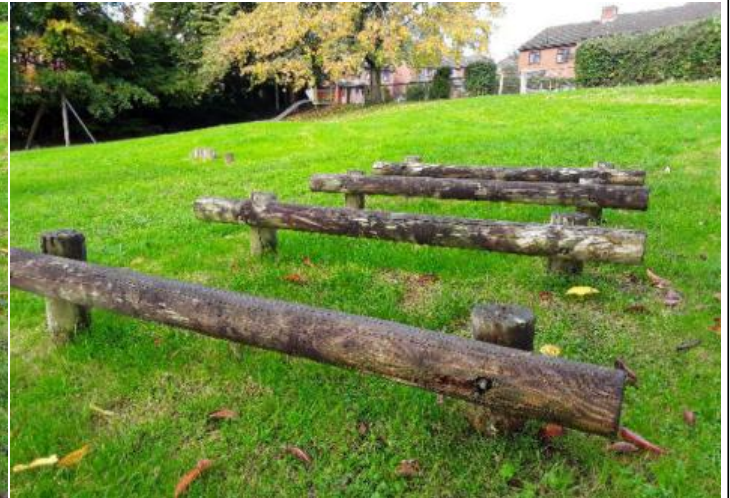
Finding: There is/are bolt cap covers missing or damaged on the item

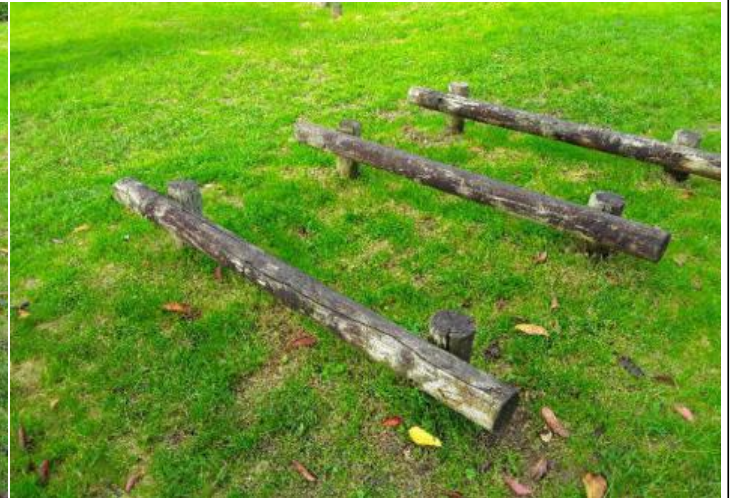
Finding: The timber has a number of splits/shakes or air cracks and this may affect the stability or allow water ingress which will accelerate the rotting process
Action: Monitor to ensure the splits do not cross through fixing points of the structure and/or cause any instability

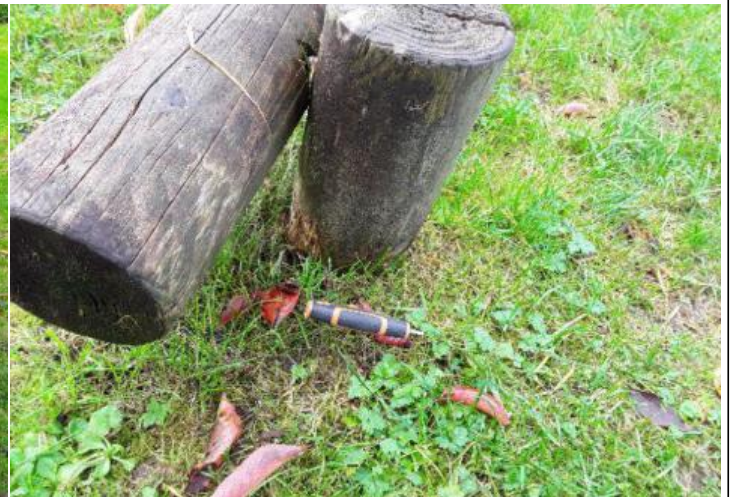
Finding: There is some evidence of rot in the timber posts
Action: Monitor for any further deterioration and replace as required

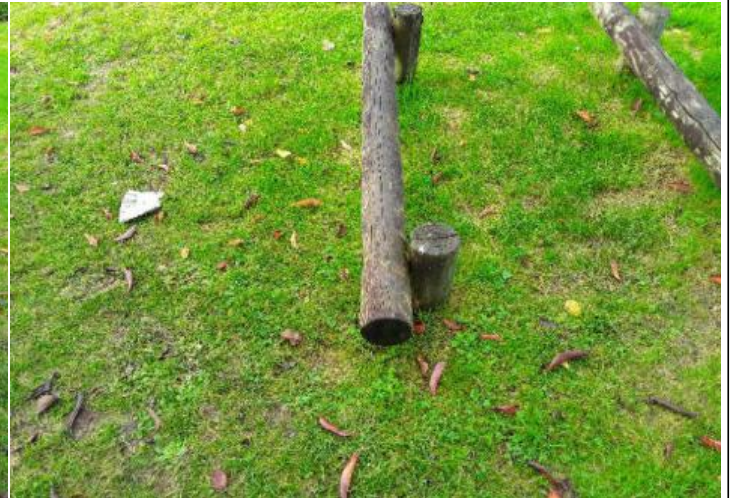
Finding: A number of fixing(s) have worked loose

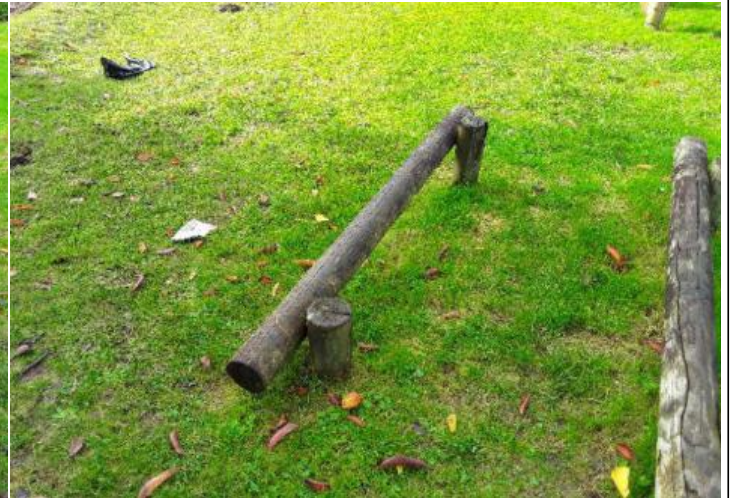
Finding: The item is slightly loose in its foundations

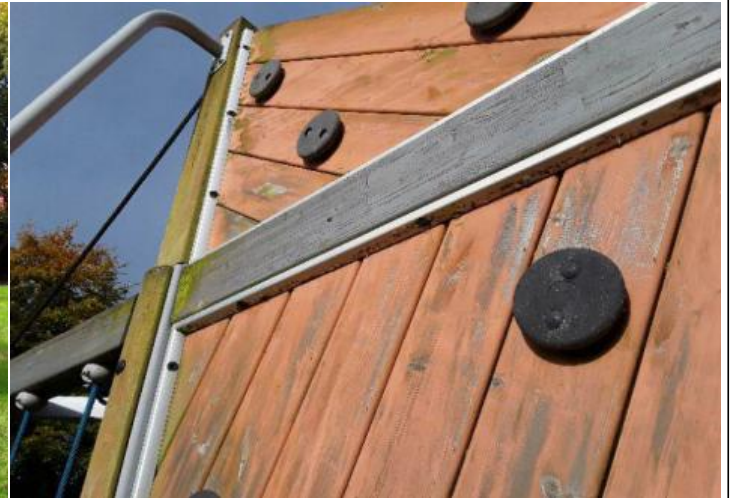
Finding: There is/are inserts missing

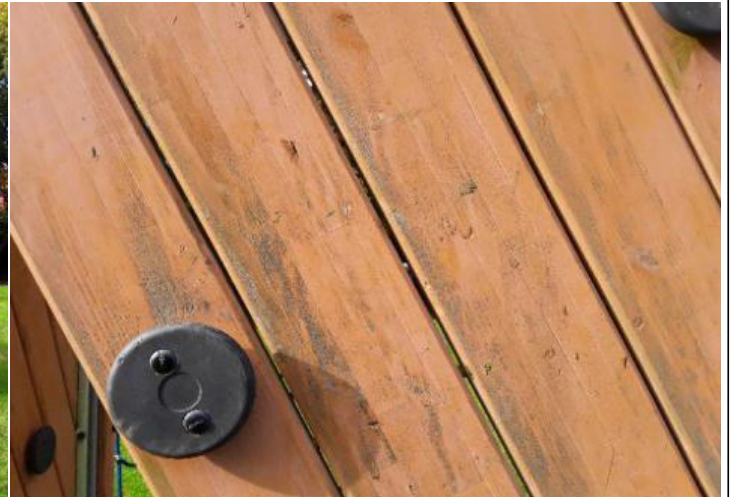
Finding: There is some damage to the item

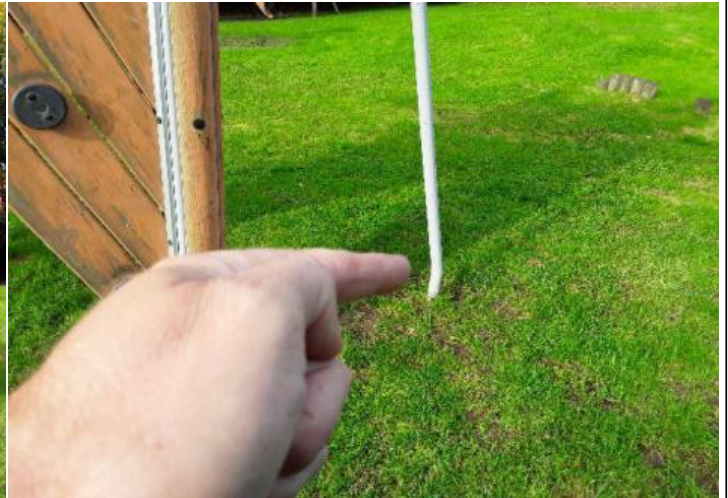
Finding: There is some damage to the pole

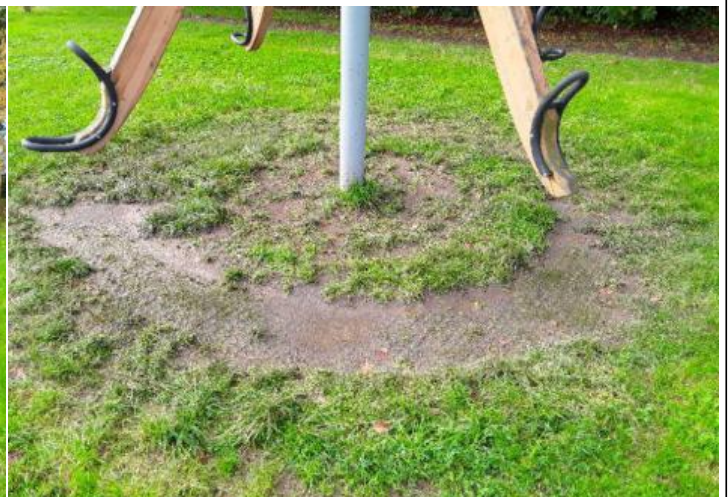
Finding: The grass mats are silted up and the soil is compacted; this may have an effect on the impact absorbing properties of the surface

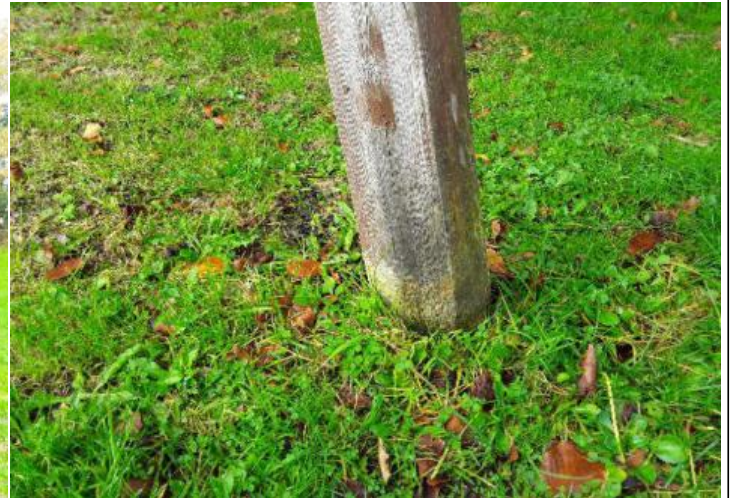
Finding: There is some strimmer / machinery damage apparent on the posts, this can penetrate the preservative applied to the timber and accelerate the rotting process
