Annual Inspection

Shropshire Council

Tollgate Road Play Area

Tollgate Road, Ludlow, SY8 1TQ

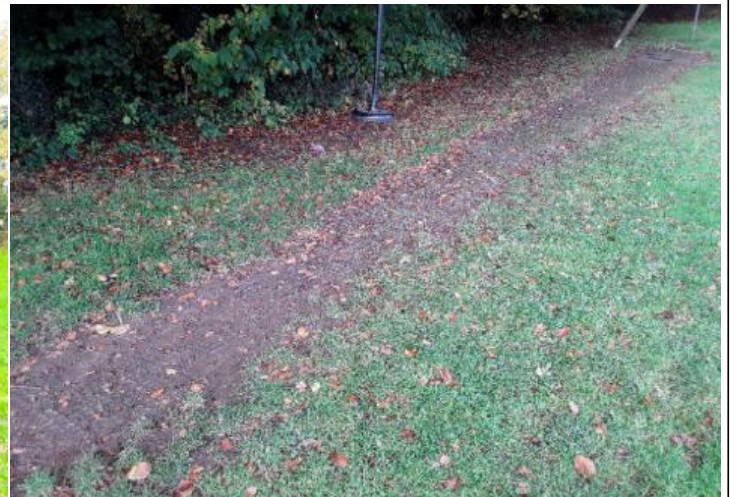
Finding: The grass mats are silted up and the soil is compacted; this may have an effect on the impact absorbing properties of the surface

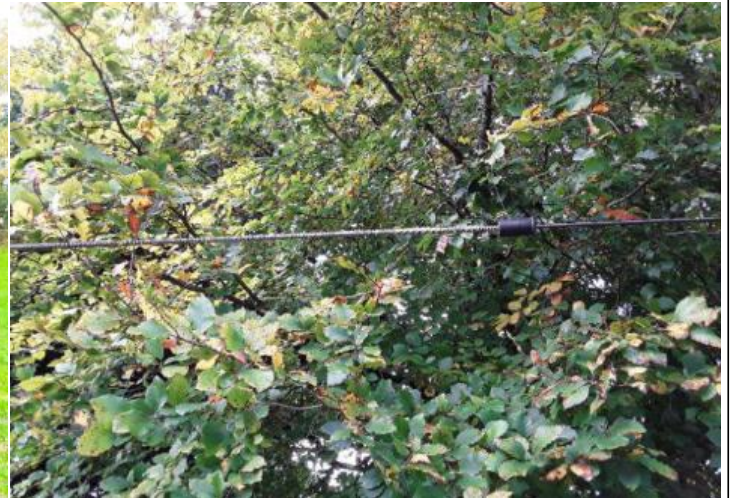
Finding: The dampening spring or tyre is damaged or broken on the item

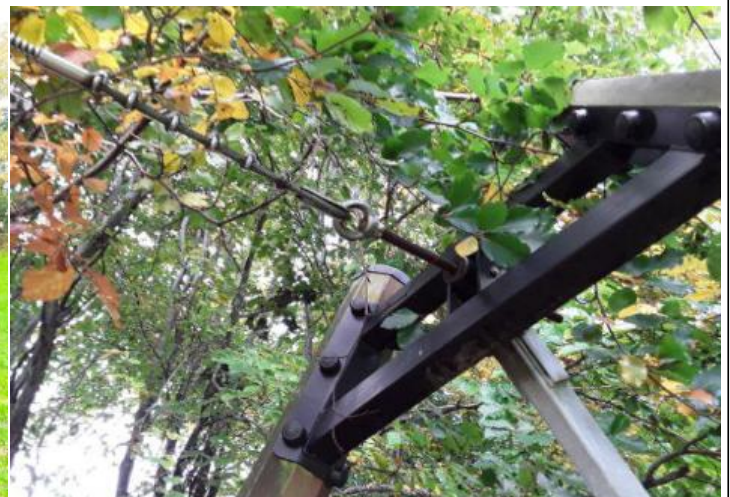
Finding: The fixings are corroding

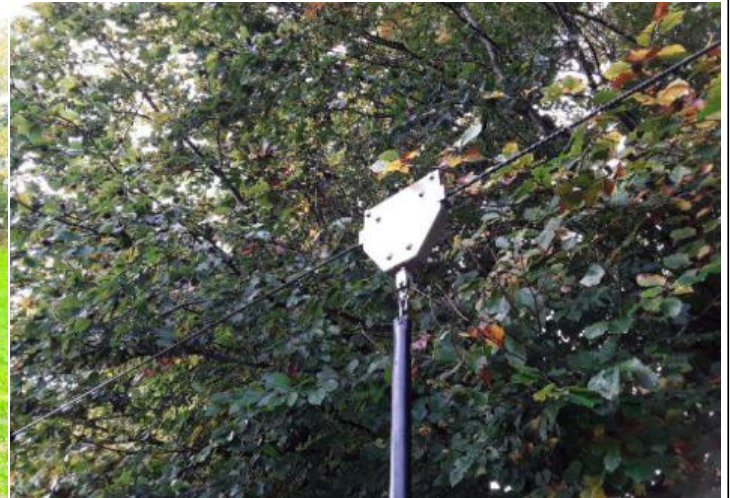
Finding: The nylon inserts are worn or missing at the point the cable enters the traveller

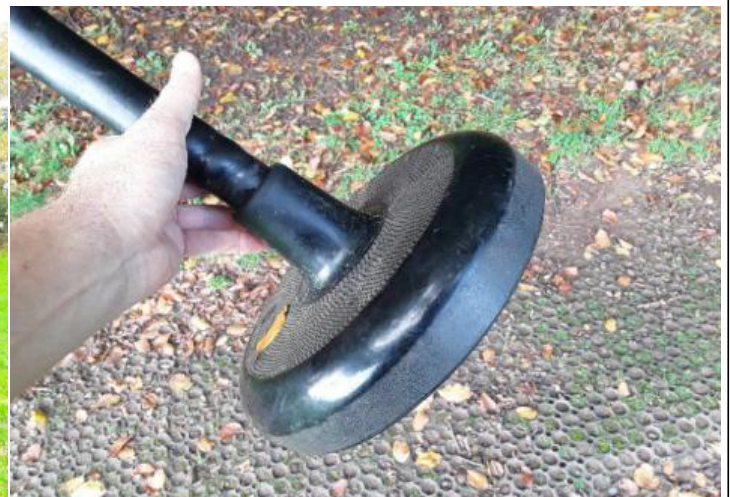
Finding: The seat connection cannot be inspected without dismantling the seat

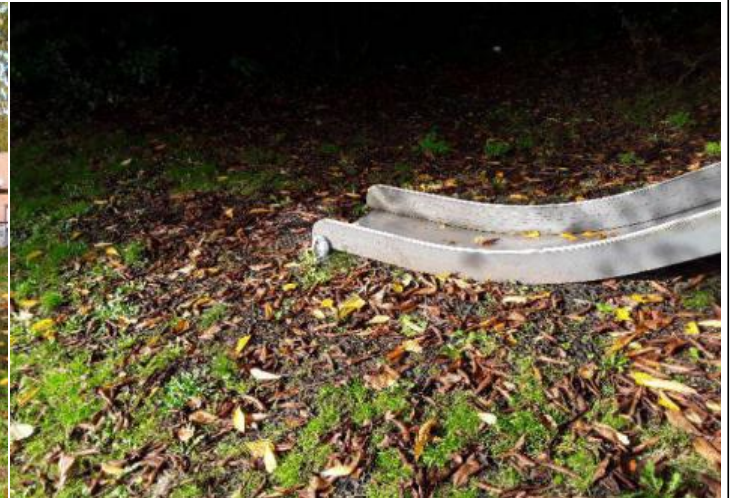
Finding: The grass mats are silted up and the soil is compacted; this may have an effect on the impact absorbing properties of the surface

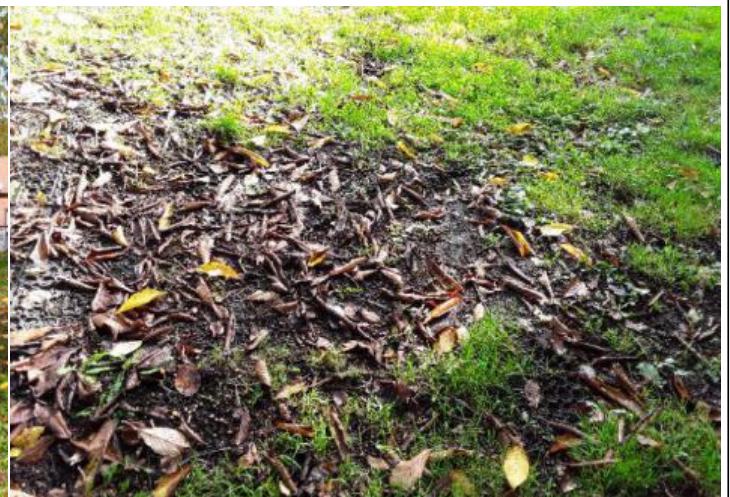
Finding: There is moderate damage to the surface **Action:** Replace the damaged areas of surfacing

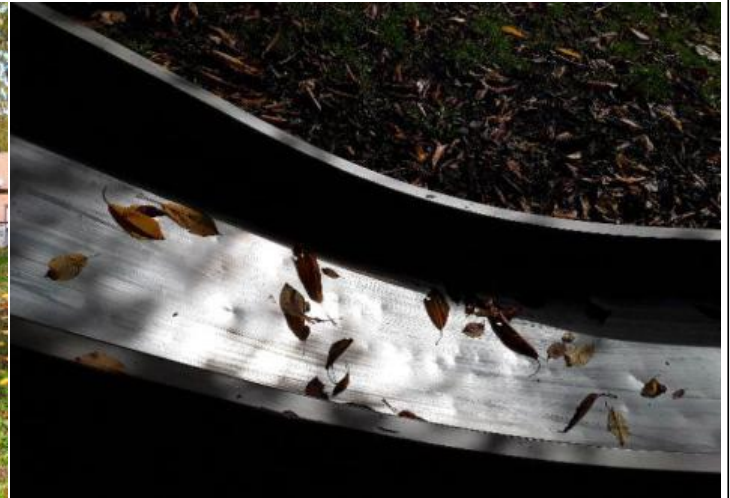
Finding: There are a number of dents in the slide surface

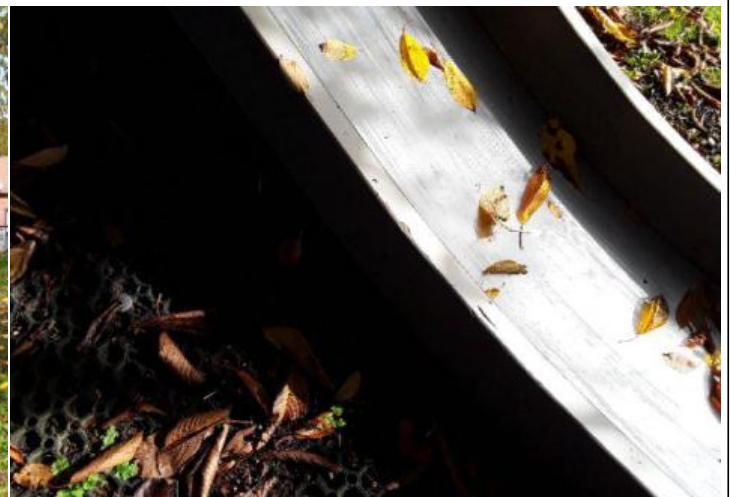
Finding: The side of the slide is damaged

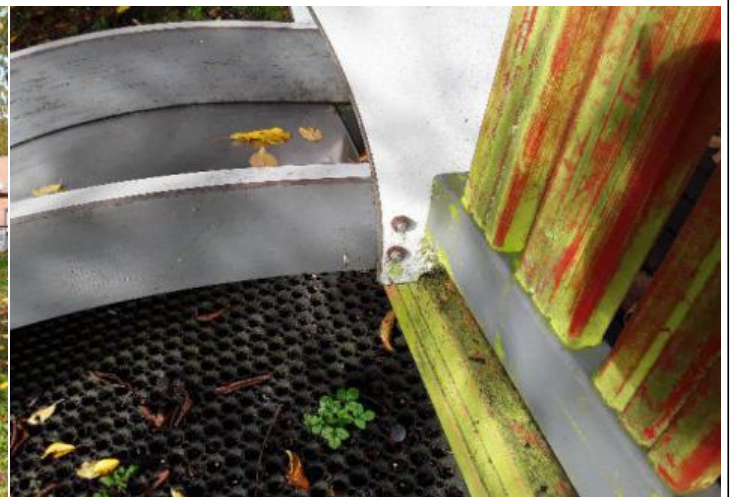
Finding: There is/are bolt cap covers missing or damaged on the item

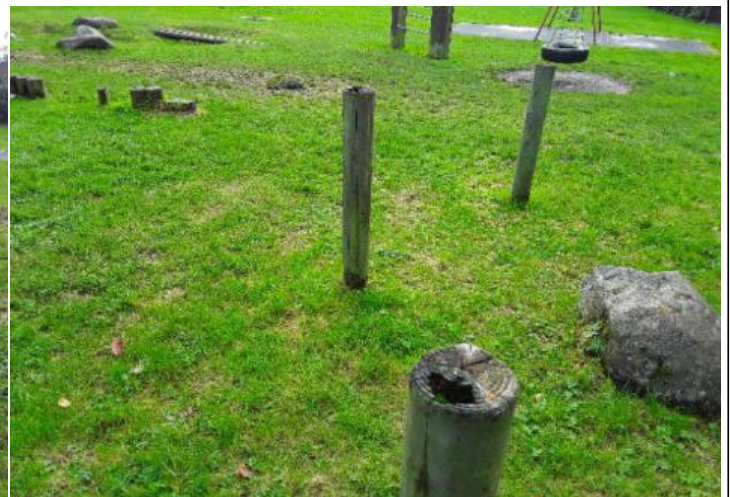
Finding: There are areas or parts of the timber on the structure that have rotted

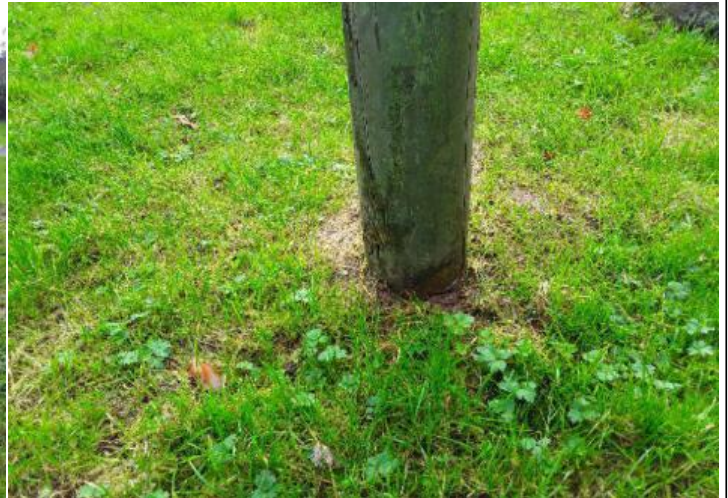
Finding: There is some strimmer / machinery damage apparent on the posts, this can penetrate the preservative applied to the timber and accelerate the rotting process
