T21023/23/001

STRUCTURAL INSPECTION

**Whitchurch Civic Centre
High Street
Whitchurch
Shropshire
SY13 1AX**

Shropshire Council

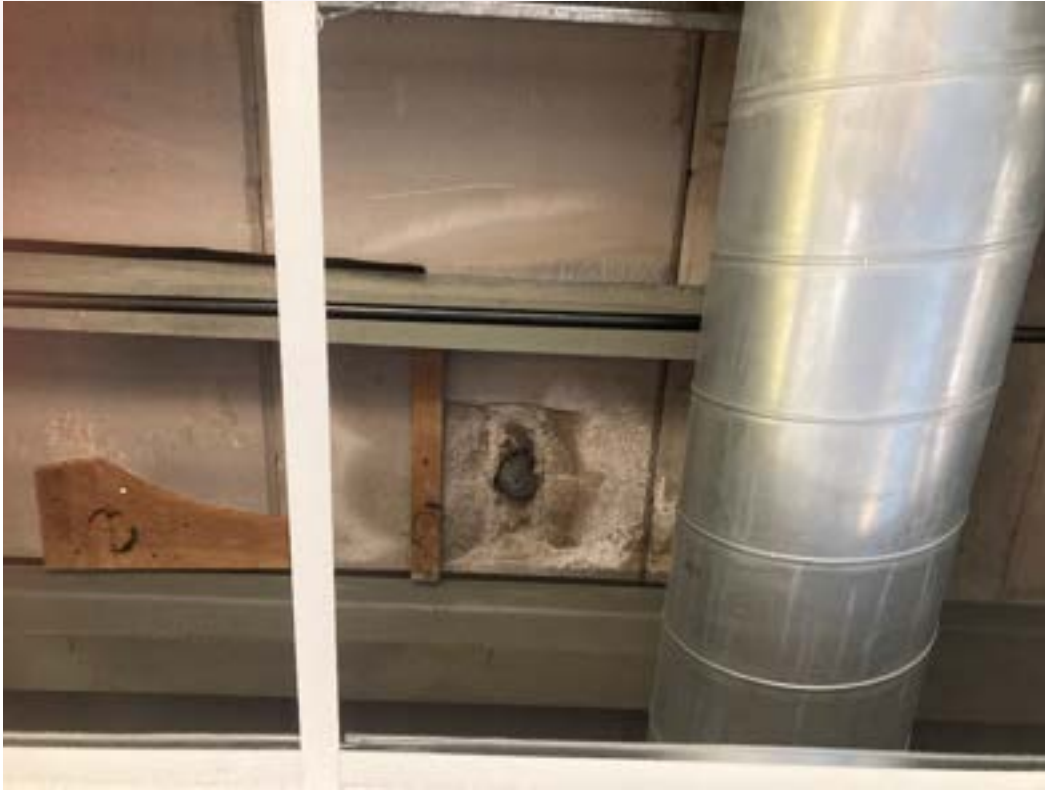
Photograph 1 RAAC panel with hole filled with wire wool and further damage and water ingress.

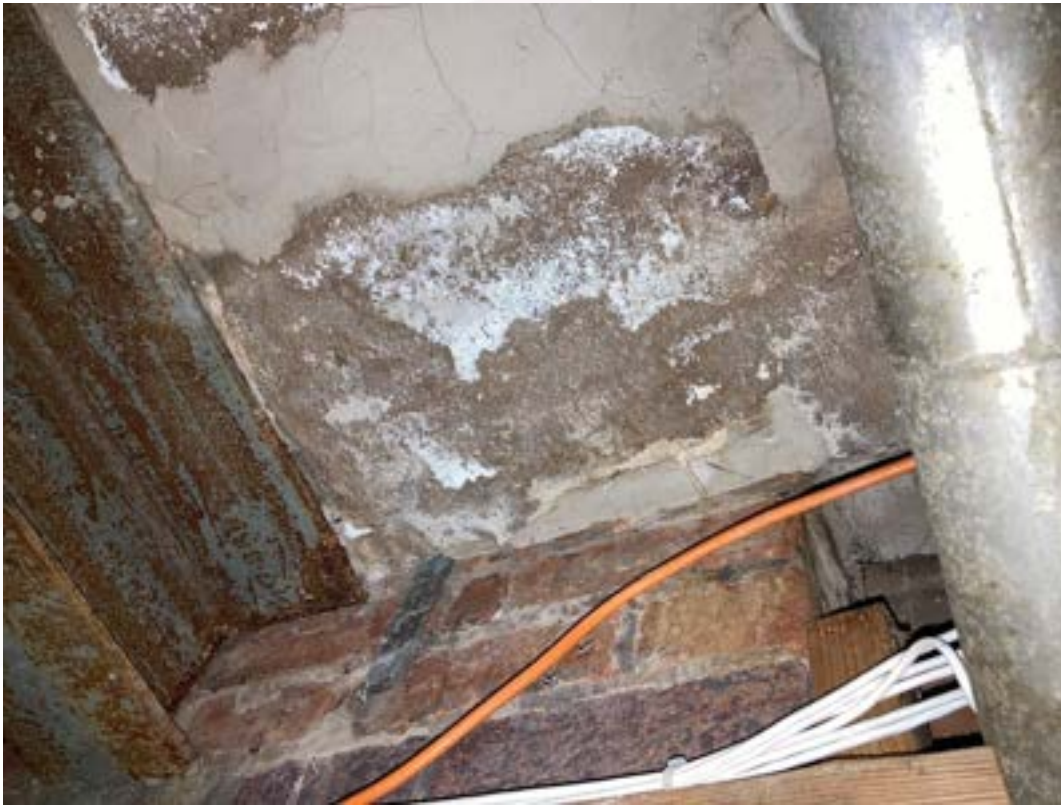
There are several areas of significant water ingress with efflorescence to the surface.

Photograph 2 water ingress and efflorescence.

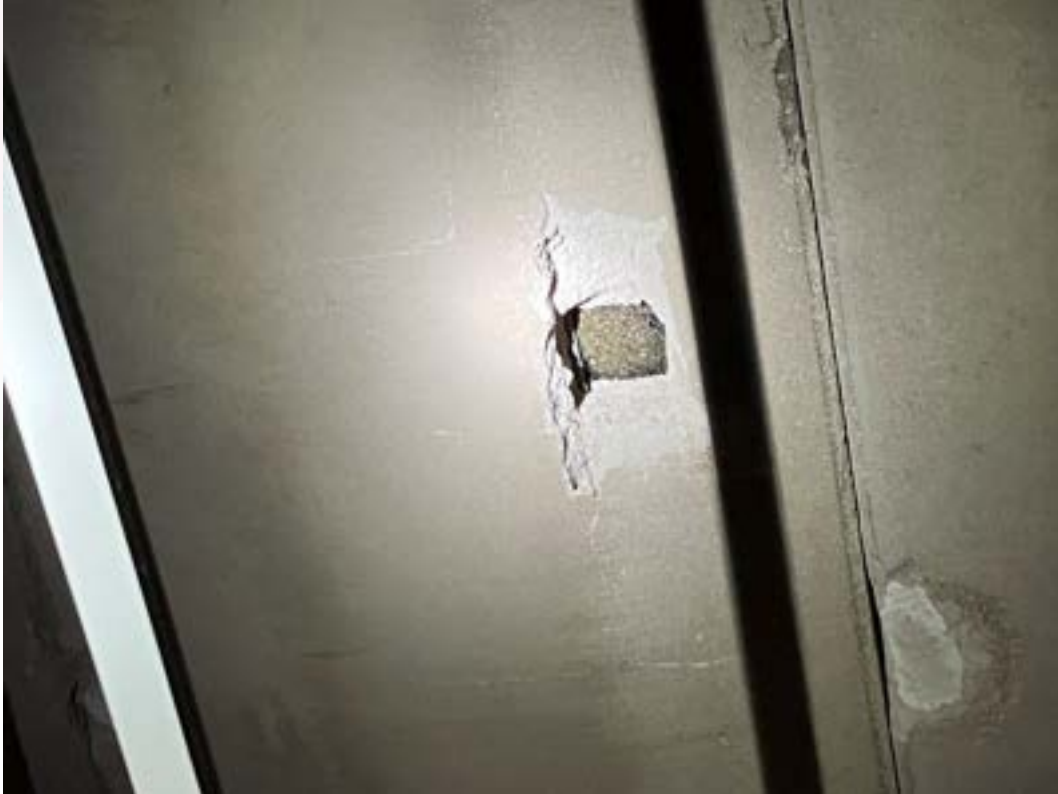
Photograph 3 typical penetration to the slab and further damage in the panel

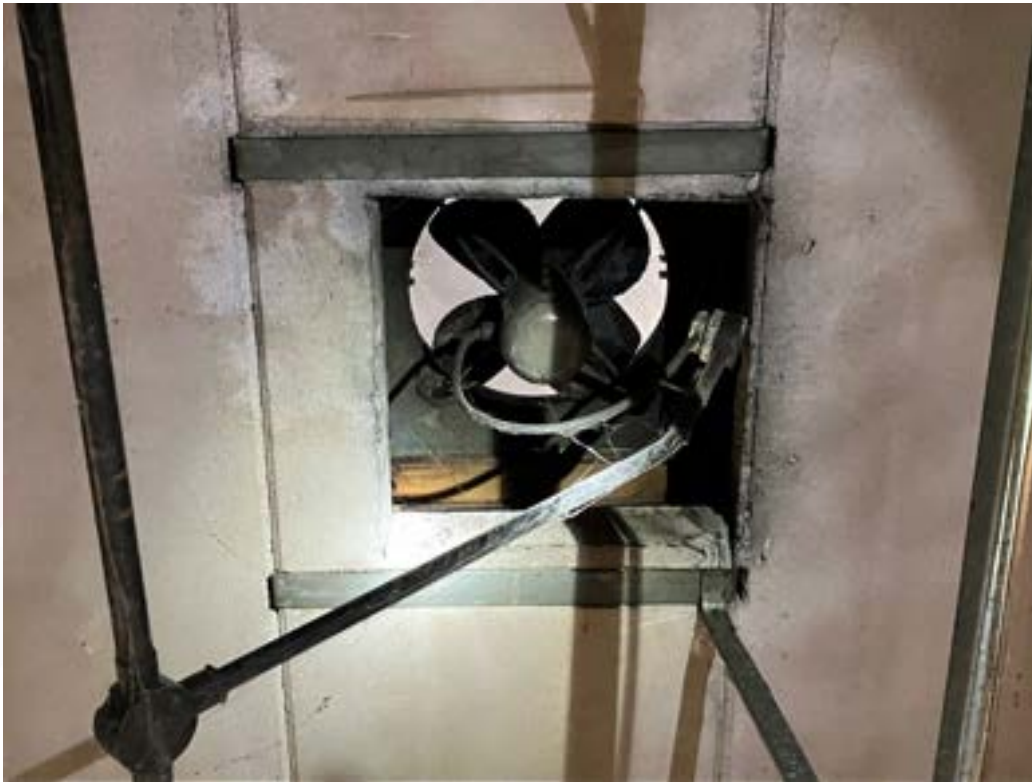
Photograph 4 typical fan installation with damaged cut ends and proprietary supports.

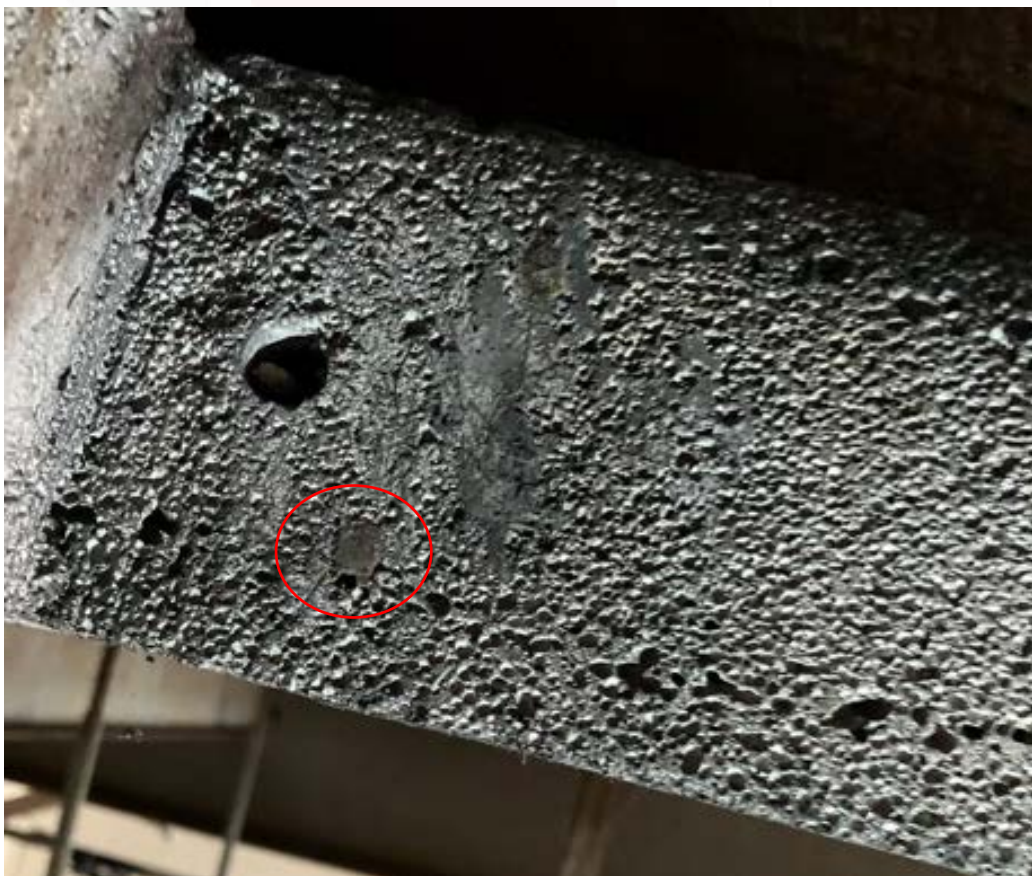
Photograph 5 single transverse reinforcement bar in fan opening and large void.

Intrusive investigation of the reinforcement has not been undertaken but there is an observed lack of transverse reinforcement at the fan openings. This is therefore classed as Red (Critical) throughout.

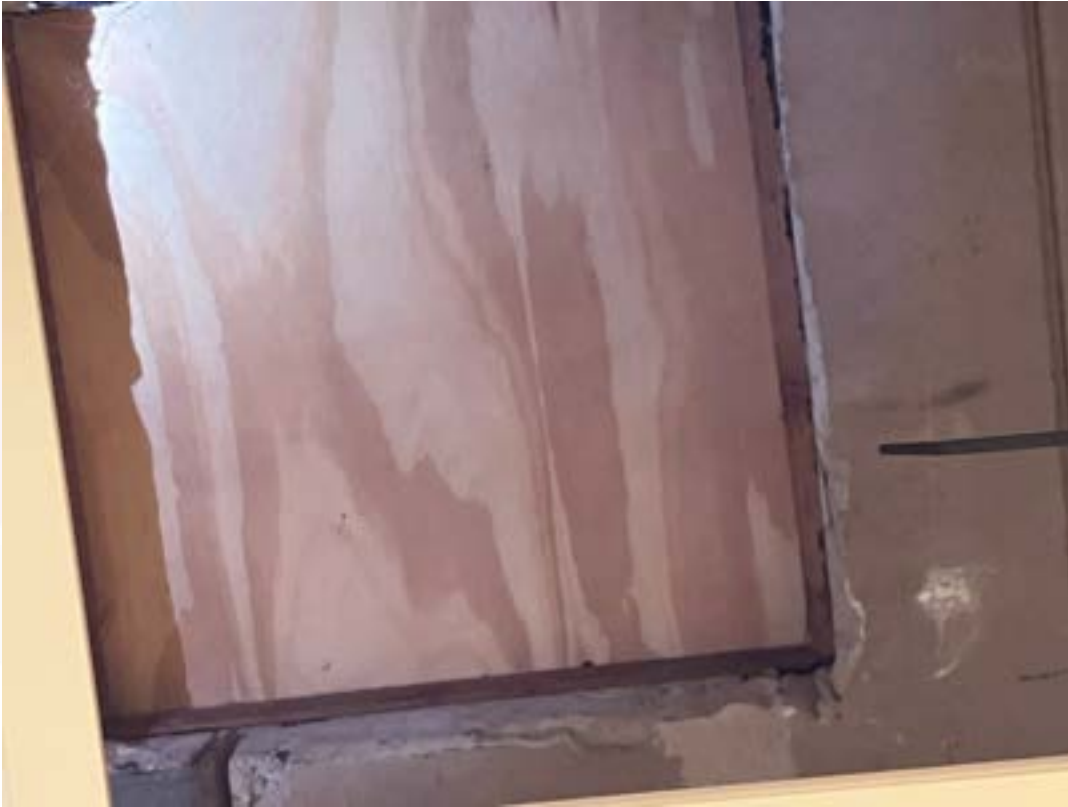
Photograph 6 unsupported openings filled with plywood.

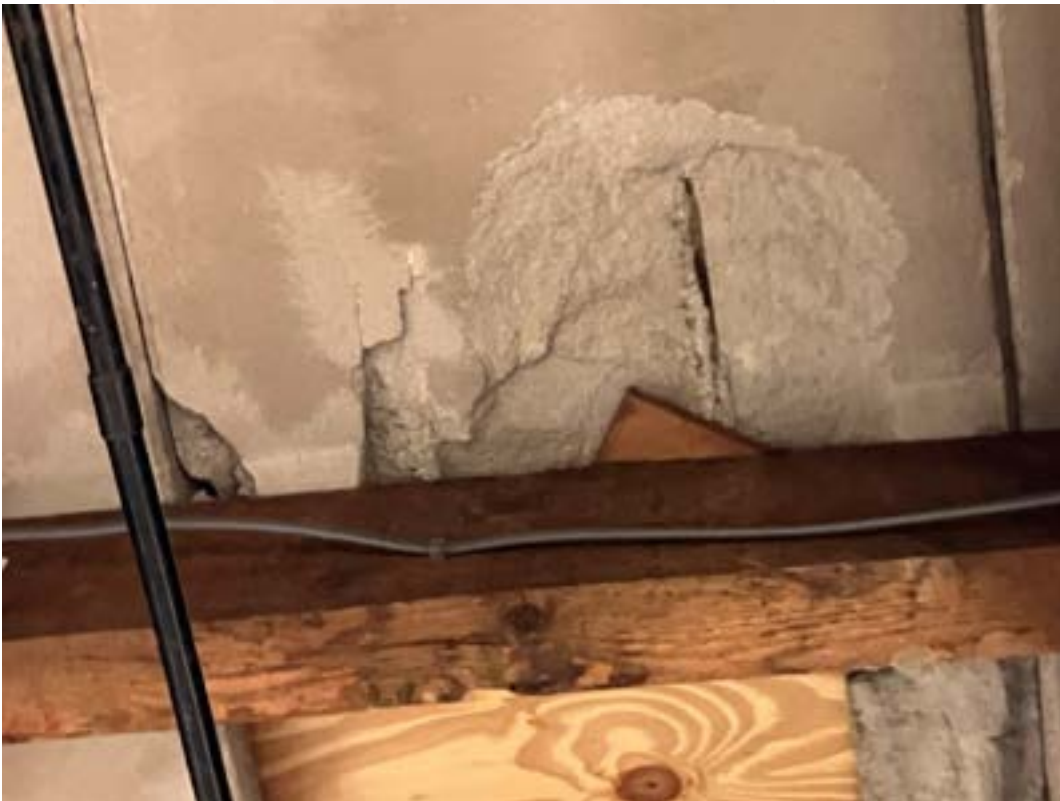
Photograph 7 damaged panel adjacent to a cut opening with additional support from timber joist.

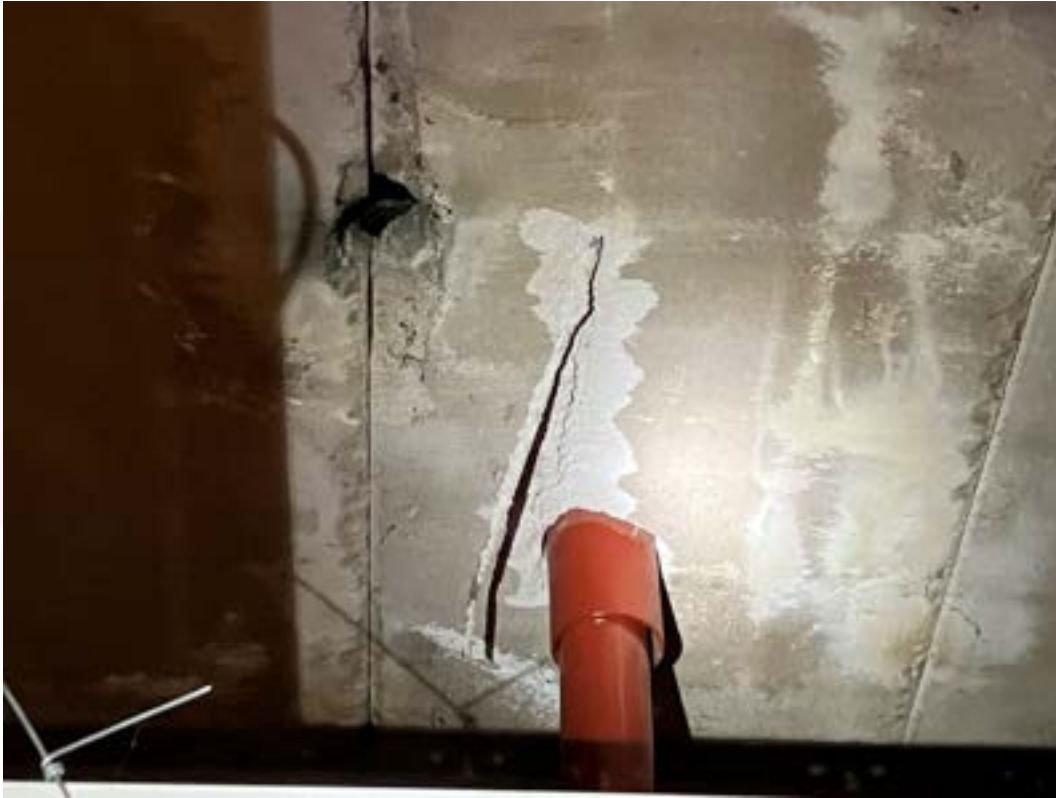
For the flue to the boiler the reinforcement has been pulled out of the way by the contractor.

Photograph 8 holes to panels and rebar pulled out of panel for new boiler flue.

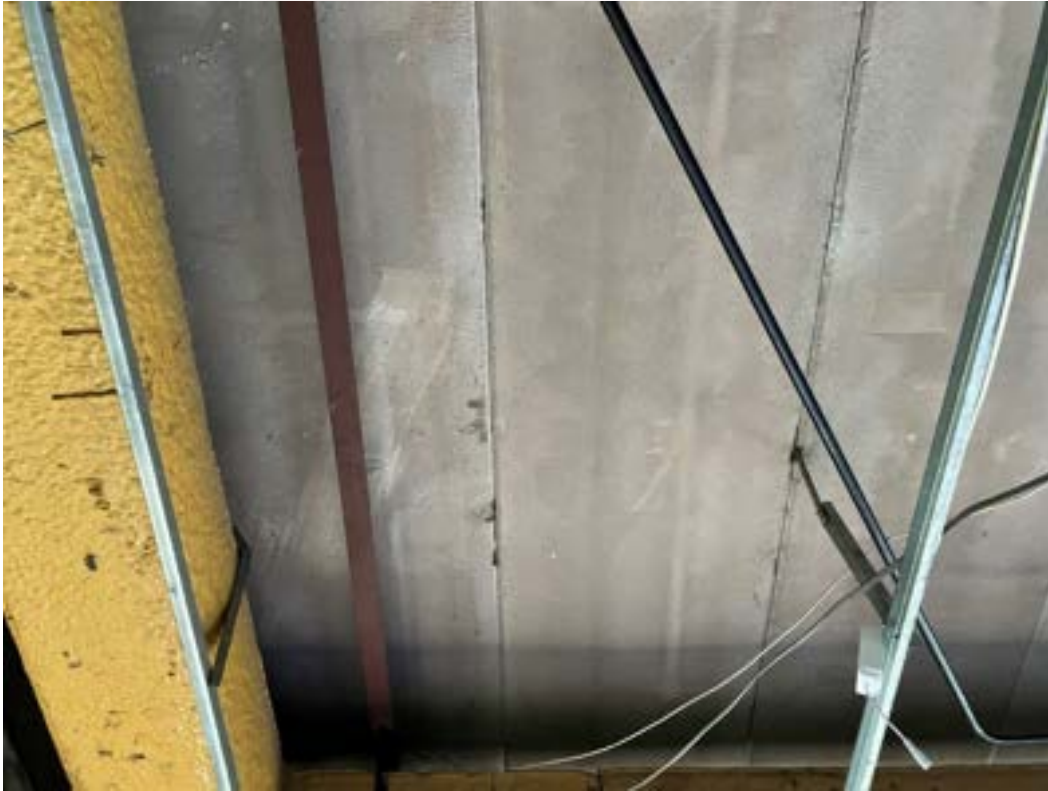
Photograph 9 watermarks to panels, note reinforcement pattern visible.

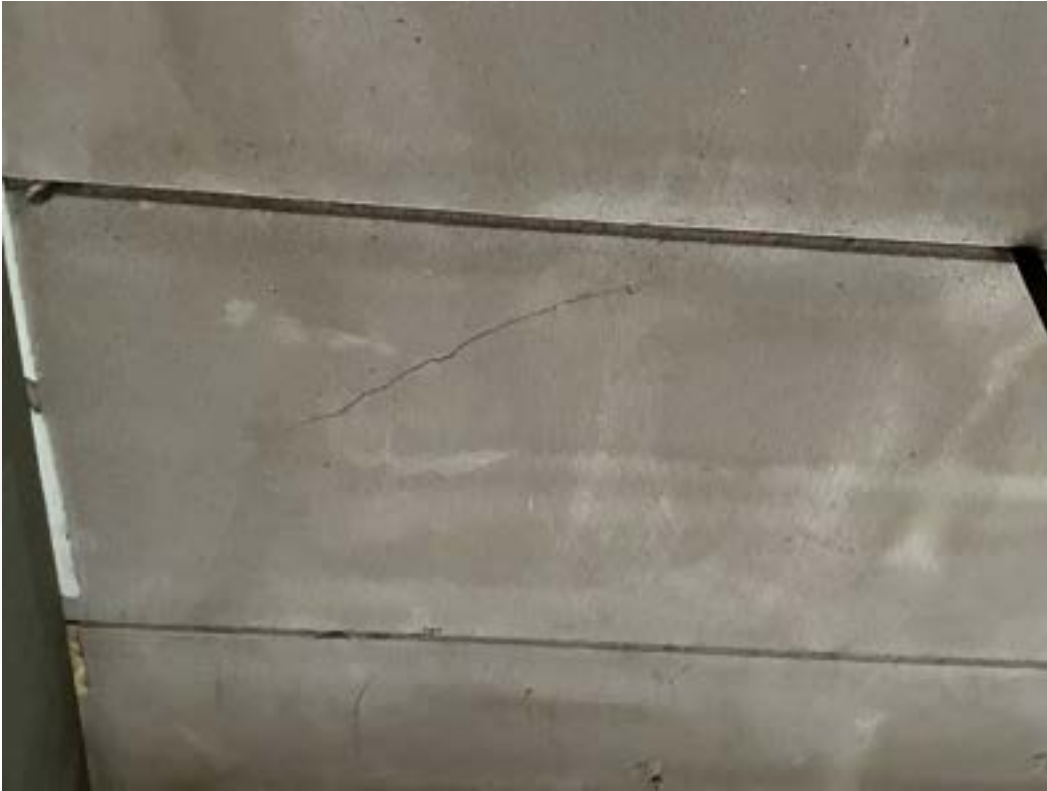
Photograph 10 cracking to RAAC panels in bar area over foyer.

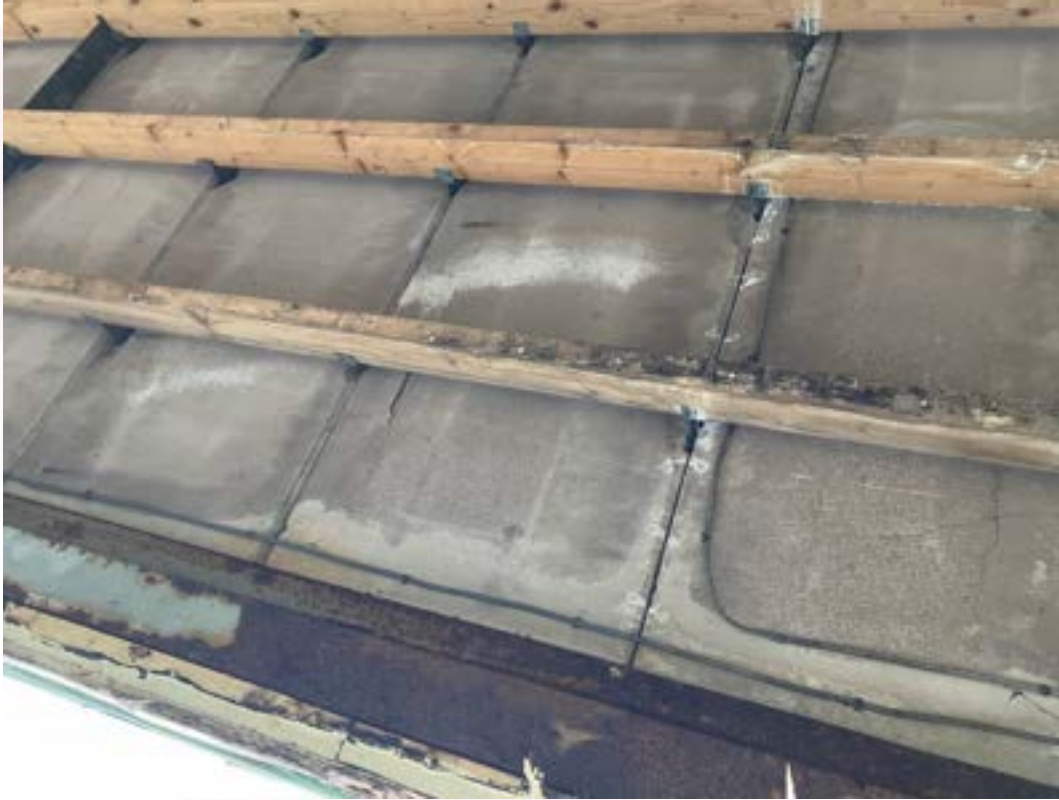
Photograph 11 typical wet panels with damages panels at corners and cracking throughout to walkway area.

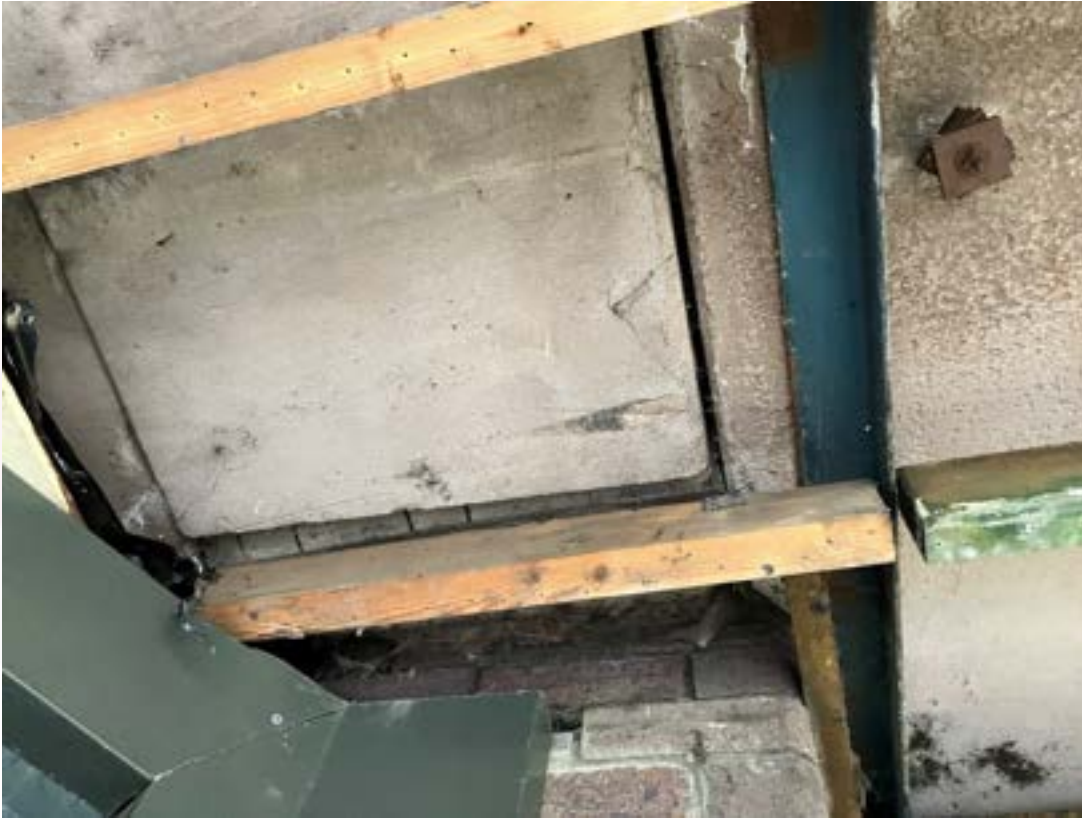
Photograph 12 cut panels poorly supported and exposed reinforcement also displacement between adjacent panels.

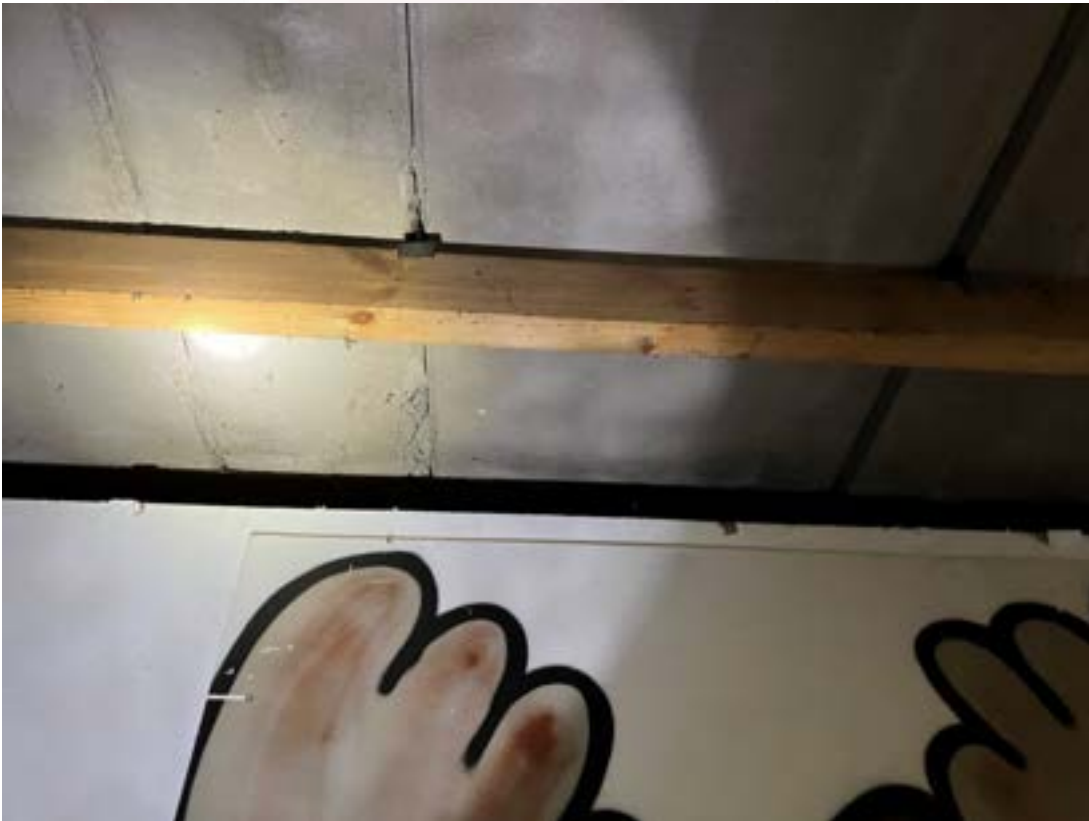
Photograph 13 typical panel damage at edges and bearings.

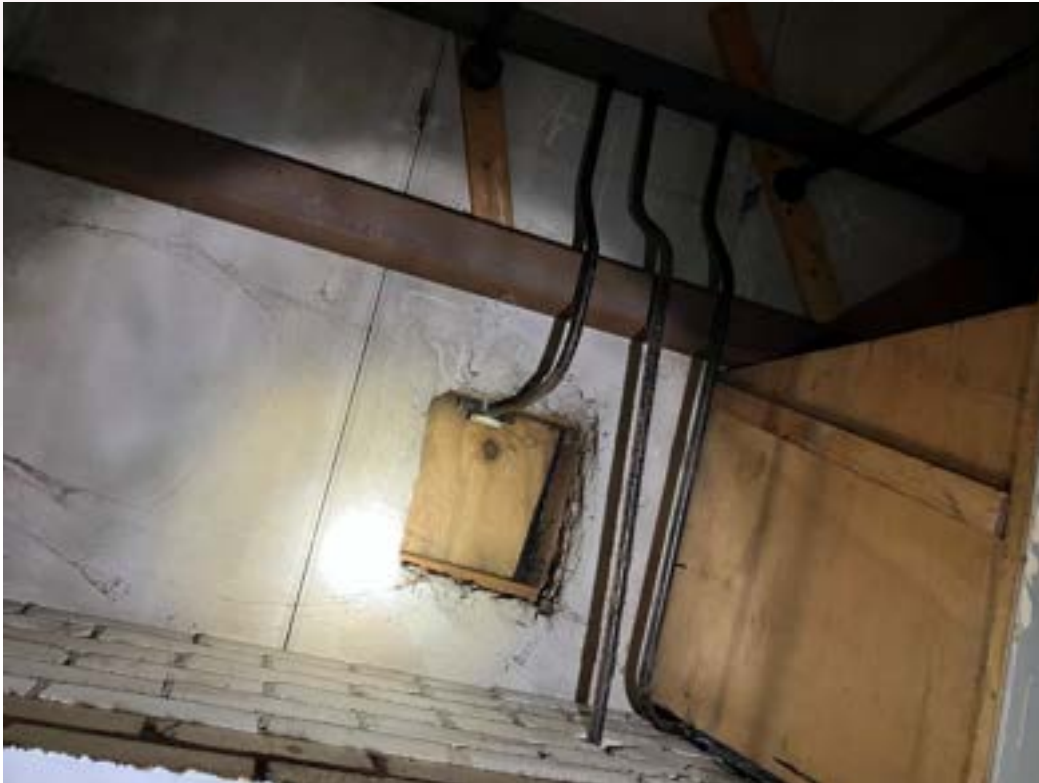
Photograph 14 unsupported large opening to panels ground floor rear rooms at back of stage.

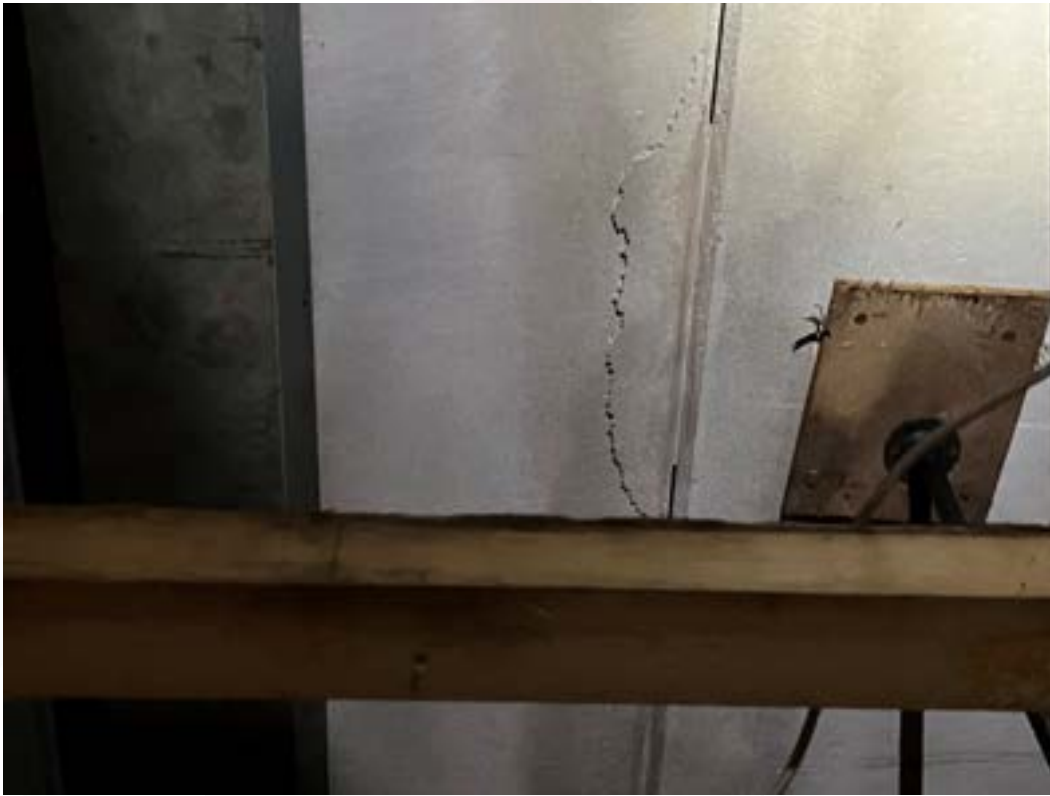
Photograph 15 cracking to panel.

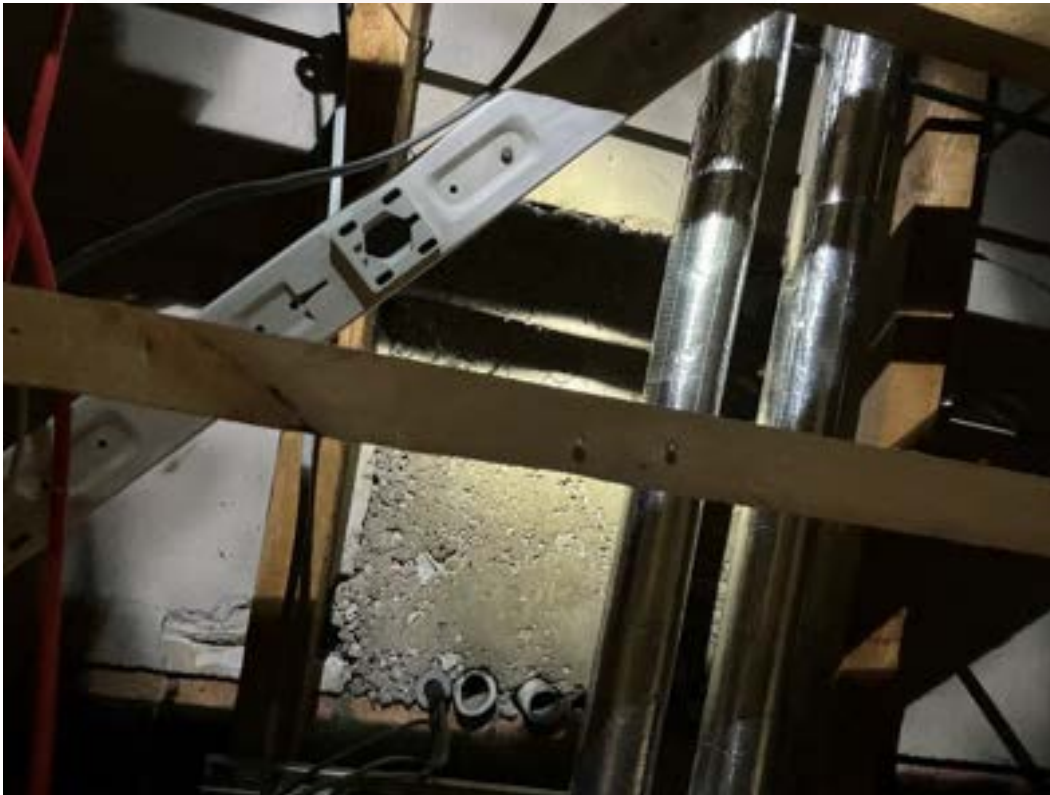
Photograph 16 cut panel infilled with concrete and supported on timber joists.

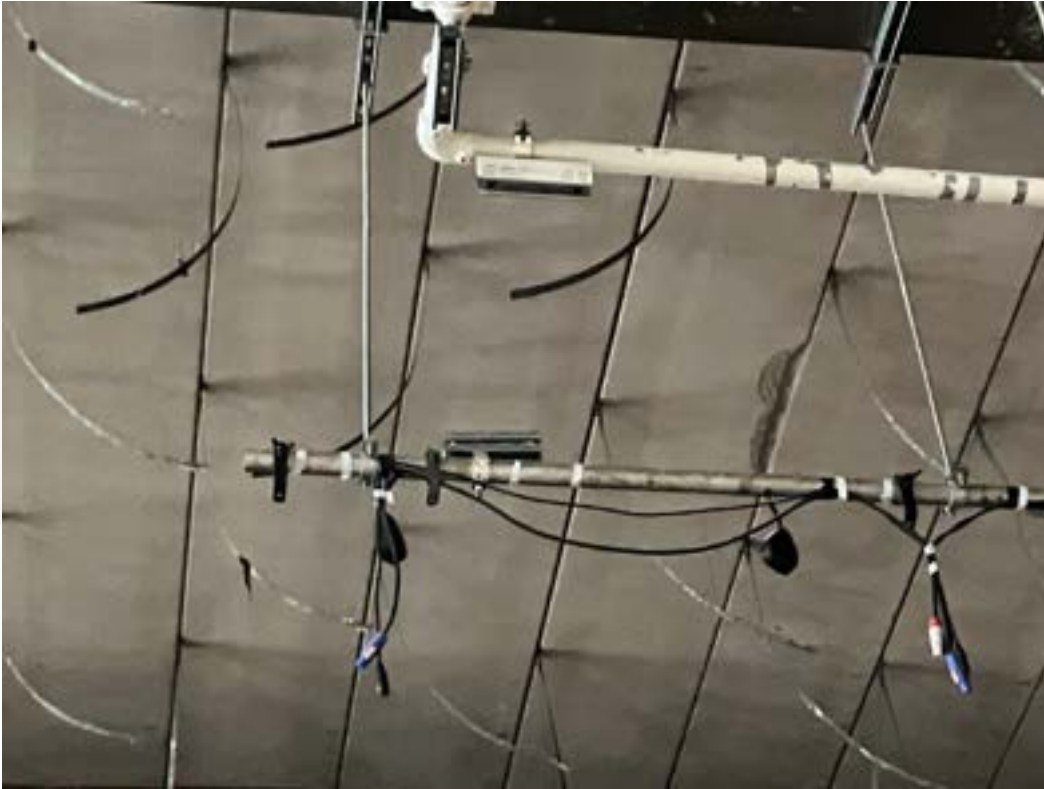
Photograph 17 damage to panel in main theatre area.

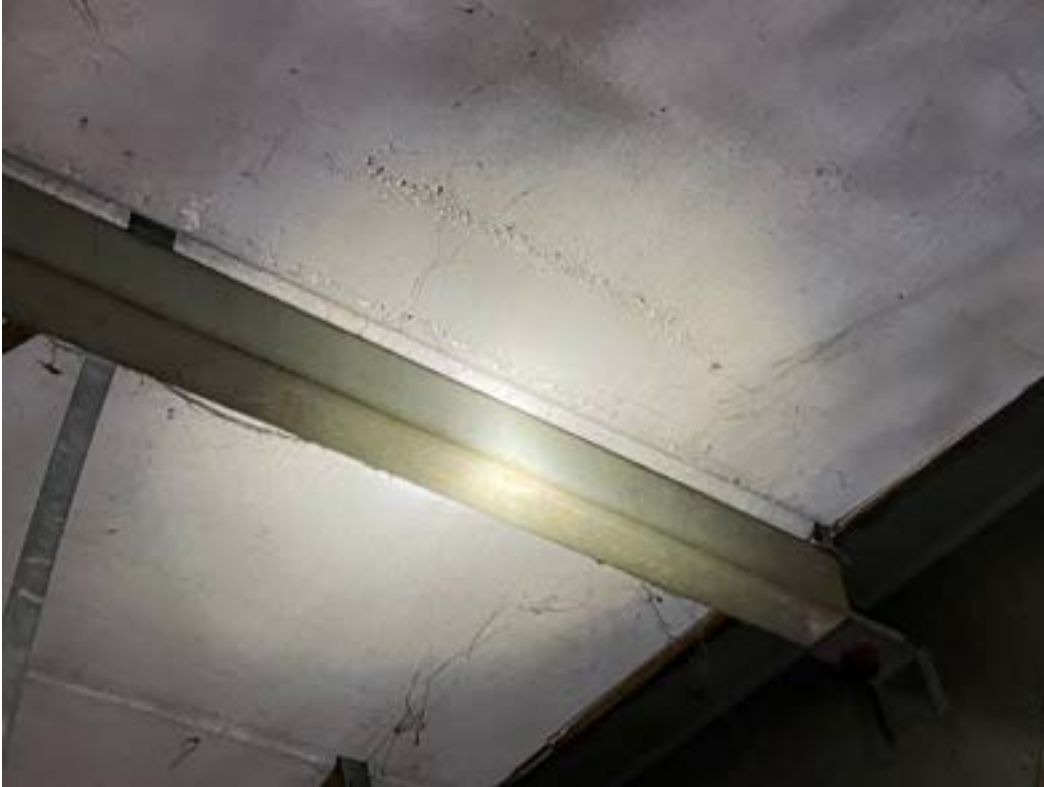
Photograph 18 close up of plank in theatre area with a line of honeycombing and voids. Hairline cracks also in the area but not visible in the photograph.

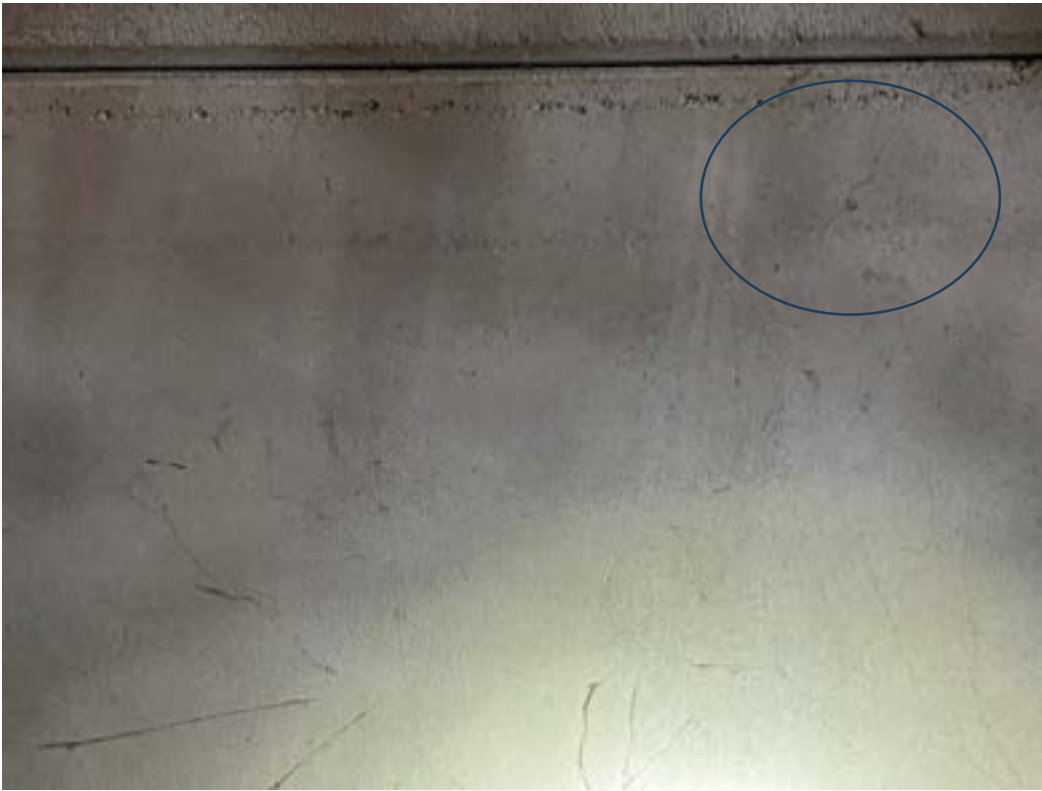
Photograph 19 hairline cracking to panel.

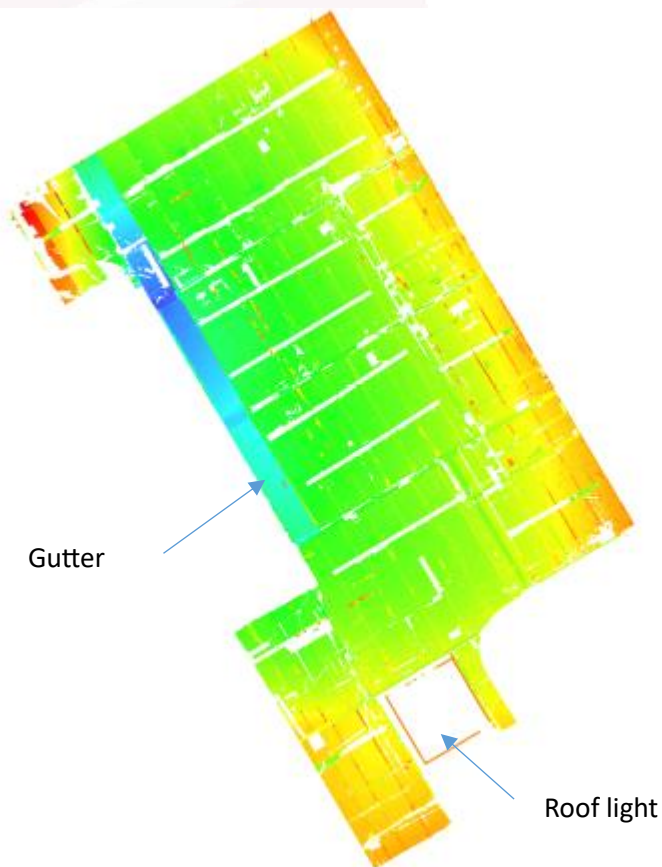
Figure 1 surface levelness Library.

The library clearly shows the fall to the gutter and the lower level of the gutter along the wall of the two-storey section indicated by the blue area.

The yellow and red lines that are running perpendicular to the white lines are the joints in the RAAC panels where the laser has measured within the gaps that have formed. The white lines are the beams or service positions or excluded areas such as roof lights.

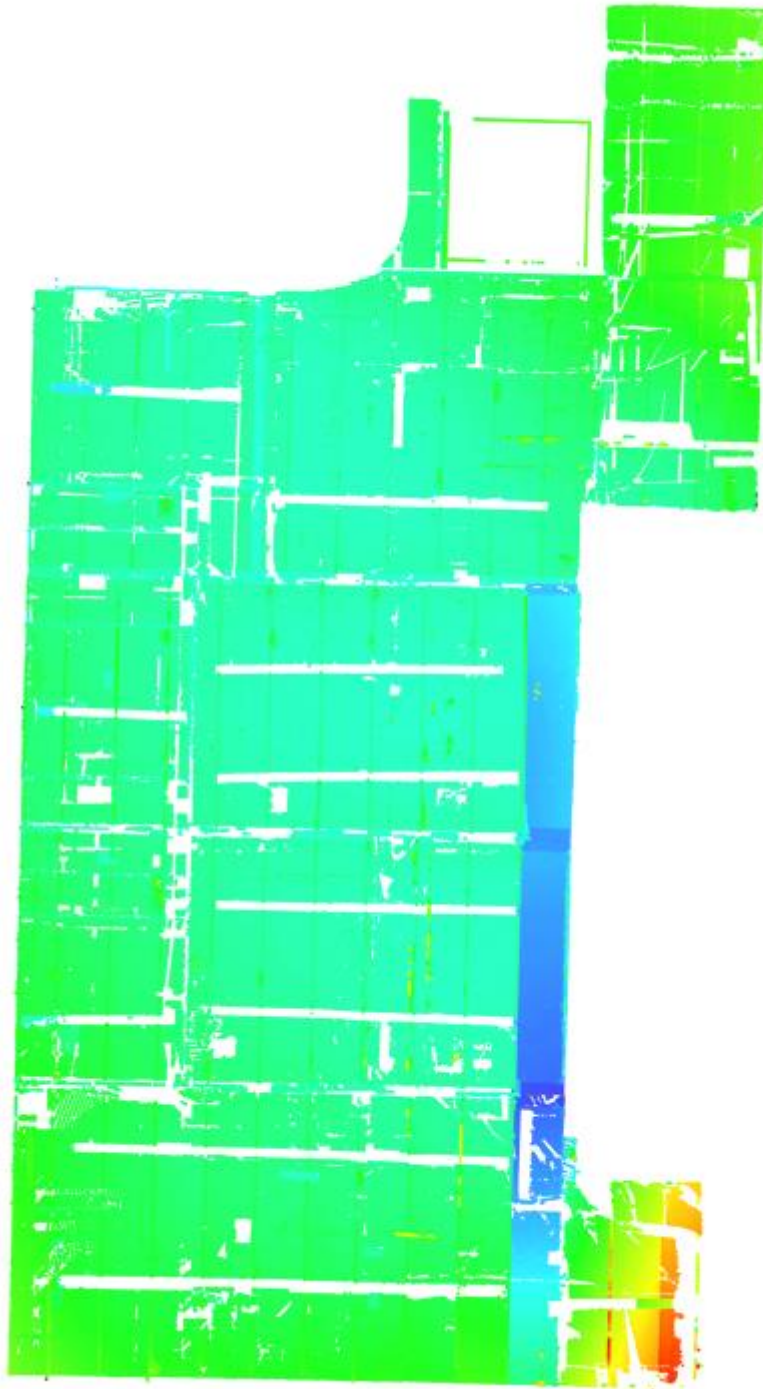
Figure 2 surface regularity from a plane

A further scan has been produced that takes a plane from the highest point and compares the position of the slab in relation to the plane.

The general in span deflections are approximately 1 in 100 to 1 in 200.

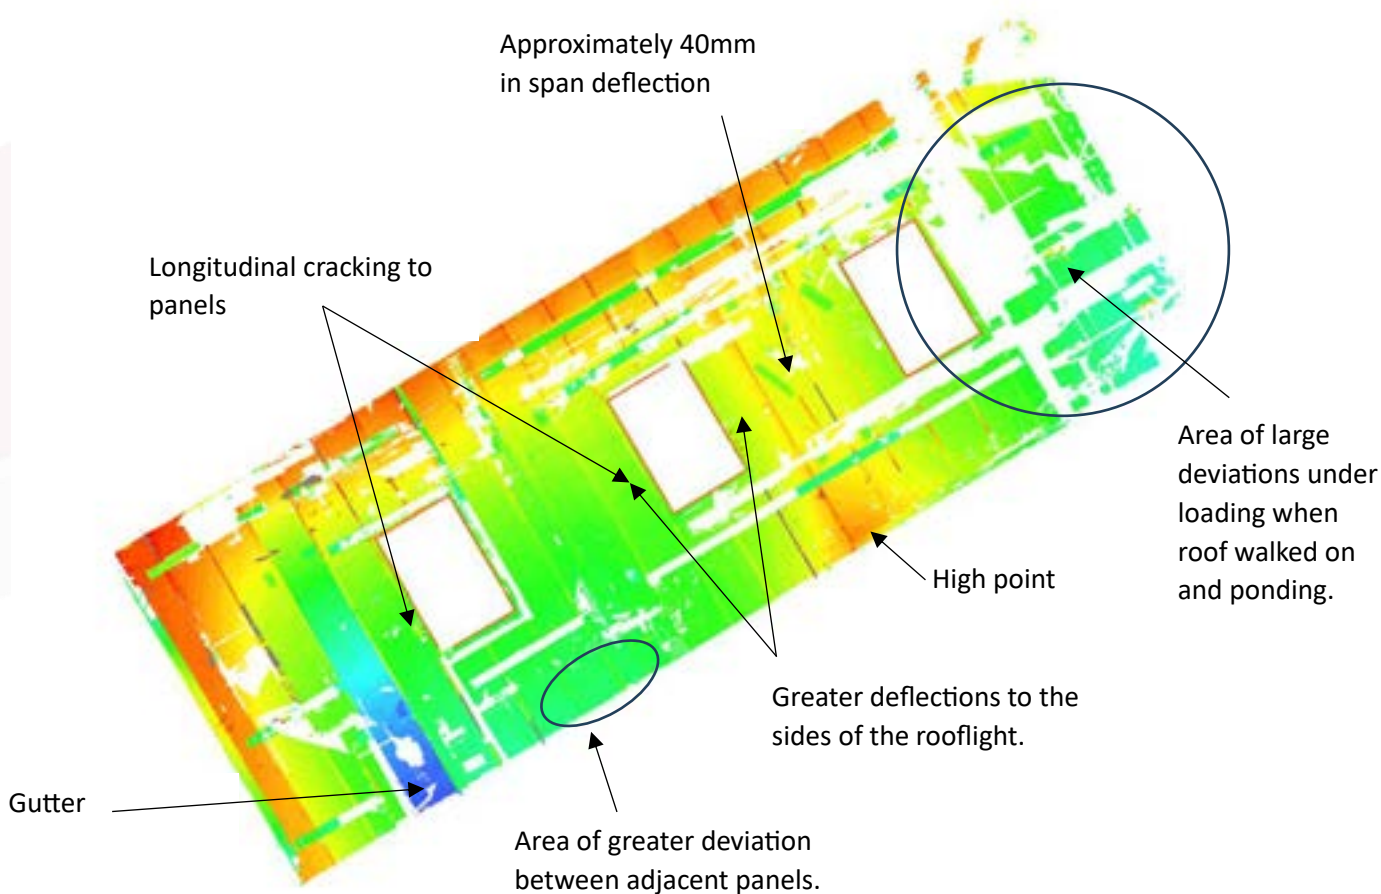
Figure 3 Library back room / workshop surface regularity

The imaging shows that there is a general fall from the external wall towards the library. This also shows that there are large deviations between panels of 20mm. There is greater deflection in the RAAC panels either side of the roof lights. The lower area is coloured green, it is in these areas that the RAAC panels have longitudinal cracking to the sides of the roof light.

There is an area that indicates 37mm in span deflection, this is taken as the difference between the red areas at the supports and the yellow area at mid-span. The green has been discounted as this is probably a prop position. This indicates in span deflections of span/100.

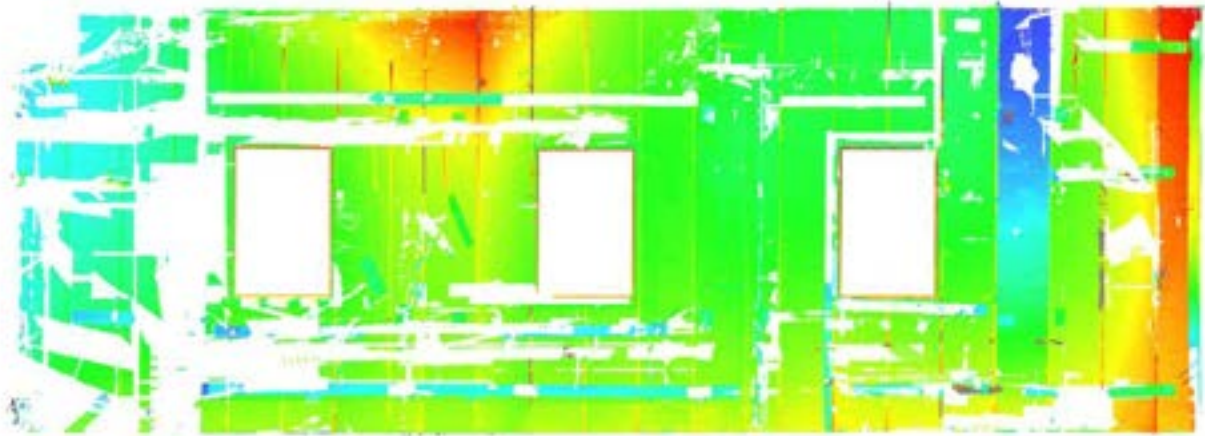
Figure 4 deviation from plane library back room / workshop

The above concurs with the findings noted above.

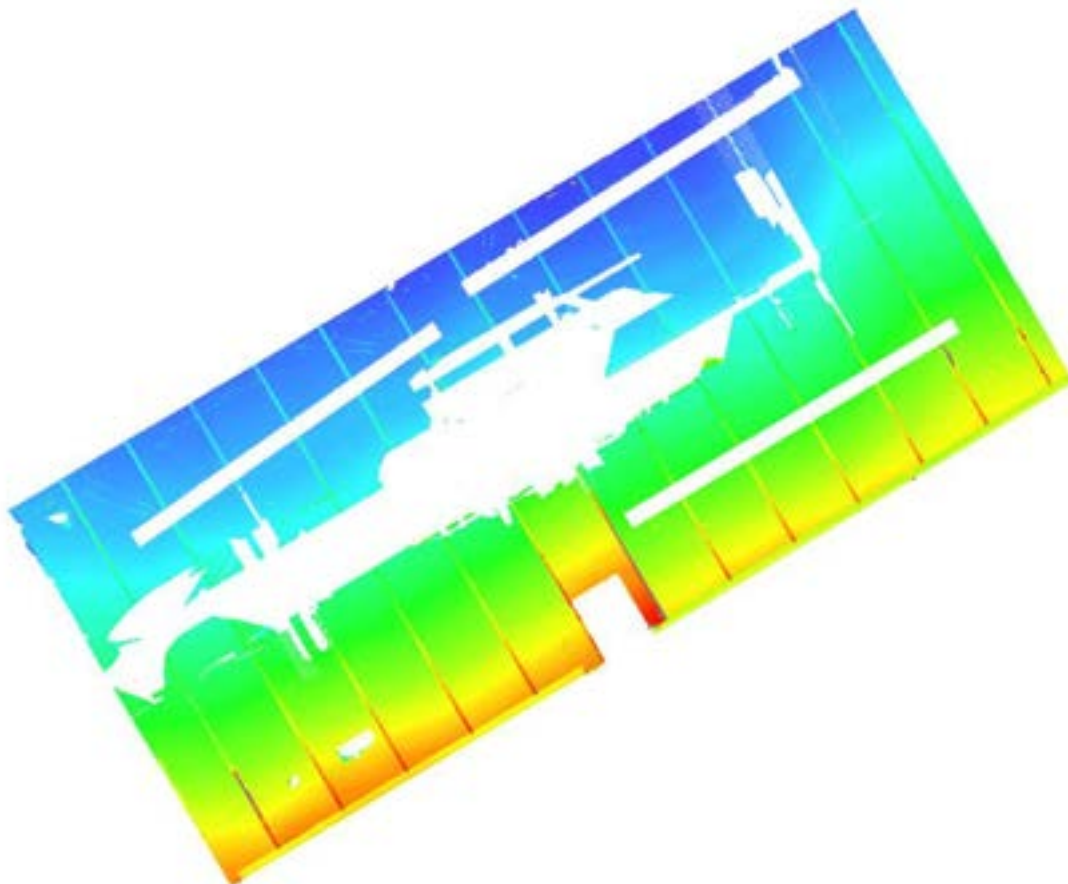
Figure 5 surface regularity garage.

The garage roof is reasonably uniform without significant deflections.

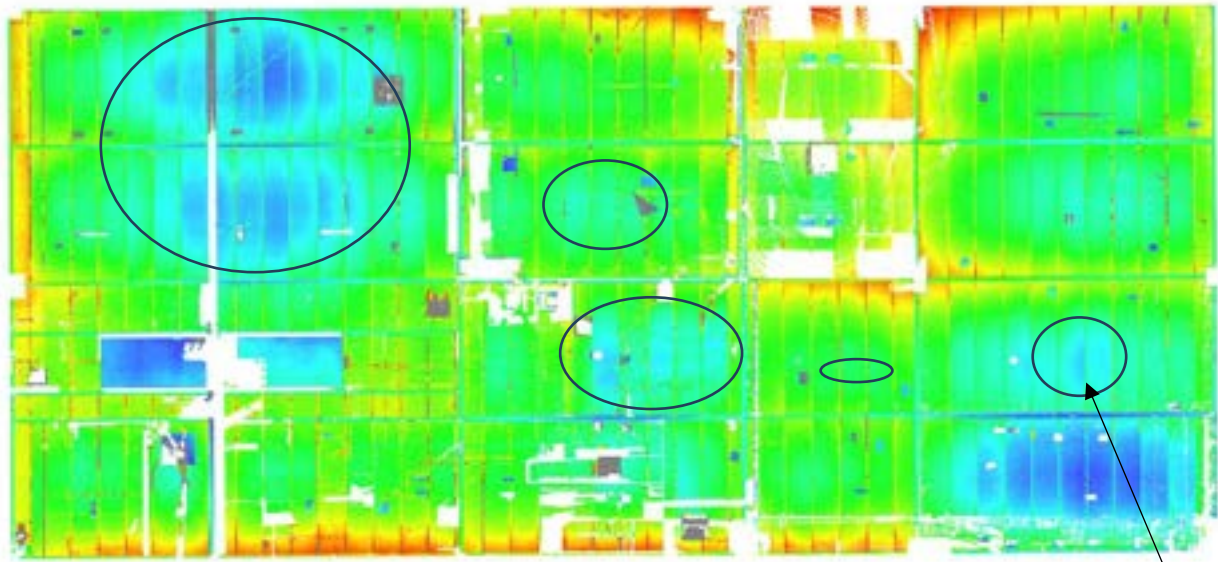
In span deflection
circa 28mm

Figure 7 deviation from plane in bar area to left-hand side with some areas of large deflections shown.

The in span deflection of the roof in this area is less than span/100.

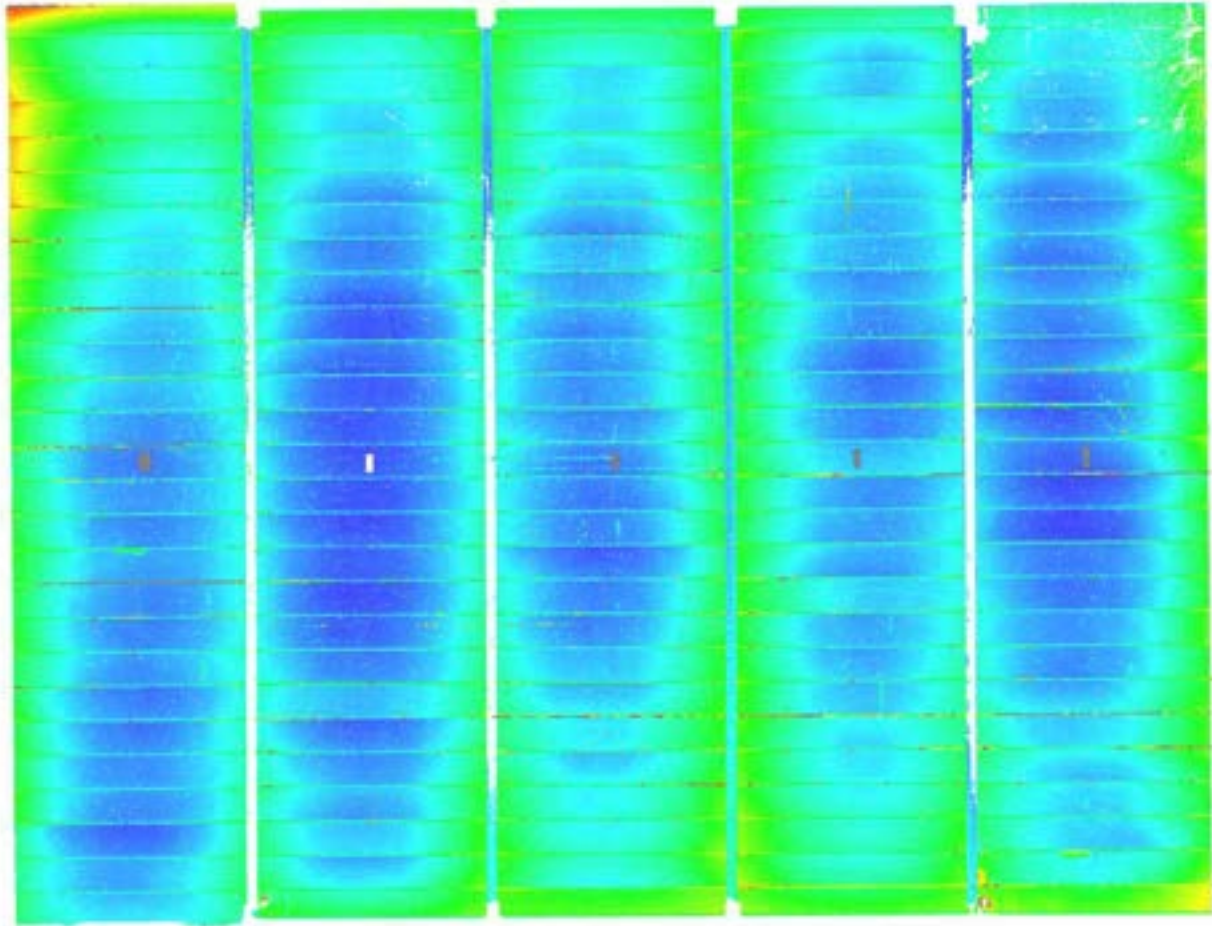
Figure 8 Theatre deviation from plane.

The theatre shows that the roof deflections are typically span/200 to span/250.
