# Arboricultural Planning Statement

## Solar Farm on Land South of Berrington

**ADAS Reference:** 1051610

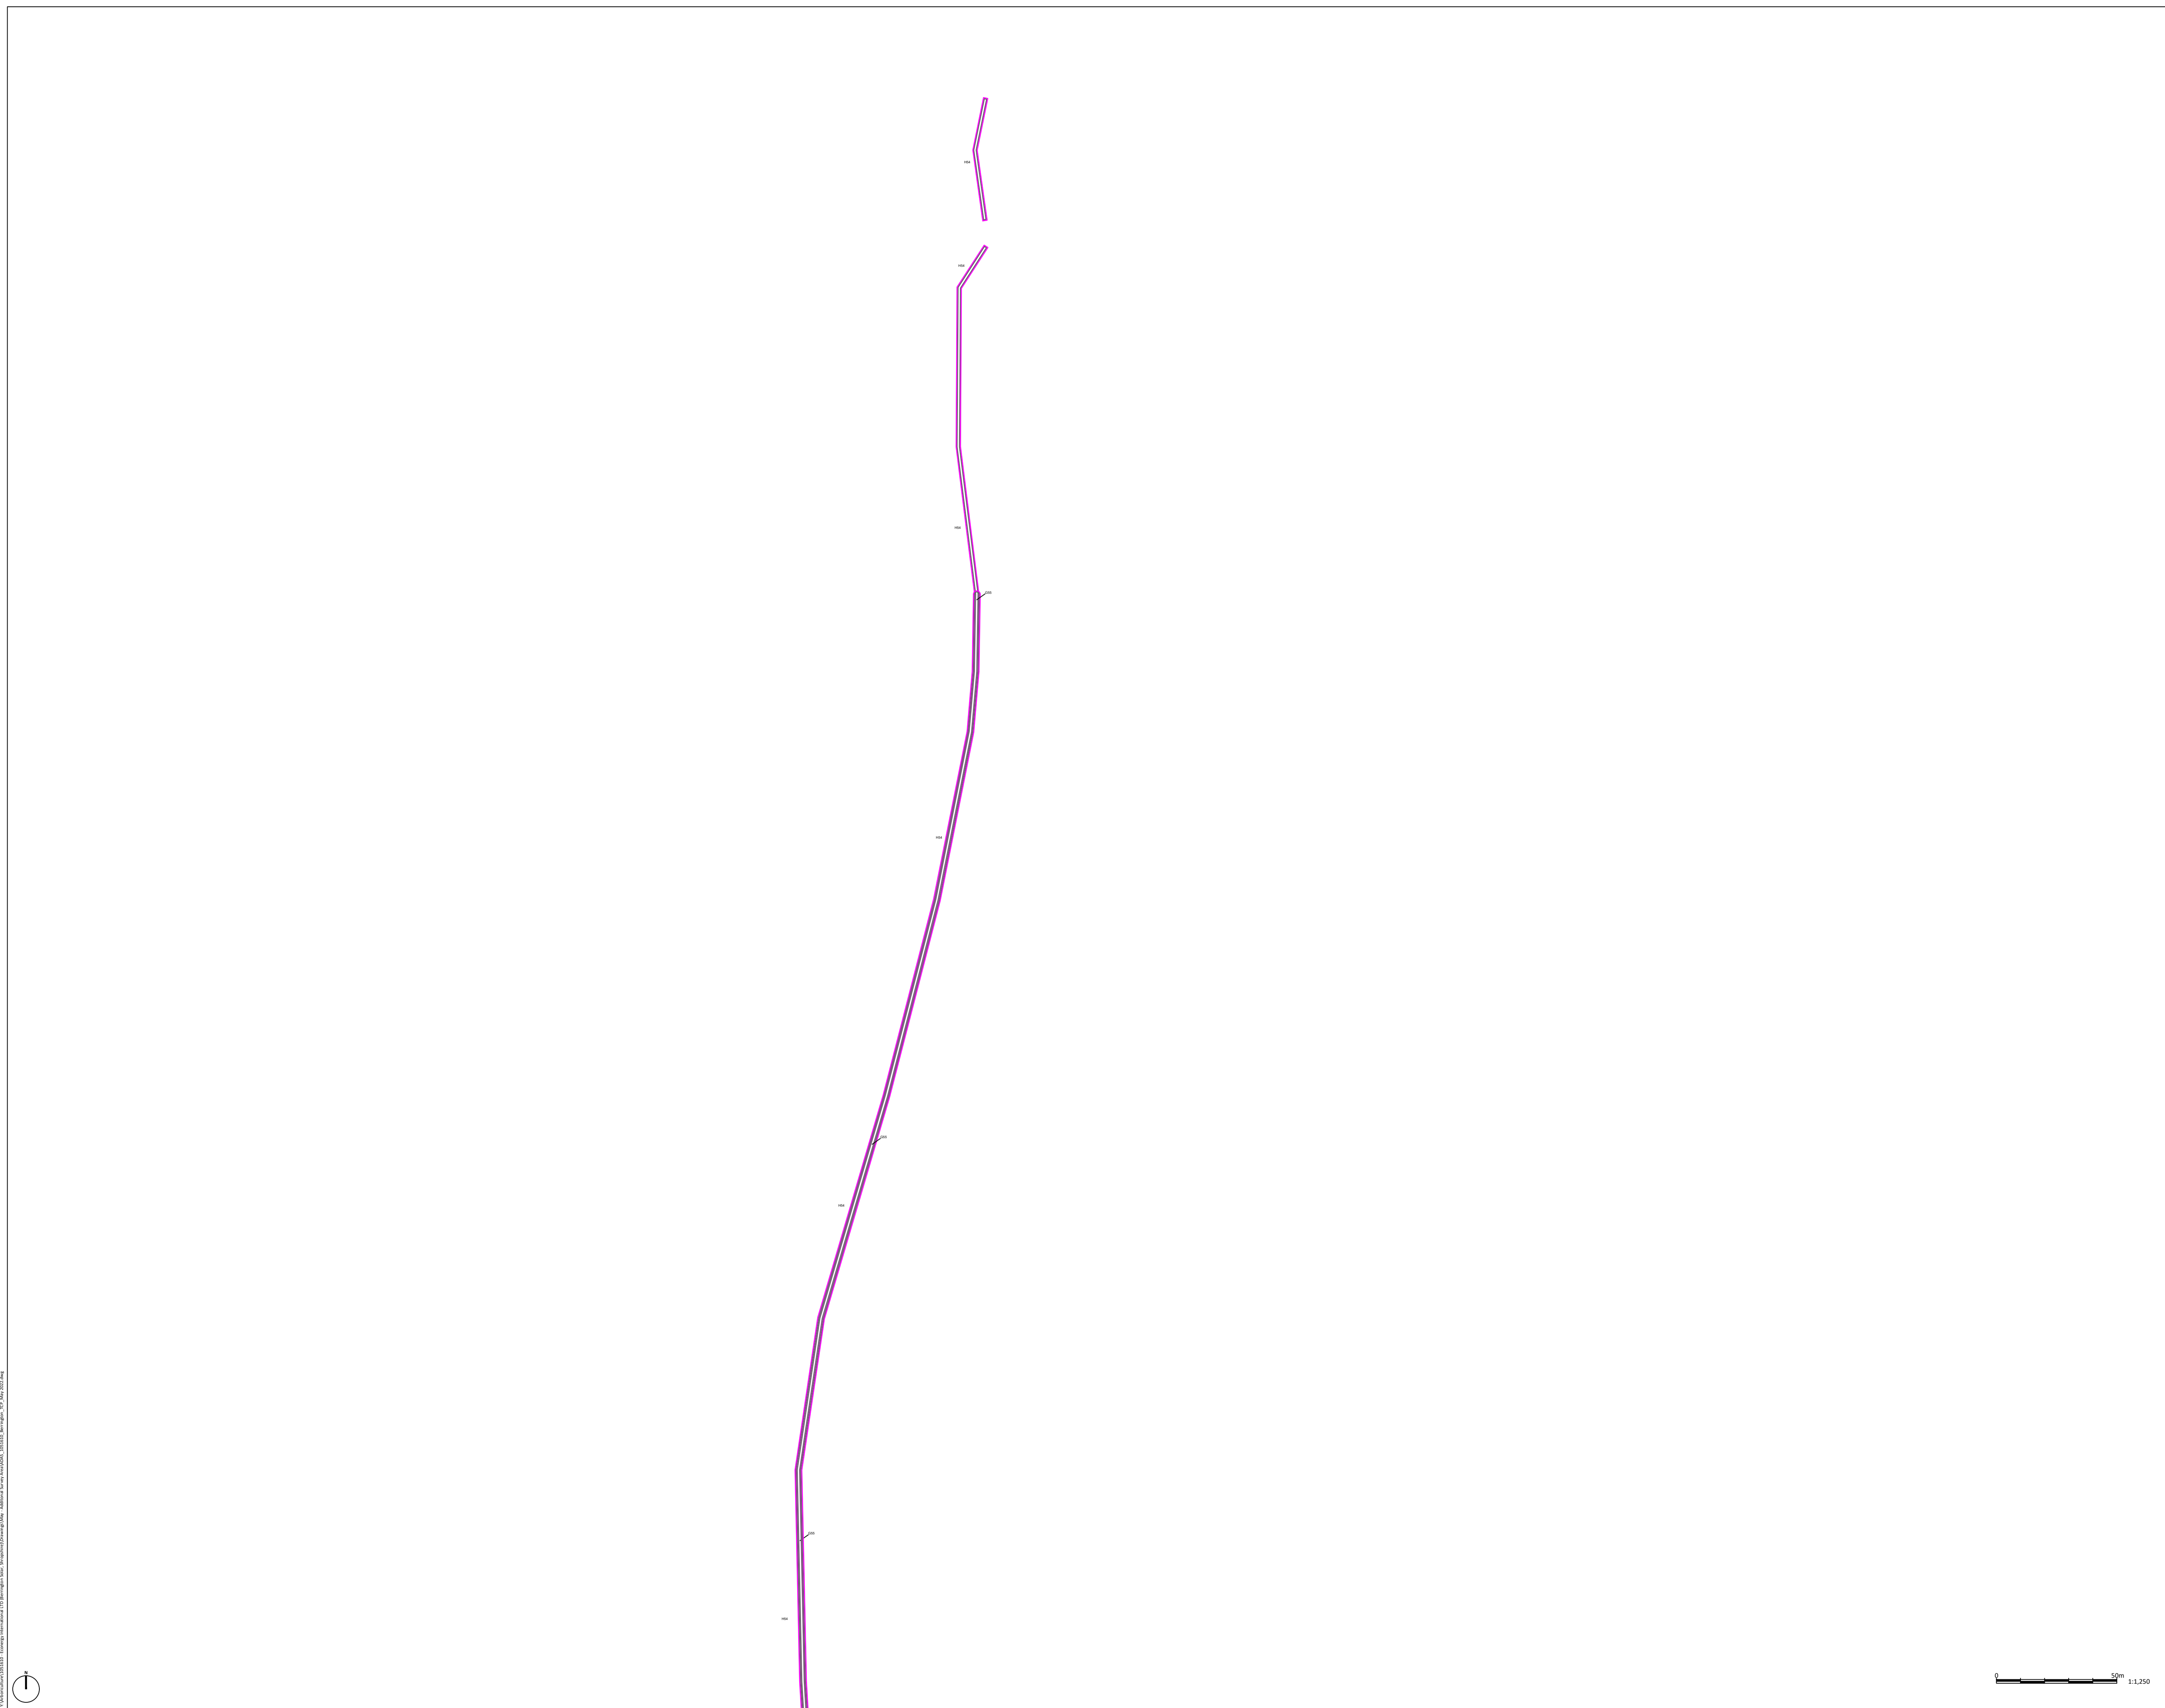
Client:  
**Econergy International Ltd**  
 Project:  
**Solar Farm on Land South of Berrington**  
 Drawing Title:  
**Tree Constraints Plan**  
 Drawing No: 1051610\_ECONERGY\_TCP\_SHEET1  
 Scale: 1:1250 @ A1

- Category A**  
Trees / Groups of high quality: with an estimated remaining life expectancy of at least 40 years.
- Category B**  
Trees / Groups of moderate quality: with an estimated remaining life expectancy of at least 20 years.
- Category C**  
Trees / Groups of low quality: with an estimated remaining life expectancy of at least 10 years, or young trees with a stem diameter below 150mm.
- Category U**  
Trees / Groups: in such a condition that they cannot realistically be retained as living trees in the context of current land use for longer than 10 years.
- Root Protection Area (RPA)**

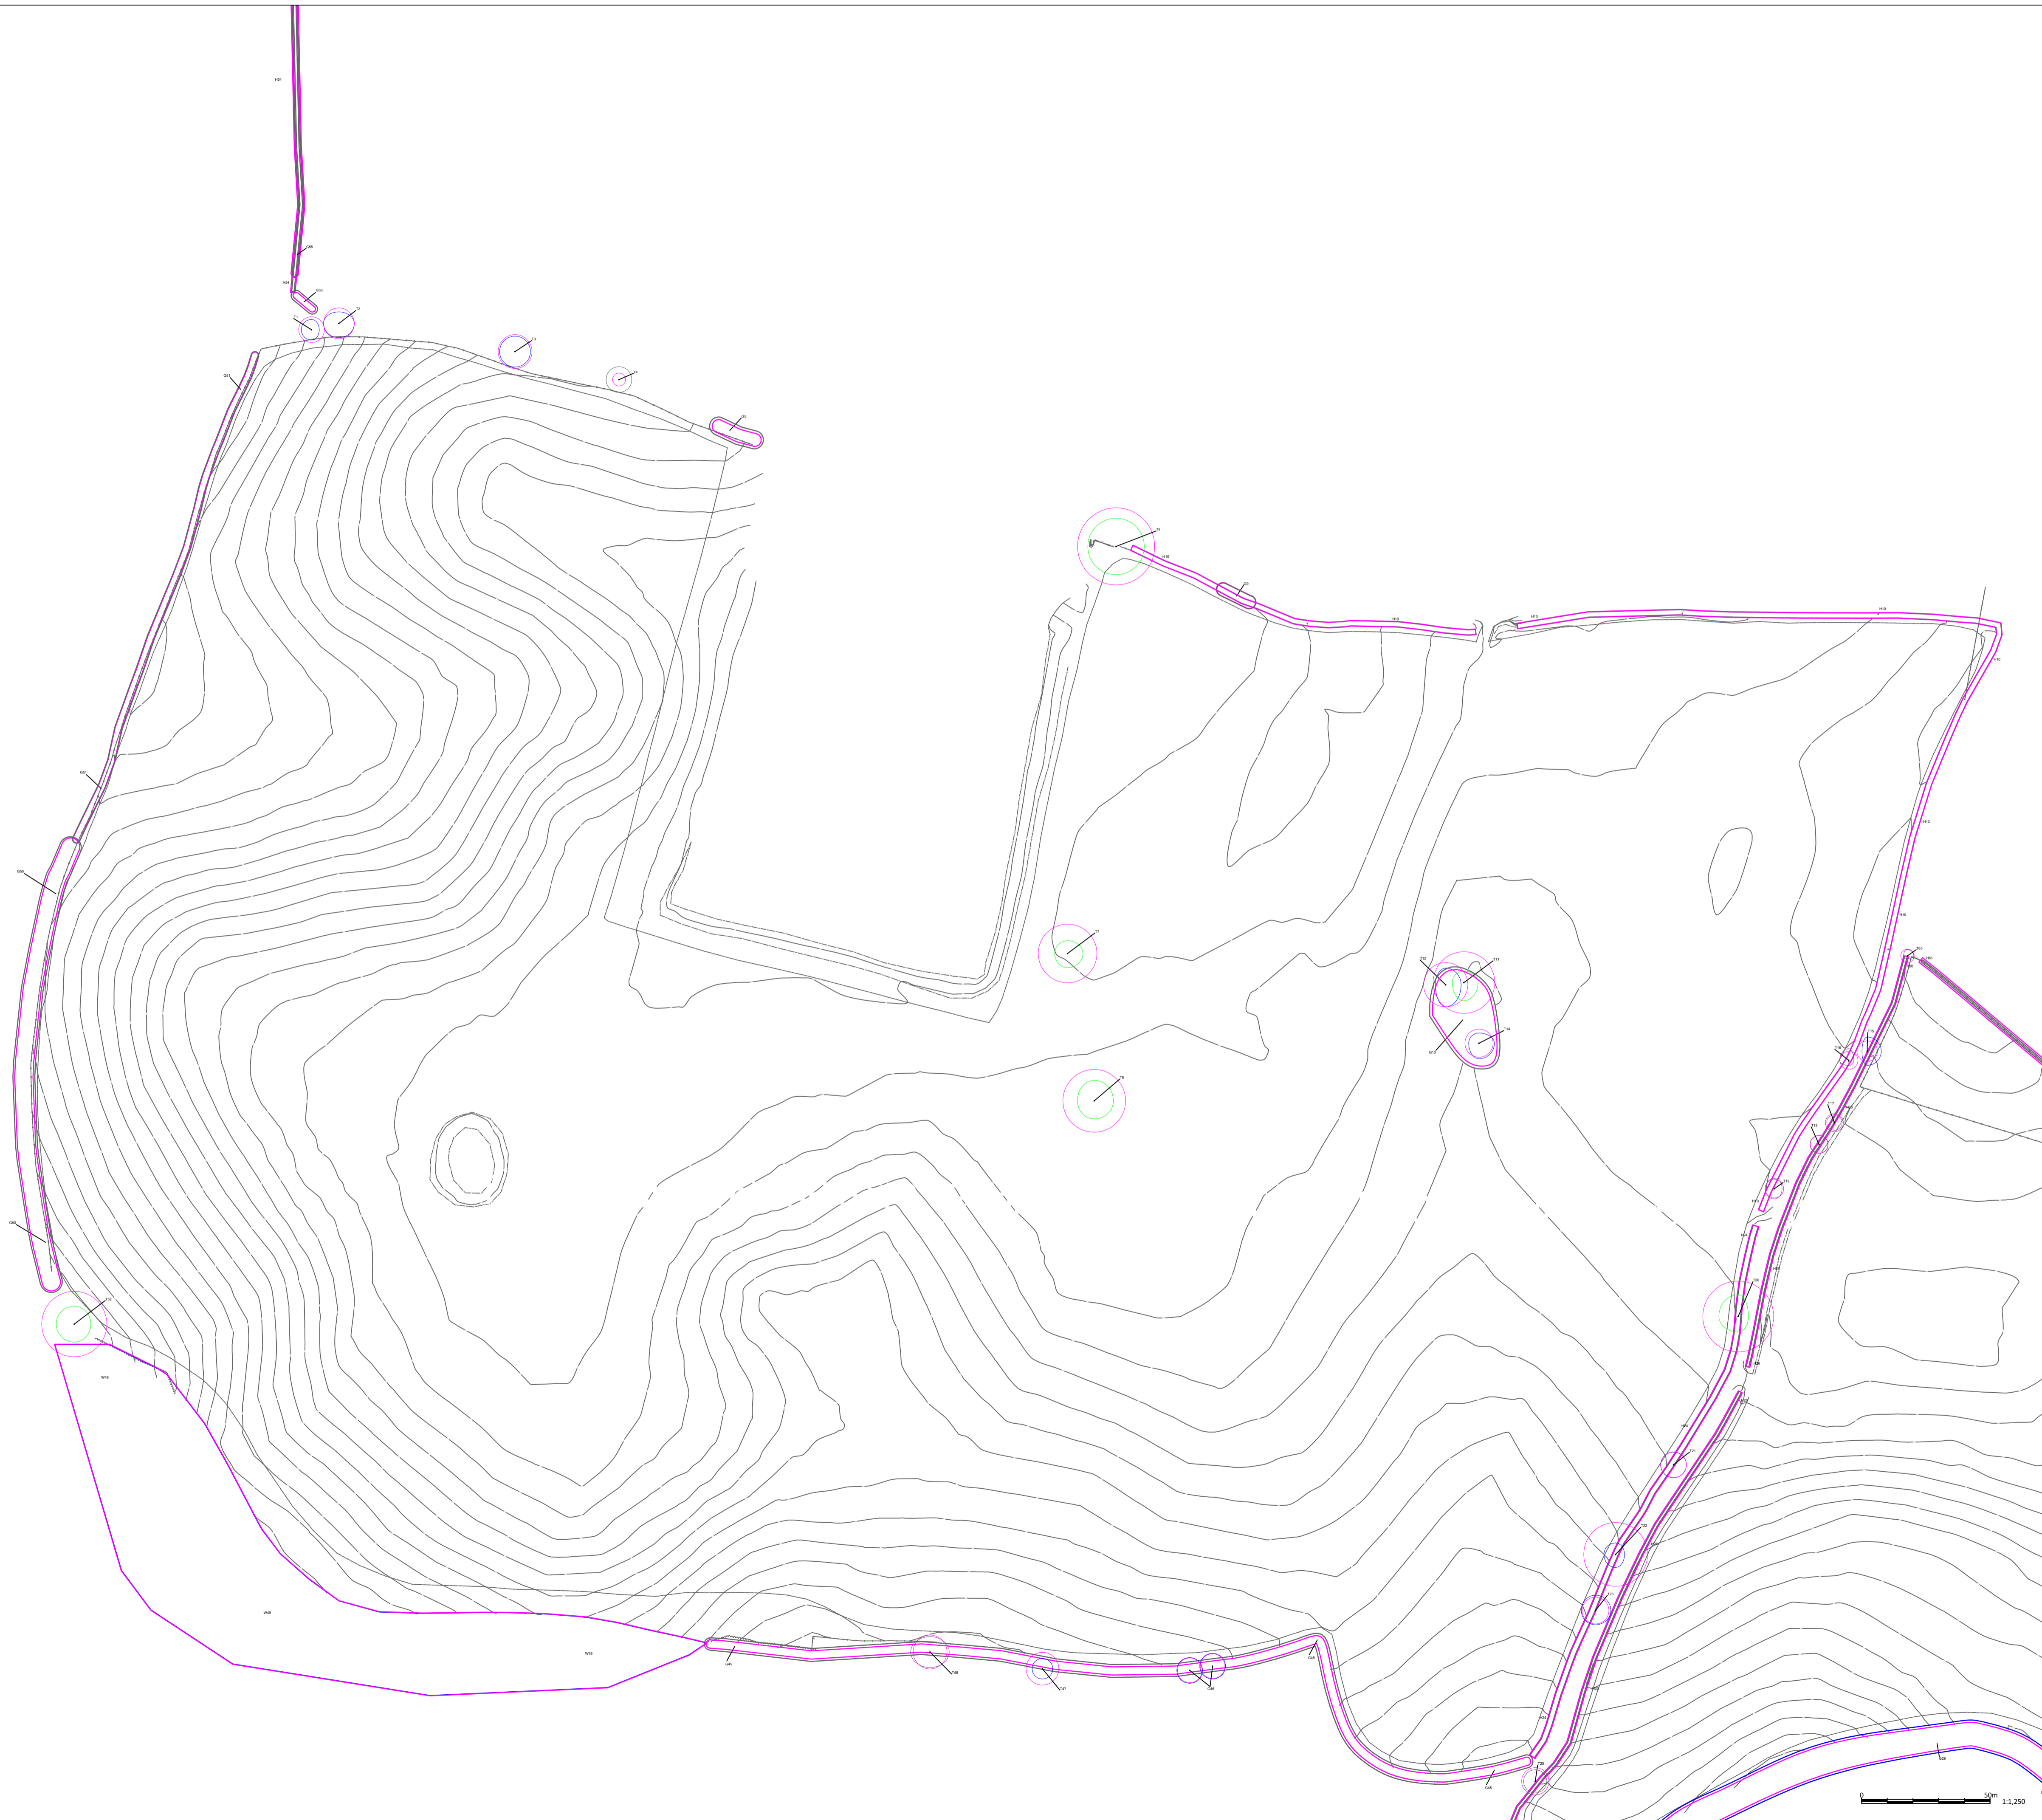
Client:  
**Econergy International Ltd**  
 Project:  
**Solar Farm on Land South of Berrington**  
 Drawing Title:  
**Tree Constraints Plan**  
 Drawing No: 1051610\_ECONERGY\_TCP\_SHEET2  
 Scale: 1:1250 @ A1  
 Drawn by: RL Date: 03/03/22  
 Checked by: IW Date: 04/03/22

- **Category A**  
Trees / Groups of high quality: with an estimated remaining life expectancy of at least 40 years.
- **Category B**  
Trees / Groups of moderate quality: with an estimated remaining life expectancy of at least 20 years.
- **Category C**  
Trees / Groups of low quality: with an estimated remaining life expectancy of at least 10 years, or young trees with a stem diameter below 150mm.
- **Category U**  
Trees / Groups: in such a condition that they cannot realistically be retained as living trees in the context of current land use for longer than 10 years.
- **Root Protection Area (RPA)**

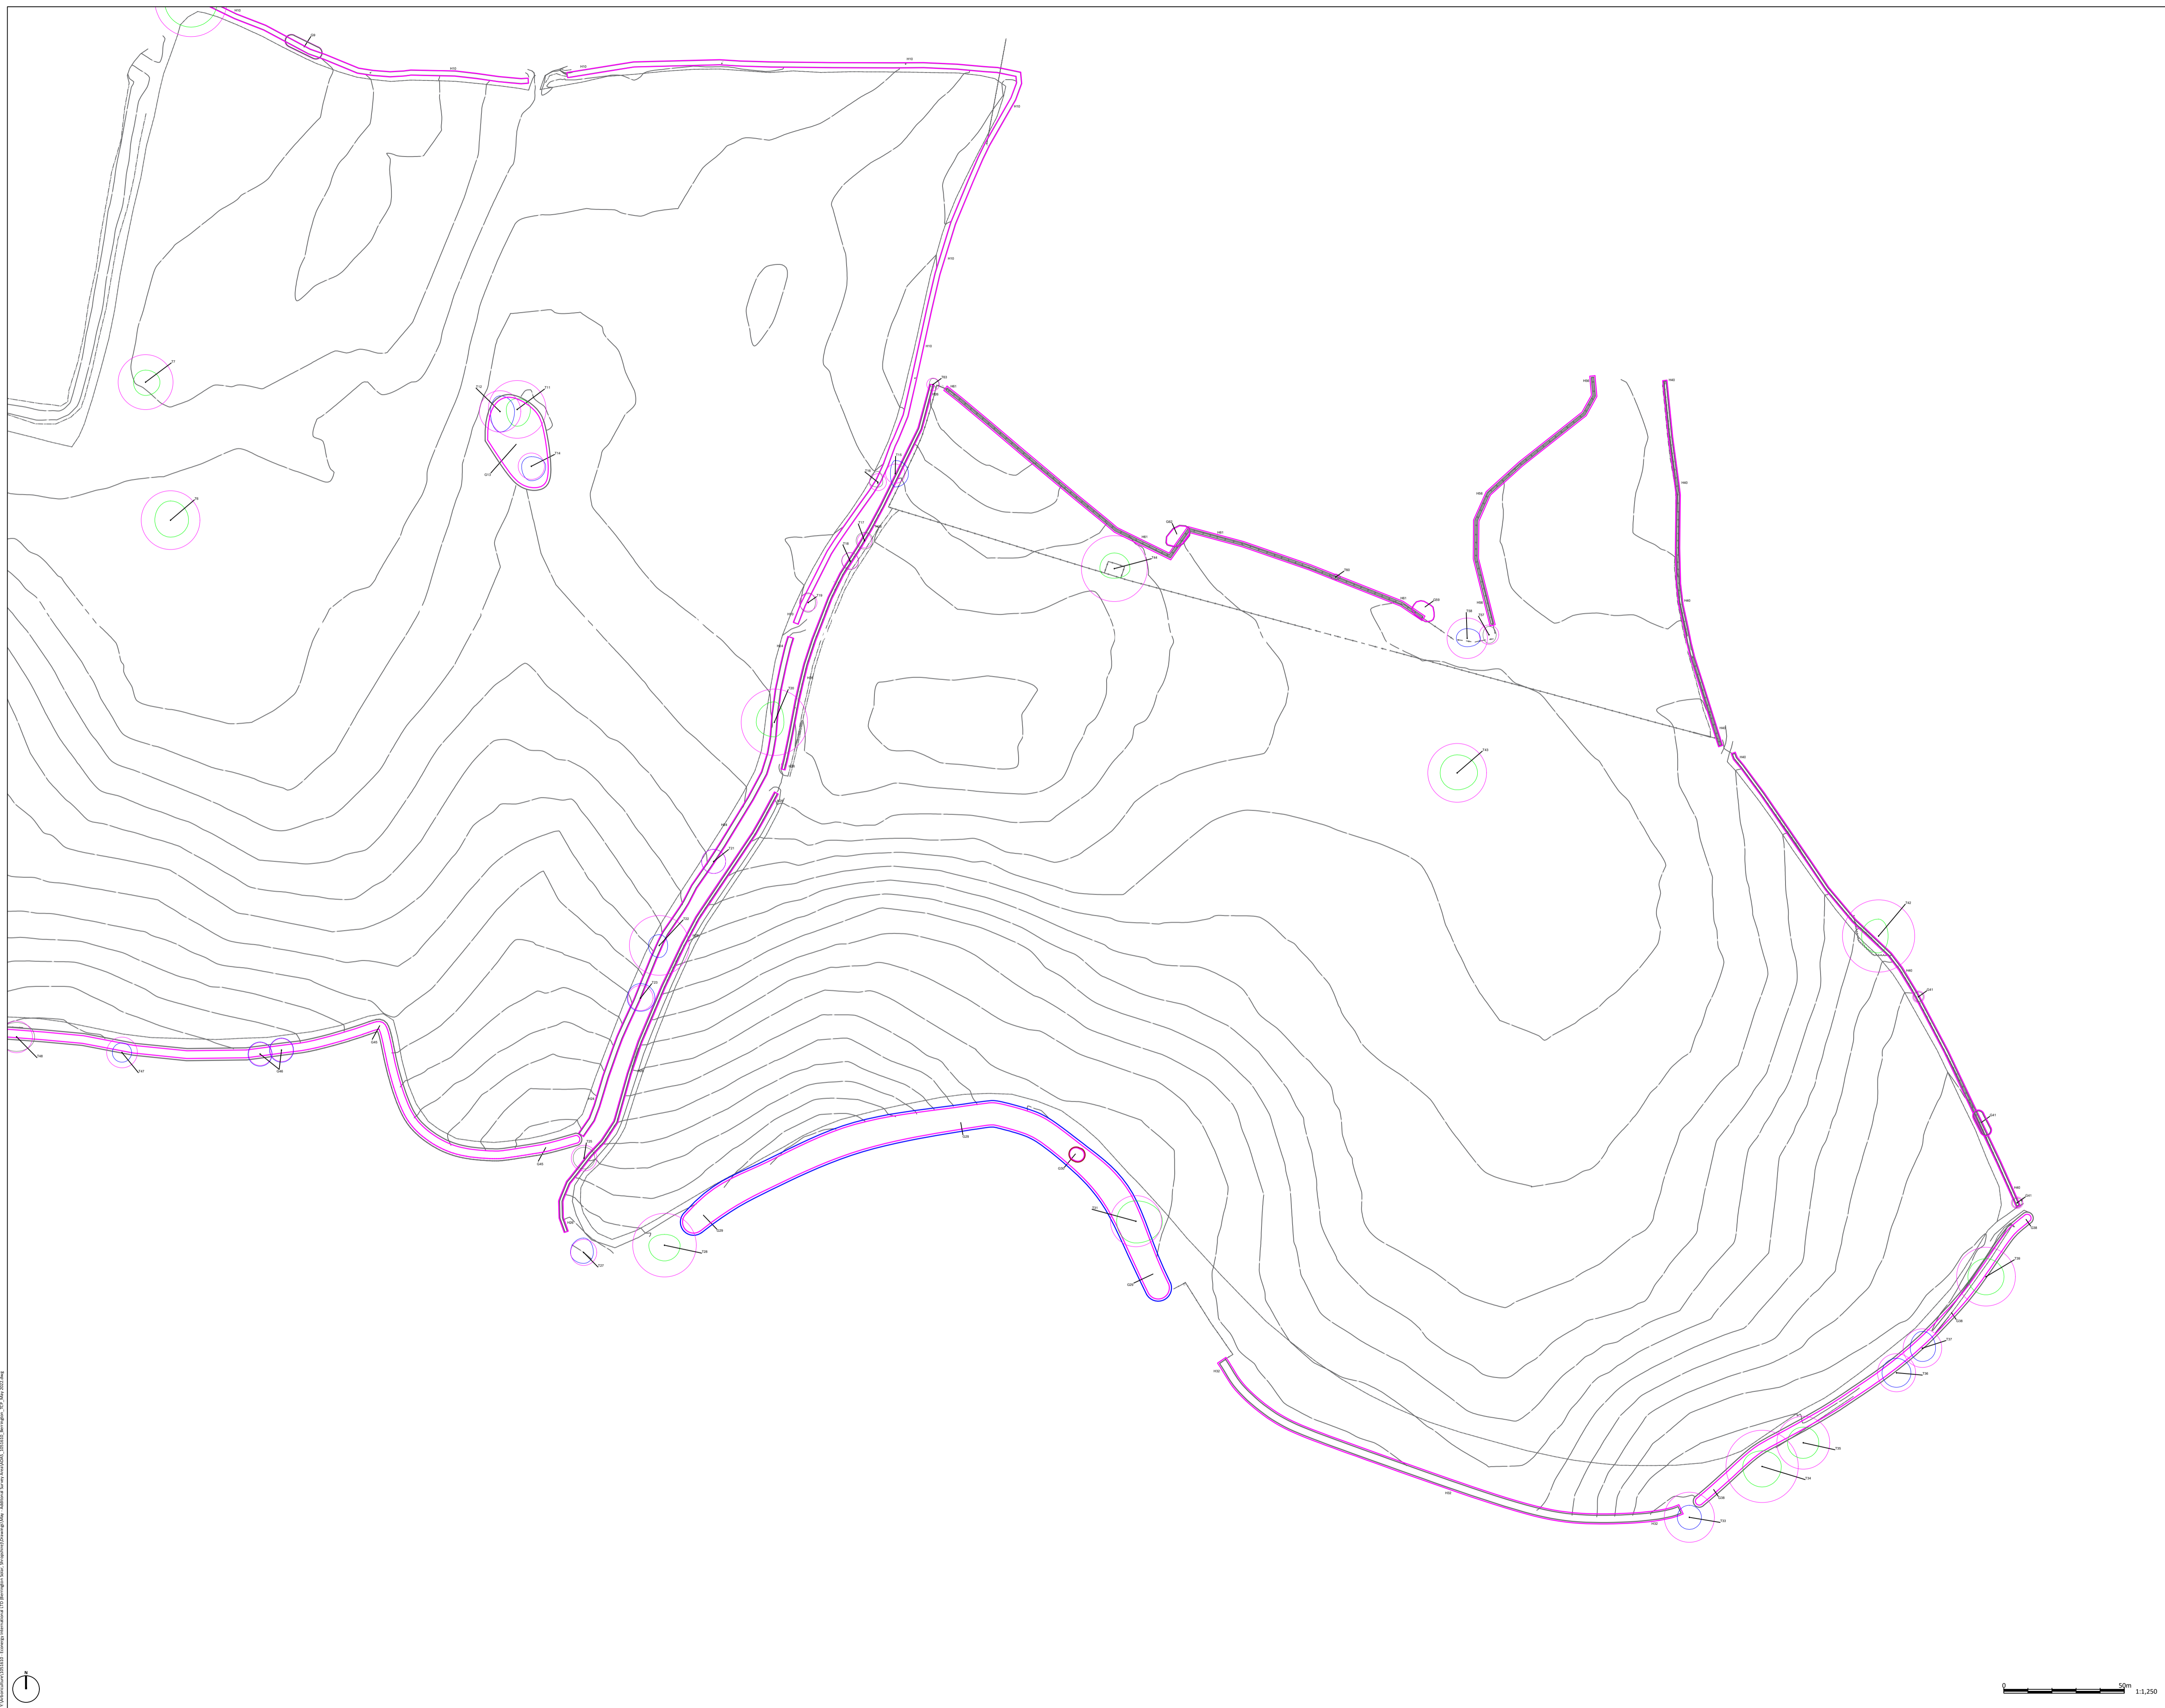
Client:  
**Econergy International Ltd**  
 Project:  
**Solar Farm on Land South of Berrington**  
 Drawing Title:  
**Tree Constraints Plan**  
 Drawing No: 1051610\_ECONERGY\_TCP\_SHEET3

- **Category A**  
Trees / Groups of high quality: with an estimated remaining life expectancy of at least 40 years.
- **Category B**  
Trees / Groups of moderate quality: with an estimated remaining life expectancy of at least 20 years.
- **Category C**  
Trees / Groups of low quality: with an estimated remaining life expectancy of at least 10 years, or young trees with a stem diameter below 150mm.
- **Category U**  
Trees / Groups: in such a condition that they cannot realistically be retained as living trees in the context of current land use for longer than 10 years.
- **Root Protection Area (RPA)**

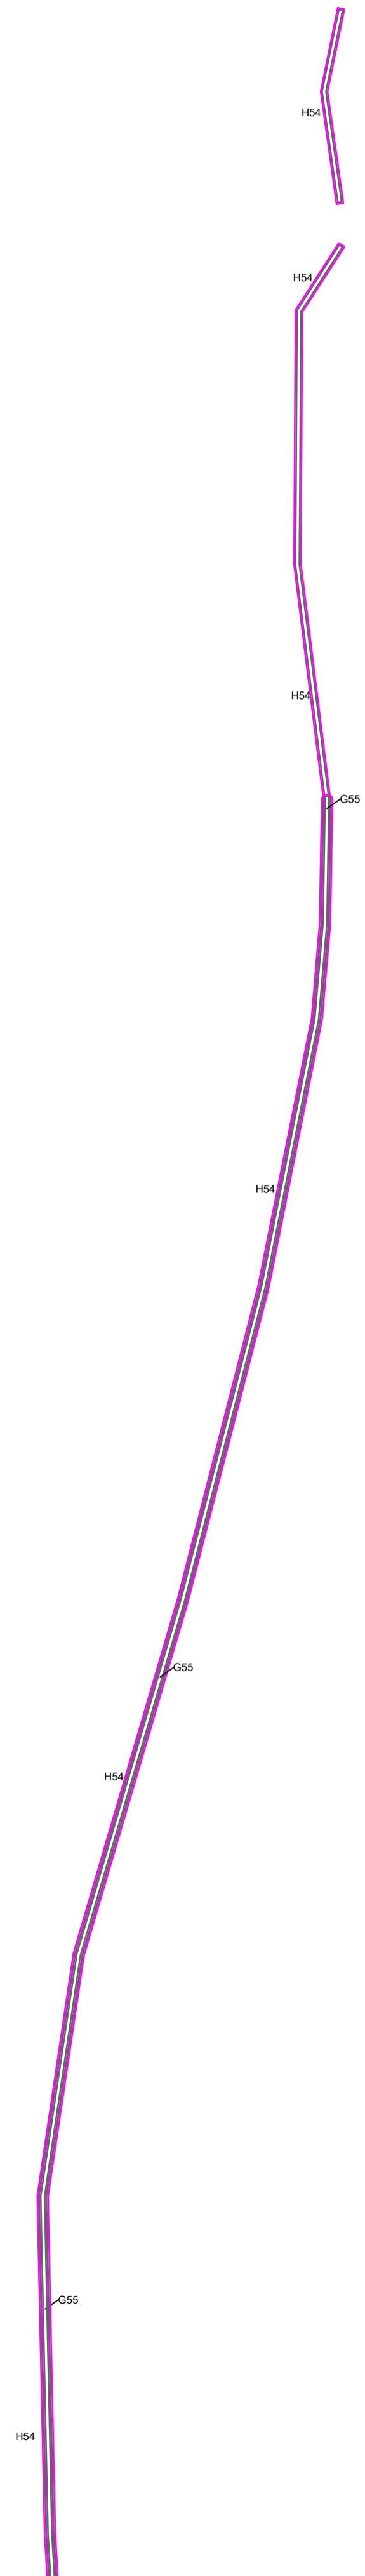
Client:  
**Econergy International Ltd**  
 Project:  
**Solar Farm on Land South of Berrington**  
 Drawing Title:  
**Tree Protection Plan**  
 Drawing No: 1051610\_ECONERGY\_TPP\_SHEET1  
 Scale: 1:1250 @ A1  
 Drawn by: RL Date: 03/03/22  
 Checked by: IW Date: 04/03/22

- Root Protection Area (RPA)**
- Groups Requiring Partial Removal**  
Approximately 15 metres from the centre of G50 and 10 metres from H24.
- Tree Protection Barriers**  
To be installed for the duration of construction and until site becomes operational, where retained trees RPA's fall within the site boundary, or within the site fencing.

Tree No:	Species	Recommended Management Work
H24	Mixed Broadleaves	Removal of approx. 10 metres required to facilitate access through the site.
G50	Mixed Broadleaves	Removal of approx. 15 metres to the centre of the group required to facilitate access into the site.

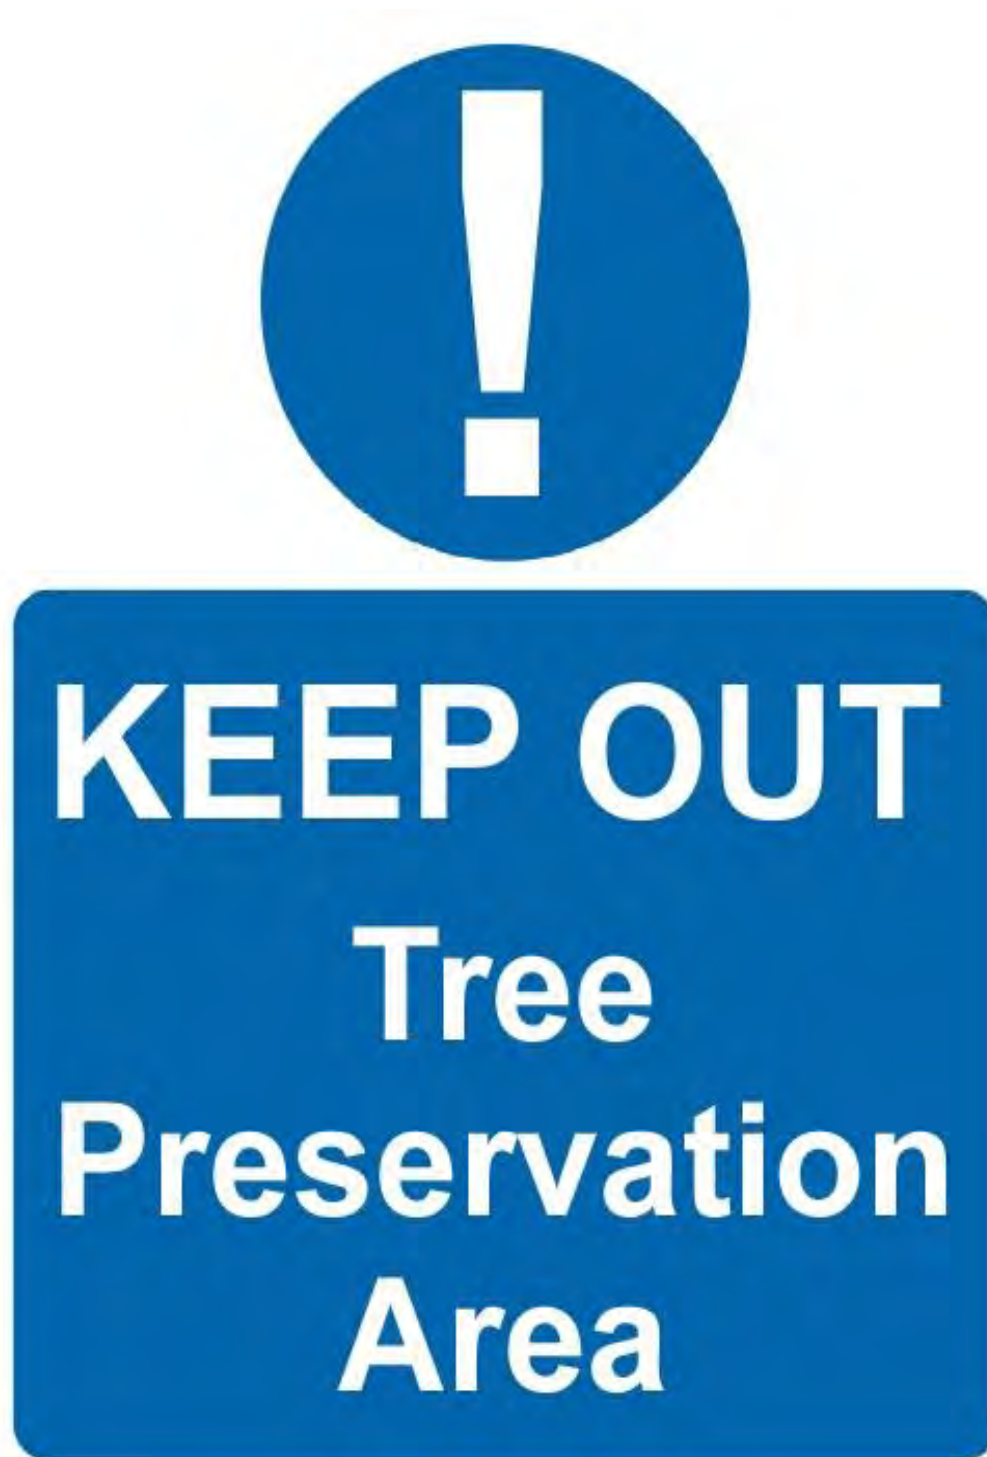
## Appendix 8: Example Tree Protection Barrier

Protective fencing should be erected along the edge of the RPA, before construction begins, and should not be moved until after all construction has finished and vacated the site. The type of fencing used should be fit for purpose, and ordinarily conform to the recommendations given in section 6.2.2 of BS 5837:2012 and be erected similar to the example shown in Figure 2 of the same standard.
