DRAFT TILLEY CONSERVATION AREA APPRAISAL

Draft for
submission to
Shropshire
Council:
August 2018

Prepared by TDR Heritage
Ltd on behalf of the Tilley
Timber Project

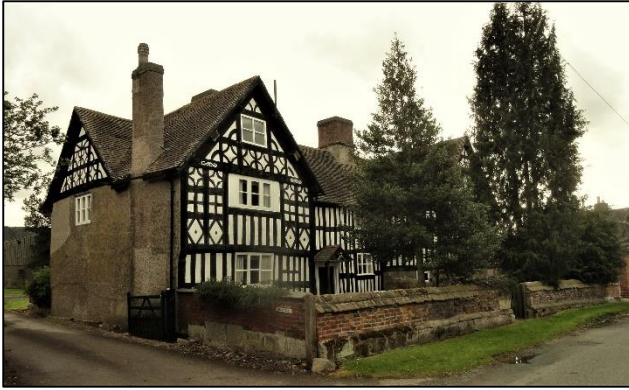
Tilley Hall is an imposing farmstead which is located in the centre of the hamlet. The principal building is timber framed with rendered wattle and daub panel infills. The building is set back from the road by a small garden behind the remains of a large block sandstone wall which has been altered using red brick beneath stone coping, although part of the taller original wall remains to the north. Built in the manner of a medieval hall house, the building forms a central hall with a large sandstone chimney to either end and two later cross wings with their prominent gabled ends facing onto the road. The 'hall' building features close studded work and the gables, one of which includes a large sandstone block sill, incorporate more elaborate timber frame motifs that were popular in high status buildings in the second half of the 16th century, including quatrefoils and lozenges. A date of 1613 is painted over the central front doorway, but recent work has dated roof timbers to 1504. Both the building and its stone and brick boundary wall are listed Grade II*, to reflect its status as a particularly important building of 'more than special interest'.

The building has a strong visual presence when viewed from the Main Street, although its impact is lessened by three tall conifers which screen parts of the building's frontage from certain view points, and which could also be having a detrimental impact on the boundary wall and house.

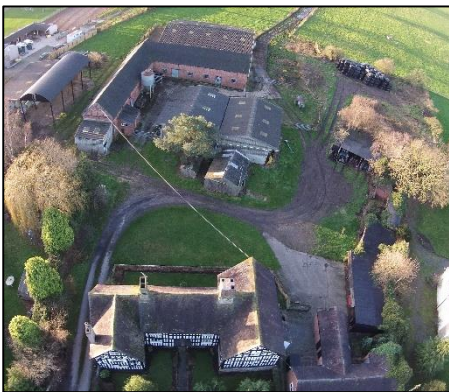
Tilley Hall Barn

To the rear of the large plot is **Tilley Hall Barn**, an L-shaped six-bay structure that was originally timber framed and which dendrochronology has tentatively dated as having a main phase of building or reconstruction in c. 1616. The building is not visible from the street and has been much altered over time, with numerous reused timbers and brick walls now replacing most of the wall frames, however it has a strong agricultural feel which contributes to the overall rural character of the hamlet, as does its location along the rear farmstead boundary.

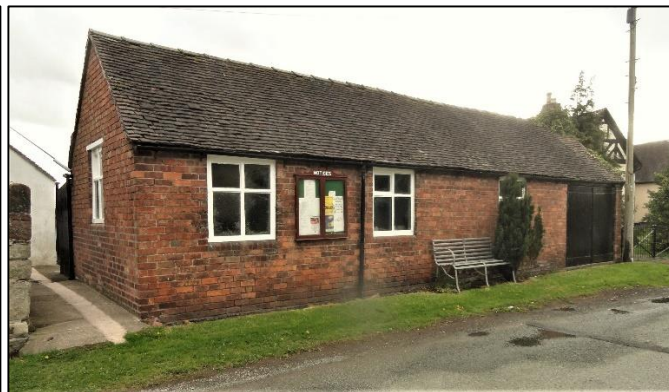
Tilley Hall Cheese Room / Dairy

Forming part of the street frontage between Tilley Hall Farm and Tilley Manor is the former **Tilley Hall Cheese Room**, which is a small single storey brick and tile building built in the early 20th century to replace an earlier timber framed structure on the site. The building currently houses the village notice board and community seating and incorporates workshop doors which open onto the road behind a grass verge. Although substantially later than the its immediate neighbours, as well as having key historic associations with the Tilley Hall farmstead, the scale and position of the building adds a sense of enclosure to the streetscape and reinforces its rural character.

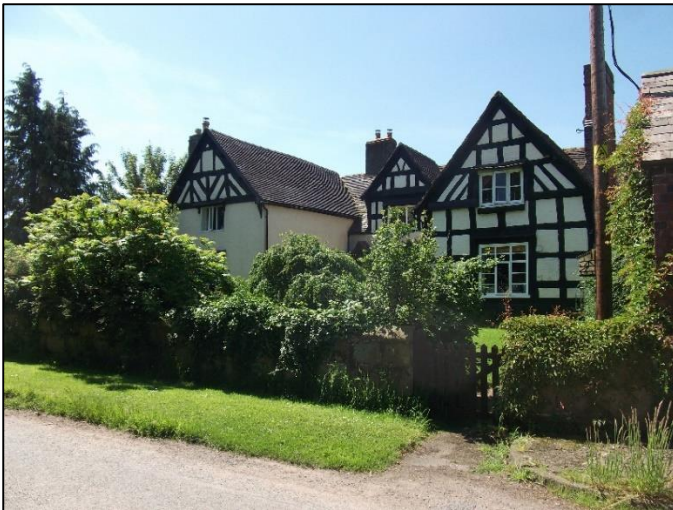
Tilley Manor is a grade II listed farmhouse located in the centre of the hamlet and is one of the yeoman farmsteads named in documents of the early 16th century. Its ostentatious timber-framing, of square-panelled timber frames with brick infill and decorative herringbone and close-studded work, visually date it to the late 16th to early 17th century. The building is arranged in a U-shape comprising a central hall with two gabled crosswings projecting towards the street. Tree ring dating has established that the current hall range dates from around 1568, and it was altered and extended, possibly in two phases by the addition of two crosswings in the early to mid-17th century. A gable dormer was added to the main hall building, along with a massive brick chimney, in c. 1616.

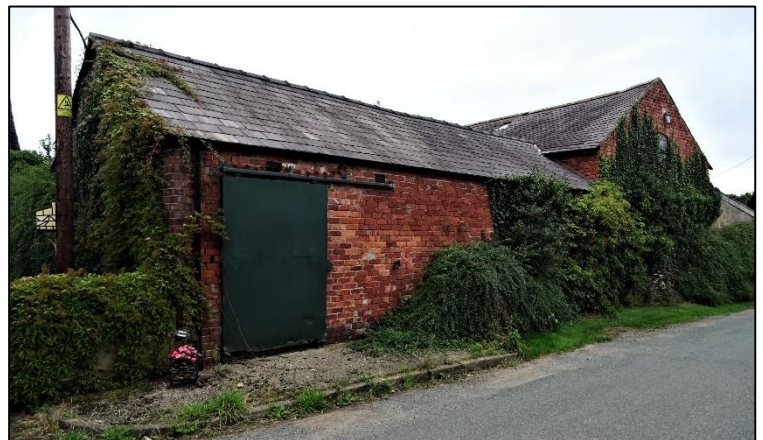
Tilley Manor Barn is part of an group comprising a single storey brick cow shed with a hay loft above and a small attached brick building which houses the milk storage tank from the milking parlour and

runs along the street frontage and the northern boundary of the Tilley Manor farmstead, being set back from the road by a narrow verge. Although apparently of 19th century date, tree ring dating from timbers in the roof structure and a single wall plate has established that the cowshed contains early timbers dating from c.1504–34 and 1564–91, although these may have been reused in the later construction. Despite the addition of a single storey breezeblock and asbestos-roofed lean-to to the north, as an agricultural building characteristic of the later development of farmsteads, the building provides a strong visual contribution to the story of the principal farms in the hamlet and how they were adapted over time.

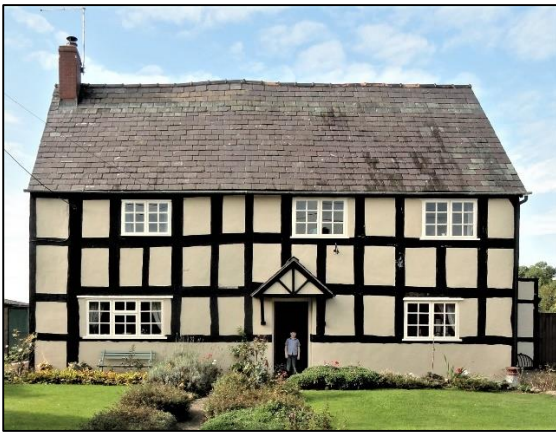
Brook Cottage

Dating to around 1617, **Brook Cottage (18 Tilley)** is a grade II listed timber framed house built on a rendered plinth with square panelled wall frames and rendered panel infills. It is known to have been three cottages at some point in its recent history and has seen considerable adaptation, including shortening of the façade by one 'square' of its wall frame. Although the building has been uncharacteristically re-roofed in slate, it makes a strong contribution to the overall conservation area and, like most older properties in the hamlet, was originally set back from the main road by a small front garden behind a large sandstone block wall. The footings of the wall can be seen at the front of the property boundary with more substantial areas of possibly reused walling that form a boundary to the side of the garden and an open space used for parking.

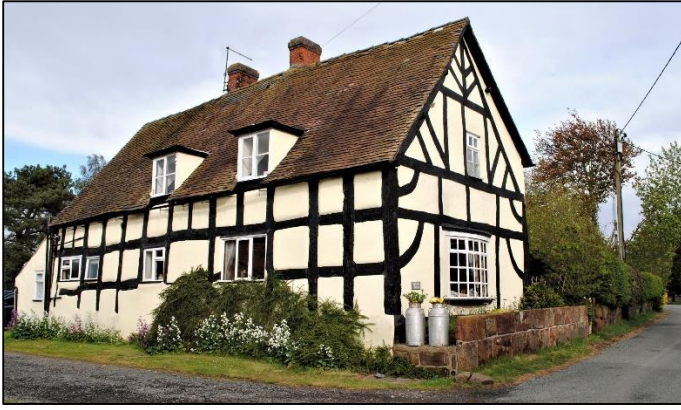
Brook Farmhouse

Brook Farm is a grade II listed timber framed former farmhouse of square panelled walling in a style characteristic of good quality, but lower status, buildings of the late 16th and 17th centuries. This has been confirmed by tree ring dating which has estimated the year of construction as c. 1580. The building is of 1 and a half storeys with dormer windows to the northern elevation within a red tiled roof which features two chimneys that mark the extent of a narrow central bay.

The building faces onto the former yard formed by itself and Brook Barn (now Tilley Barn) with its gable facing onto the road. The gable is set back only a short distance from the road, behind a narrow verge and boundary wall of large sandstone blocks, some of which is hedged above, and shows evidence for the roof to the southern elevation having been raised at some point in its history.

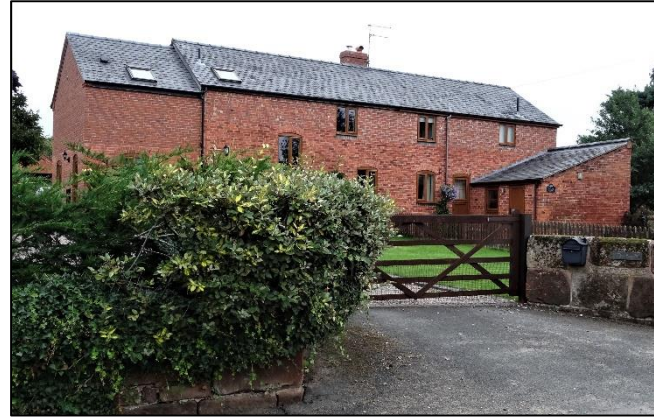
Tilley Barn, formerly part of Brook Farm

The unlisted **Tilley Barn** is sited toward the rear of the former farmyard of Brook Farm and is of brick with a slate roof. At the roadside, the plot has a boundary wall of large sandstone blocks, set back from the road by a narrow verge; the stone of which is understood to have originated from the demolition of the medieval bridge that spanned Sleaf Brook. Although the barn is known to have been rebuilt after a fire in 1923 and has since been converted to housing, it retains a strong visual and locational relationship with the former farmhouse which helps reinforce the agricultural character of the hamlet.

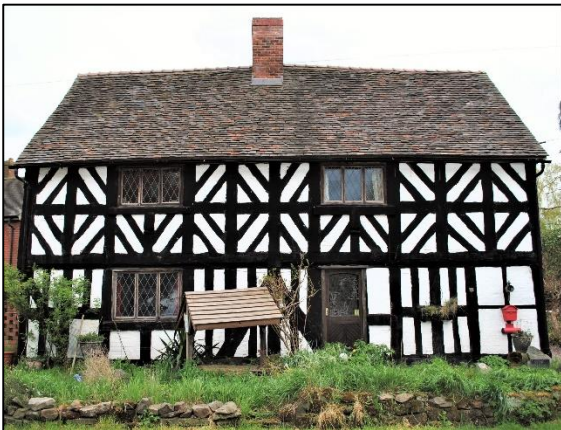
Oak Cottage is a grade II listed two storey timber framed building with painted brick and render infill, a plain red tile roof and a rebuilt off-centre central brick chimney. The building has square framed walling with close studded timberwork to the ground floor and herringbone decoration to the upper storey, features which highlight the status of this building in the late 16th to early 17th century. Tree ring dating has established that the building is likely to have been constructed c.1616, however the northern bay has evidence for the remains of a jetty, a feature generally considered to be earlier, and which has been underbuilt in brick. This may suggest that an earlier structure on the site was altered and updated at a key point in Tilley's history. In-keeping with the overall character of the hamlet, the building is set back from the road by a small garden behind a narrow verge and low sandstone boundary wall, although the wall is formed by small, rough coursed stones which suggest that it was rebuilt in a later period.

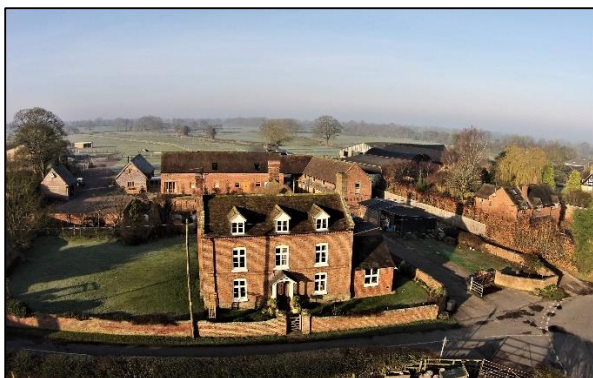
Tilley Farmhouse and barns

Located at the junction of the Tilley Road from Wem and the main street, and set back from the road behind a short brick wall and grass verge, **Tilley Farmhouse** is a red brick, grade II listed building of the late 18th century, with later additions and alterations. The symmetrical frontage of the building and its height, at two and a half storeys, are common features in a Georgian building of some status but are distinctly different to the dominant character of the hamlet. As one of the buildings in the hamlet known to have been occupied by a yeoman farmer by the early 16th century, Tilley Farm contributes to the character of the hamlet by visibly showing how the wealthier properties in the settlement continued to be adapted and changed over time. Large sandstone blocks, common to the boundary walls and early buildings in Tilley, can be seen in an elevation visible from the road and this, in addition to tree ring samples which date parts of the roof structure to between 1604 and 1619, provides evidence for an earlier core, or show that it was extensively rebuilt or refaced in the 18th century to the fashion of the day.

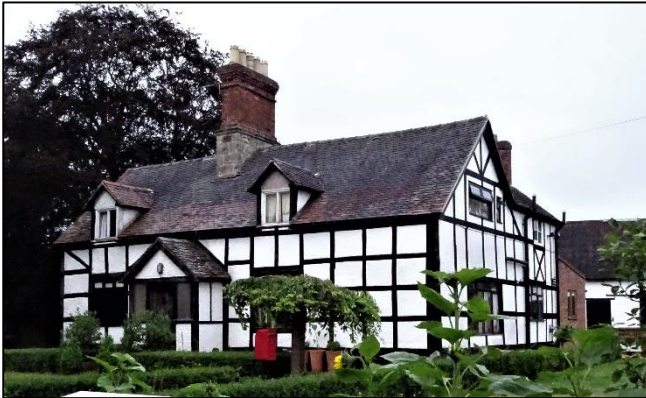
Ferndale House (Tilley Lodge)

Ferndale House (listed as Tilley Lodge) is located at the southern end of the hamlet, in close proximity to the railway line which cut through the settlement in 1858. The principal building comprises a grade II listed timber framed building of square wall panels of one and half storeys with dormer windows and a plain tile roof. The location of the large stone chimney stack with later brick additions immediately opposite the entrance suggests that the building was built as a baffle entry house, a feature typical of buildings of the early 17th century. Although the building and its boundary wall have undergone some alteration, it continues to contribute to, and reinforce, important

characteristics of the older building in the settlement, including the use of materials and its position, being set back from the road behind a boundary wall and small garden.

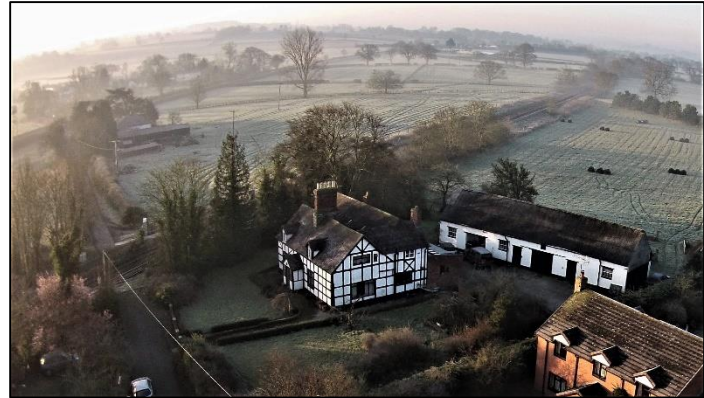
Ferndale Barn and Ferndale House

To the rear of the principal house and set at an angle is **Ferndale Barn**, a long single storey agricultural building incorporating wide openings and metal framed windows, covered with a corrugated iron roof. The barn has a strong relationship with Ferndale House and forms part of the former farmyard. Although relatively unremarkable in its external appearance, tree ring dating has established that this building contains locally felled, reused timbers from a cruck building that was constructed in around 1458 and this adds an additional historical dimension to the building and the contribution it makes to the history of Tilley.

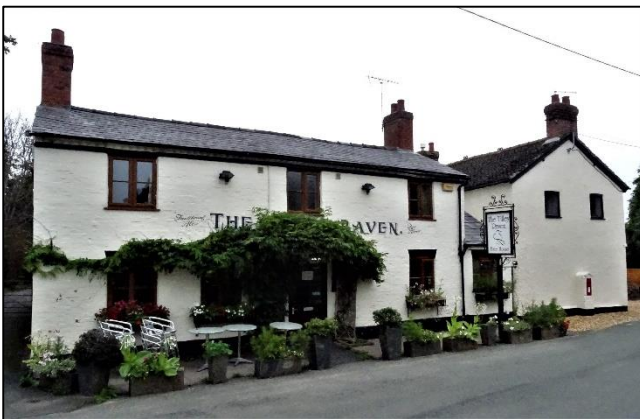
Tilley Raven Inn

Thought to be no earlier than 1700, documentary evidence indicates that **The Tilley Raven Inn** was originally a house and was occupied by 1717. The painted, red brick two storey building has a slate roof, and faces onto the street frontage, from which it is set back by a narrow paved area. The building was a domestic house until 1868 when it was converted into a public house and is located in the centre of the hamlet. Its proximity to the roadside makes it very visible to travellers on the road from Wem and a core component of the later development of the hamlet.

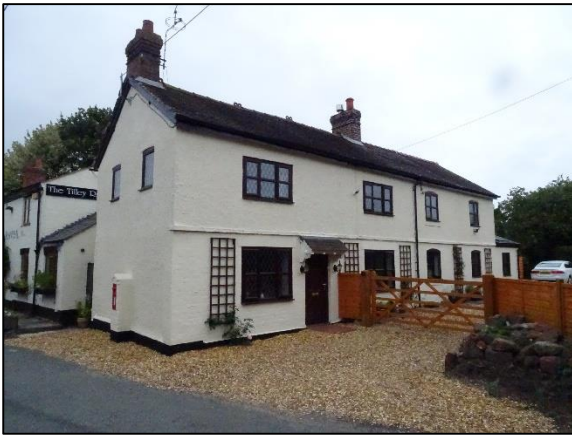
15 Tilley

As the location of the hamlet's smithy from 1880, **15, Tilley** is situated adjacent to the Raven Inn in a good-sized plot, with its gable end facing onto the street. Although now a two storey, pebble dashed and painted building, tree ring analysis has identified parts of the structure as being of mid-15th century date and suggest that it may have been a former open hall house. The building was altered in c.1590, which may have included raising of the red tiled roof and the insertion of a chimney. Despite changes to the building, including new windows and doors, the scale and history of the building still contribute to the overall character of the proposed conservation area.

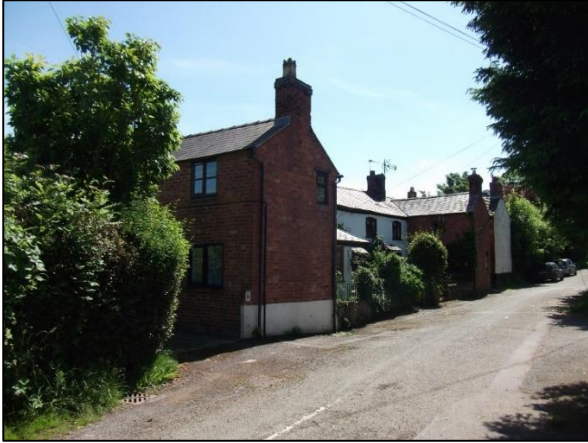
2-6 Tilley

2- 6 Tilley is a short terrace of four unlisted brick properties with slate roofs formed by a central painted section set back from the road behind a large red sandstone block wall and short paved garden, with two gable wings built end on to the road. Although apparently of 19th century date, and believed to have been estate cottages for the Tilley estate constructed c. 1830-1850, survey work in No.3 (the central range) identified the smoke blackened remains of a possible open hall cruck building of at least two bays of c. 1501-4. The building does not feature on the map of Tilley in 1631 and it has been speculated that this is because the early building had been adapted into a non-domestic, farm building by this time.

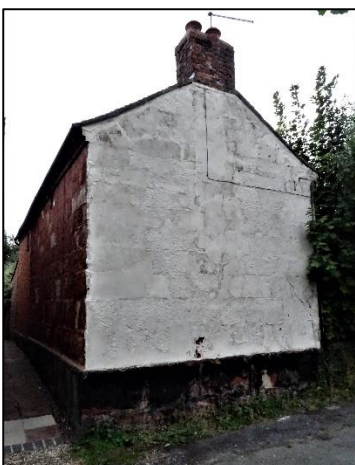
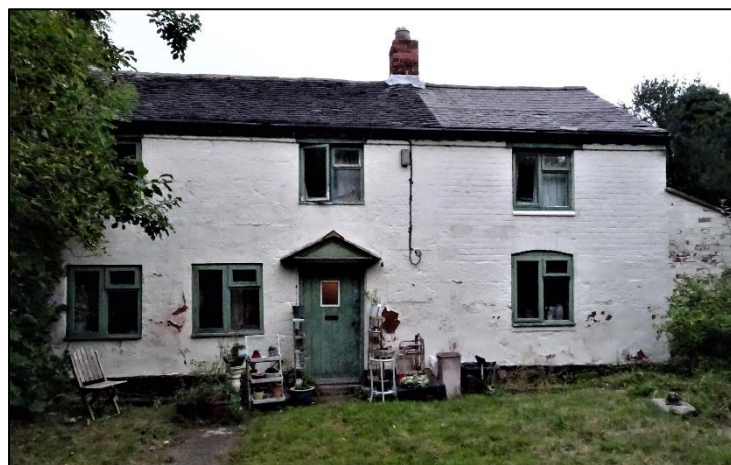
1, Tilley roadside gable and front elevation

At the southern extent of the hamlet, and immediately behind the gable of No.2, **1, Tilley** is a detached building of sandstone and brick beneath a red tiled roof, with its gable end facing onto the road behind a short verge. The origins and development of the building are unknown but it is

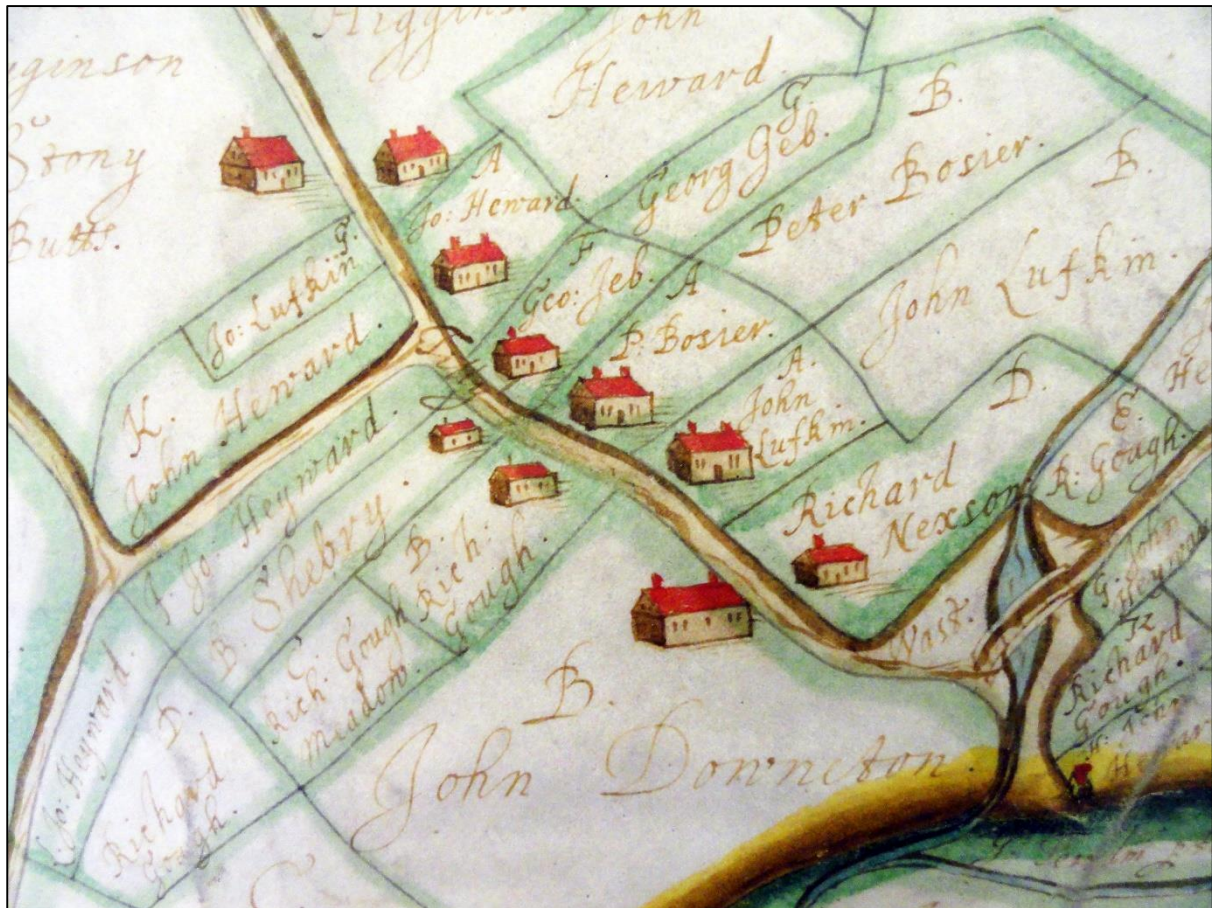
1. Excerpt from the 1631 estate map showing the heated, domestic houses in the hamlet. Note the direction of north which means that the mapping shows the Sleep Brook is shown at the lower right hand corner.

An estate map commissioned for the Earl of Arundel in 1631 provides some detail for the layout and composition of Tilley at this time. Then, as now, Tilley formed a small linear settlement, starting at an area of 'waste' land with a bridge over the Sleaf Brook at the north of the hamlet and extending to a building that was located slightly to the south of the 19th century railway line. Along the Main Street are shown nine distinct domestic buildings of varying sizes, each of which apparently drawn 'from life', with different numbers of windows and chimneys reflecting the status of each building – important in a period in which taxes were gathered according to the number of hearths and windows a building possessed. The map is notable in that it does not provide any illustrations of unheated buildings, animal or grain houses and recent survey work, which has identified the remains of a former open hall house at the south of the hamlet that was definitely in situ in the early 16th century, seems to support the idea that the map was limited to domestic housing, perhaps for the purposes of taxation and land ownership.

Many of the properties shown on the 1631 map are shown as being situated in enclosed fields or 'crofts', which were used for tillage or pasture, and were typically worked by the occupier. The boundaries of many of these enclosures have become fossilised through the centuries and are still visible in the hamlet. They are unusual in that they are formed by a raised bank and ditch which effectively provide an element of drainage and highlight the issues faced by settlers in this low-lying marshy landscape. The use of the plots is reinforced by information from the 1845 tithe map and award which identifies numerous field names that are largely related to meadowland and 'crofts'.
