**Amateur Swimming Association
Swimming Pool
Visual Condition Survey**

1. Swimming Pool Name: Quarry Swimming Pool
2. Swimming Pool Address: Priory Road, Shrewsbury, SY1 1RU
3. Swimming Pool Owner: Shropshire Council
4. Swimming Pool Operator: Serco Leisure
5. Visual Survey Inspection Date: 5.8.16
6. Brief description of facility: The building houses multiple swimming pools with Ancillary changing rooms, reception vending area, multiple cafés and spa/sauna/steam room. Service plant room and office accommodation. There are 3 swimming pools: 33m Pool with 6 lanes and a 51 metre flume, this pool also has 3 diving boards which are no longer in use and a spectator gallery. There is also a 25m pool, an 18m pool and a 10m pool.
7. Year of original build: 1880-(Main Quarry Pool added in 1971)
8. Gross area of Building: Approximately 4460m²
9. Number of floors: Four Floors
10. Operational hours per week: n/a
11. Major Renovation and Refurbishment History:

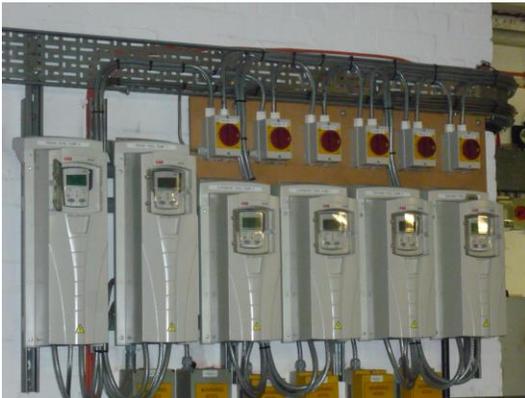
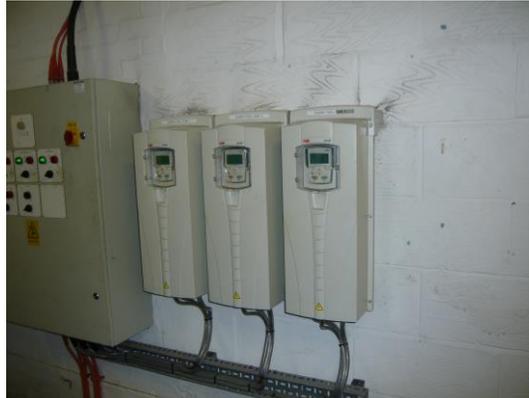
There is a conscious effort to become energy efficient through the use of systems such as:

- Variable speed air fans linked to humidity control
- Variable speed drives on circulation pumps

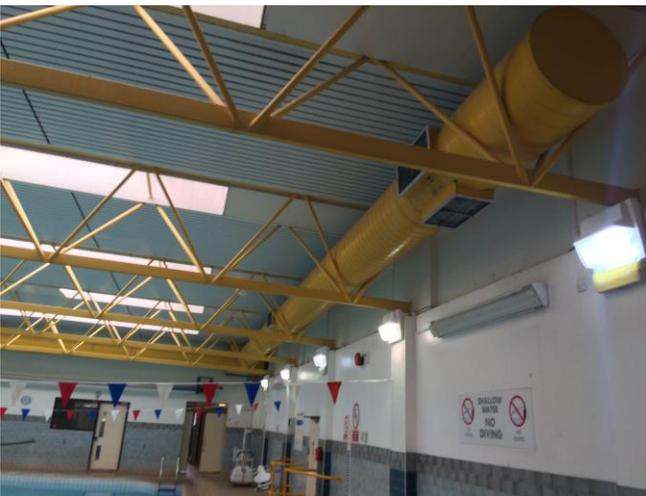
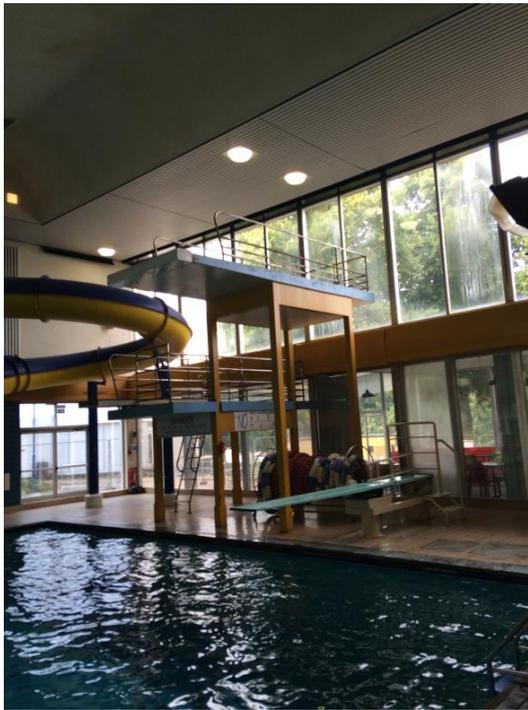
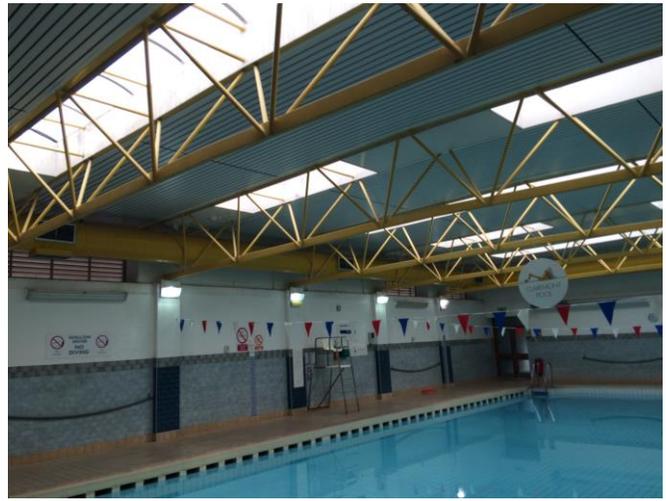
47. Pool Hall (S)

Pool access for swimmers is through two access points (1) communal male and female changing tunnels to quarry pools, and (2) from the communal male and female changing tunnels to the other pools. Both access routes are sufficiently near to the shallow end of the pool in the quarry pool and the middle pool in the 3 pool configuration.
