Whitchurch Swimming Centre

Building Surveyor's Inspection Report

Shropshire Council

9th April 2021

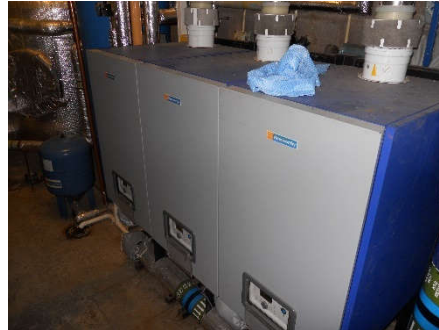
Photo 2 - LTHW heating boilers.

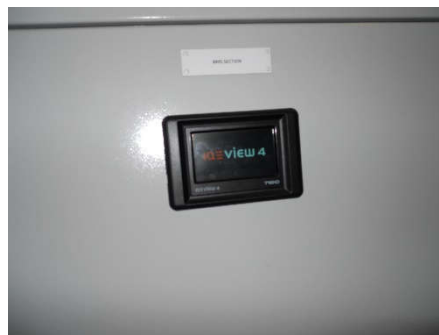
Photo 8 - Plant control panel with Trend BMS controls and IQ view 4 display.

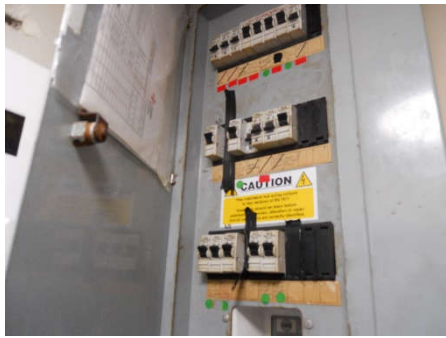
Photo 10 - Wylex distribution boards.

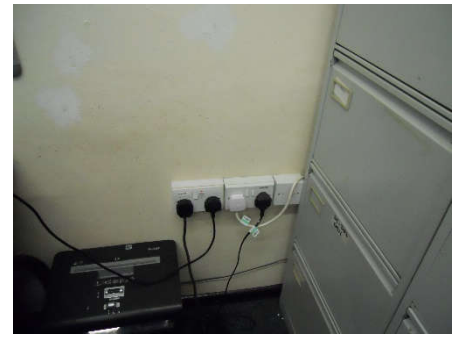
Photo 12 - Small power outlets.

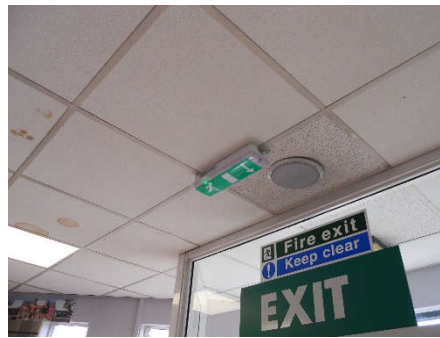
Photo 14 - Emergency bulkhead light fitting.

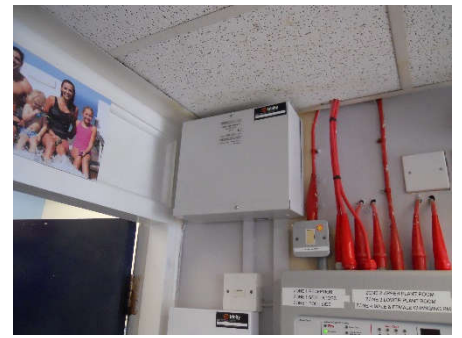
Photo 15 - Intruder alarm panel.

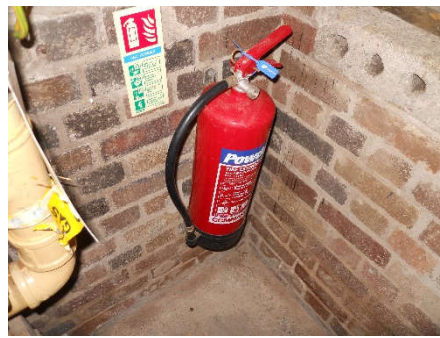
Photo 17 - Powder fire extinguisher.

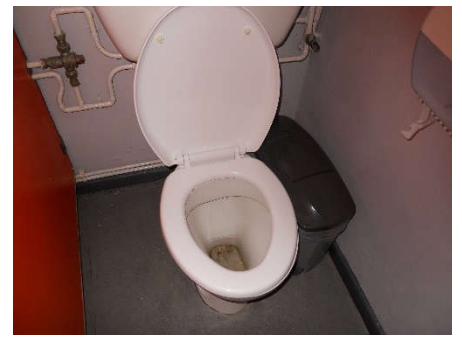
Photo 21 - Typical WC pan.

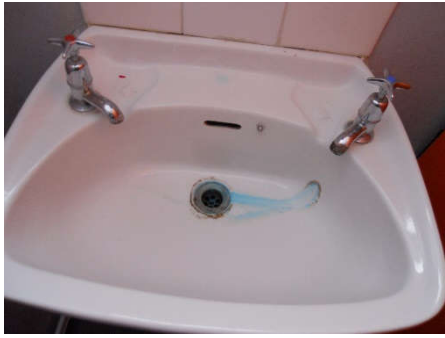
Photo 22 - Typical wash hand basin.

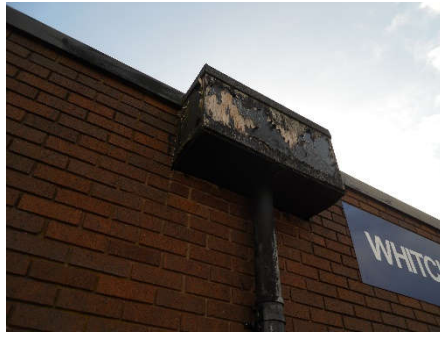
Photo 23 - Rainwater down pipe and hopper head detail.

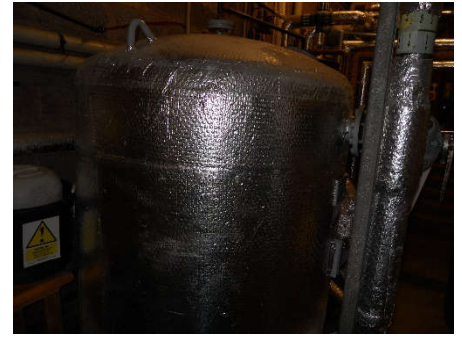
Photo 24 - Pool water horizontal multi-media filtration unit.

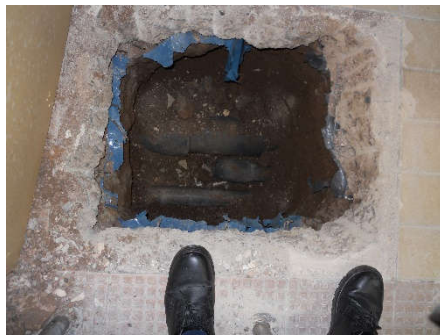
Photo 26 - Pipework to skimmers in promenade.

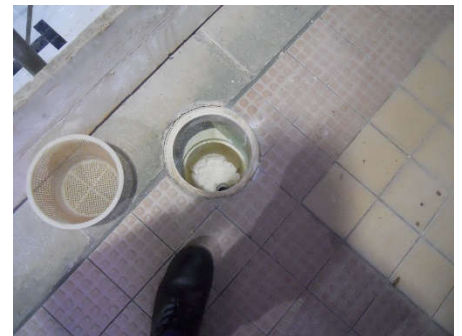
Photo 27 - Typical pool skimmer box.

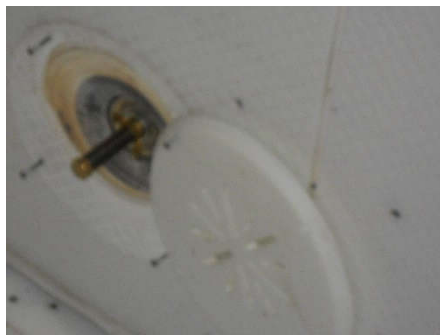
Photo 29 - Typical pool inlet with diffuser, plugged.

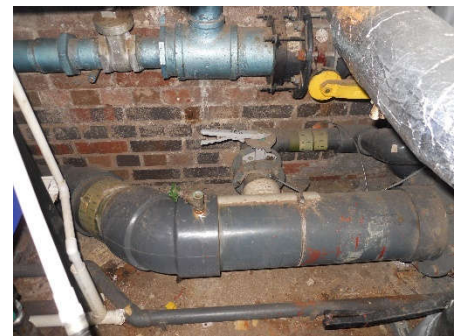
Photo 30 - Pool plastic supply pipework.
