Annual Inspection

Shropshire Council

Tollgate Road Play Area

Tollgate Road, Ludlow, SY8 1TQ

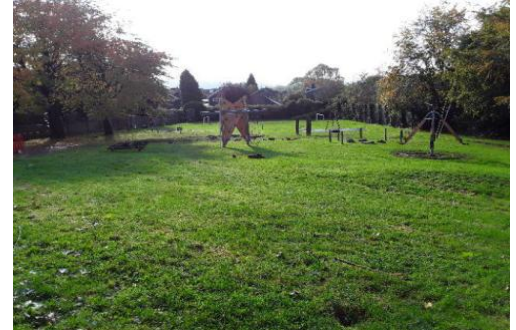
Item: Site General
Manufacturer: Owner/Operator
Surface Type: N/A
Item Quantity: 1
Equipment Compliance: N/A
Surface Area Compliance: N/A

Maintenance work appears to be ongoing and there is unsecured temporary fencing in the play area - Remove or secure

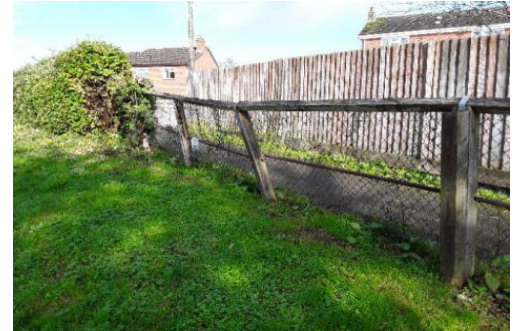
Item: Fence - Timber & Mesh Infill
Manufacturer: Not Identified
Surface Type: N/A
Item Part Number:
Item Quantity: 1
Equipment Compliance: N/A
Surface Area Compliance: N/A
Total Findings: 6

The fence has severe rot and is damaged exposing projecting fixings and there are unsecured sections of fencing within the play area - Remove all damaged and rotted fencing and secure safety fencing

A number of fixings have worked loose around the fencing - Secure all loose fixings

There is surface corrosion / rust present on the item - Consider treating the item

There is some strimmer / machinery damage apparent on the posts, this can penetrate the preservative applied to the timber and accelerate the rotting process - Monitor for any deterioration (rot) and replace as required

There are areas or parts of the timber on the structure that have rotted - Replace all affected timbers

The area / equipment on site has been isolated from use however the area is still accessible and the means of isolation has either introduced additional hazards that may cause harm in the event of users accessing the area or is insufficient to stop users from accessing the equipment - Provide a more suitable isolation method

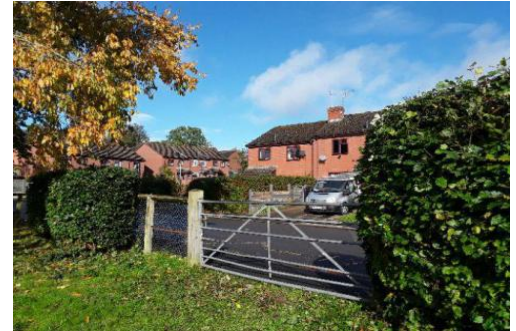
Item: Gate - Maintenance
Manufacturer: Not Identified
Surface Type: Grass
Item Quantity: 1
Equipment Compliance: N/A
Surface Area Compliance: N/A

There is some damage to the item creating sharp edges - Repair and remove all sharp edges

The weld(s) on this item have failed - Repair item

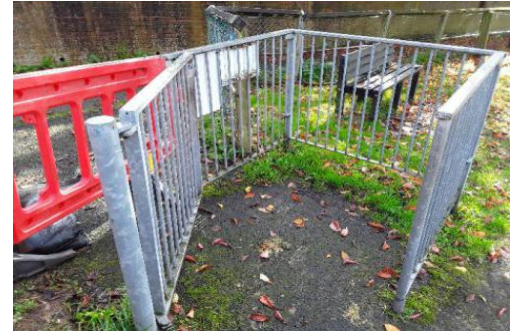
Item: Kissing Gate
Manufacturer: GL Jones
Surface Type: Bitmac
Item Quantity: 1
Equipment Compliance: N/A
Surface Area Compliance: N/A

There is algae, silt or moss growth on the surface resulting in slippery conditions - Clean and treat appropriately

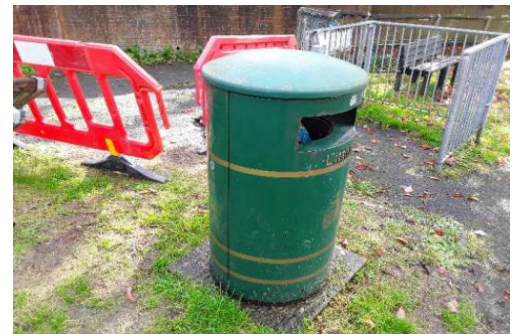
Item: Litter Bin
Manufacturer: Broxap
Surface Type: Concrete
Item Quantity: 1
Equipment Compliance: N/A
Surface Area Compliance: N/A

The paintwork on this item has been damaged or worn exposing the metal underneath which is rusting / corroding - Treat affected areas and repaint

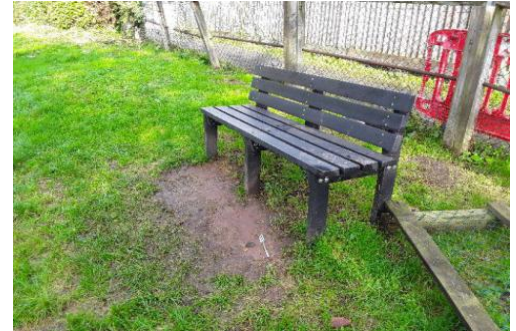
Item: Bench
Manufacturer: Not Identified
Surface Type: Grass
Item Quantity: 2
Equipment Compliance: N/A
Surface Area Compliance: N/A

The area around the item has eroded and may become slippery - Reinststate eroded area

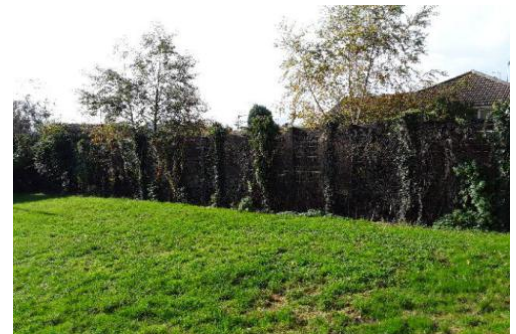
Item: Fence - Chainlink
Manufacturer: Not Identified
Surface Type: N/A
Item Quantity: 1
Equipment Compliance: N/A
Surface Area Compliance: N/A

The adjacent foliage is overhanging - Cut back and maintain

The fence is severely damaged in places - Repair or replace all affected sections

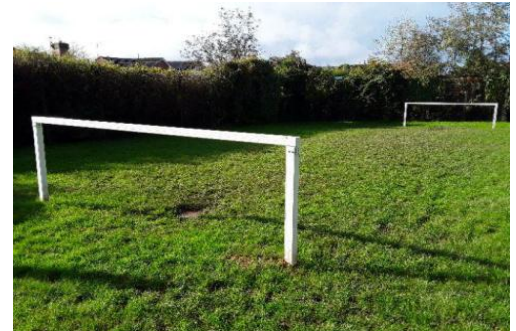
Item: Football Goal
Manufacturer: Not Identified
Surface Type: Grass
Item Quantity: 2
Equipment Compliance: N/A
Surface Area Compliance: N/A

NB: We have undertaken a maintenance inspection only of the football goal(s); full load testing falls outside the scope of our inspection. - Implement load testing as required

The paintwork on this item has been damaged or worn exposing the metal underneath which is rusting / corroding - Treat affected areas and repaint

The surface has eroded in some areas and may be slippery in wet conditions - Reinstate the surface

There is/are inserts missing - Replace missing inserts

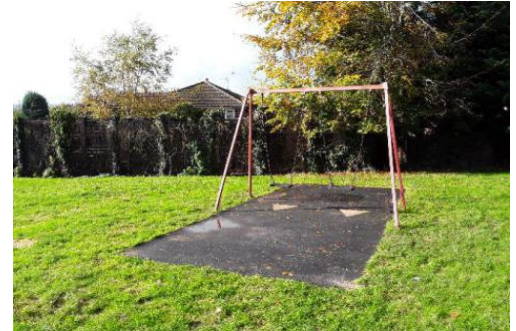
Item: 1 Bay 2 Seat (Flat)
Manufacturer: S M P (Playgrounds Ltd)
Surface Type: Wet Pour
Item Quantity: 1
Equipment Compliance: No
Surface Area Compliance: Yes

There are significant gaps (over 30mm) between the surface and the edging or between the joints in the surface; these are large enough for a small foot to enter - Repair surfacing

There are trip hazards at the edges of the surface - Reinstate surrounding surface levels to remove the trip points

There is some minor damage to the surface - Monitor for any further deterioration and repair as required

The chain openings are in excess of 8.6mm and do not meet the recommendations of BS EN 1176 Part 1 - Monitor - No remedial work recommended

The shackles are worn in excess of 40% and require renewing - Replace worn shackles

The surface has subsided in some areas - Monitor for any further deterioration and repair as required

The surface is lifting at the edges and creating trip points - Repair perimeter of surfacing to remove trip points

The paintwork on this item has been damaged or worn exposing the metal underneath which is rusting / corroding - Treat affected areas and repaint

The seat has minor damage or wear - Monitor for any further deterioration and replace as required

The connecting links are in excess of 8.6mm and less than 12mm and fail the requirements of BS EN 1176 Part 1; clause 4.2.13, Chains - Monitor use and replace with compliant links at the next maintenance cycle

The chain links are worn in excess of 60% and require renewing - Replace worn chains

The bushes are worn or missing - Replace worn or missing bushes

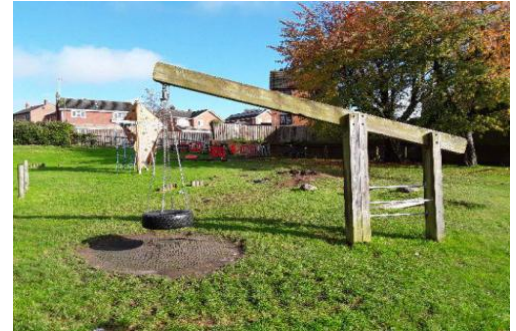
Item: Single Point Swing - Type 3
Manufacturer: Not Identified
Surface Type: Grass Matrix Tiles
Item Quantity: 1
Equipment Compliance: No
Surface Area Compliance: Yes

There is/are bolt cap covers missing or damaged on the item - Replace missing or damaged bolt cap covers

There is some strimmer / machinery damage apparent on the posts, this can penetrate the preservative applied to the timber and accelerate the rotting process - Monitor for any deterioration (rot) and replace as required

There is some evidence of rot in the timber posts - Monitor for any further deterioration and replace as required

Due to the dimensions of the timber it was not possible to ascertain the condition of the timber at its core without further testing. We recommend a Resi-PD survey to establish the condition of the timber at its core. - Contact the Play Inspection Company office for further information

There is damage apparent on the beam, this can penetrate the preservative applied to the timber and accelerate the rotting process - Replace the damaged beam

The grass mats are silted up and the soil is compacted; this may have an effect on the impact absorbing properties of the surface - Consider HIC testing impact absorbing properties to ensure the correct surface qualities are maintained for the equipment and replace as required

The surfacing is severely damaged - Replace damaged areas of surfacing

There is some notable evidence of chain wear - Monitor for any further deterioration and replace when 40% worn

There is some wear to the suspension joint - Refer to manufacturer specification and service or replace as required

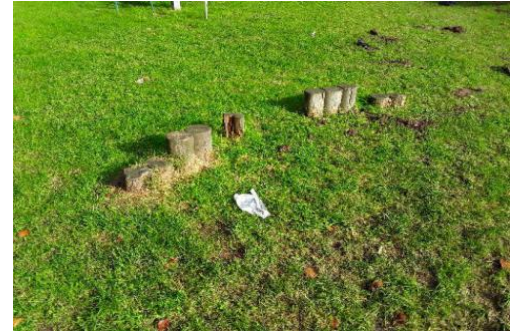
Item: Log Walk
Manufacturer: Not Identified
Surface Type: Grass
Item Quantity: 2
Equipment Compliance: Yes
Surface Area Compliance: Yes

There are areas or parts of the timber posts that have rotted or are missing - Replace all affected timbers

There is some strimmer / machinery damage apparent on the posts, this can penetrate the preservative applied to the timber and accelerate the rotting process - Monitor for any deterioration (rot) and replace as required

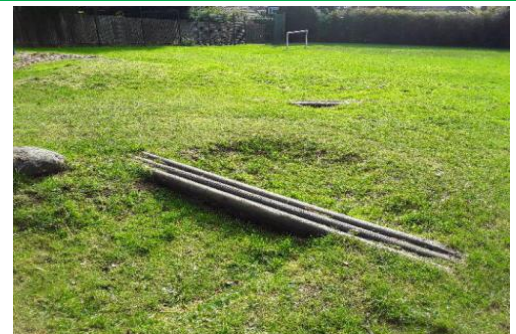
Item: Bridge
Manufacturer: Not Identified
Surface Type: Grass
Item Quantity: 2
Equipment Compliance: N/A
Surface Area Compliance: N/A

The timber has a number of splits/shakes or air cracks and this may affect the stability or allow water ingress which will accelerate the rotting process - Monitor to ensure the splits do not cross through fixing points of the structure and/or cause any instability

There are areas or parts of the timber on the structure that have rotted - Replace all affected timbers

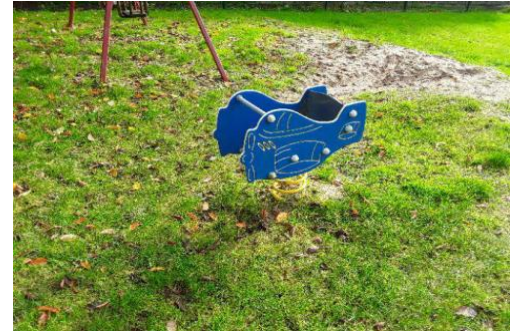
Item: Spring Aeroplane
Manufacturer: Fahr Industries
Surface Type: Sand
Item Quantity: 1
Equipment Compliance: Yes
Surface Area Compliance: Yes

The paintwork on the spring has been damaged or worn exposing the metal underneath which is rusting - Treat any rusting components and repaint

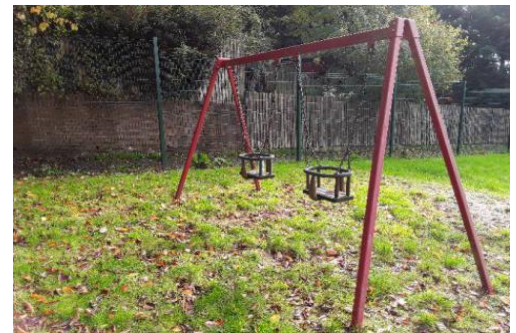
Item: 1 Bay 2 Seat (Cradle)
Manufacturer: S M P (Playgrounds Ltd)
Surface Type: Sand
Item Quantity: 1
Equipment Compliance: Yes
Surface Area Compliance: Yes

There is some notable evidence of chain wear - Monitor for any further deterioration and replace when 40% worn

The bushes are showing signs of wear - Monitor for any further deterioration and replace as required

There is some wear to the shackles - Monitor for any further deterioration and replace when 40% worn

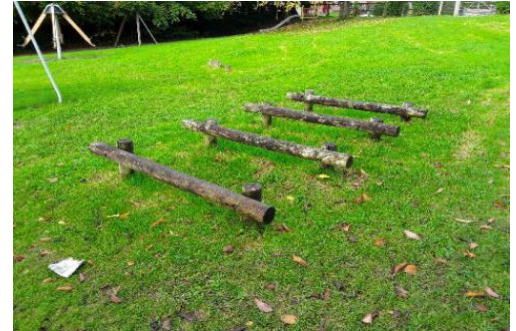
Item: Leap Frog
Manufacturer: Not Identified
Surface Type: Grass
Item Quantity: 1
Equipment Compliance: Yes
Surface Area Compliance: Yes

There is/are bolt cap covers missing or damaged on the item - Replace missing or damaged bolt cap covers

A number of fixing(s) have worked loose - Secure all loose fixings

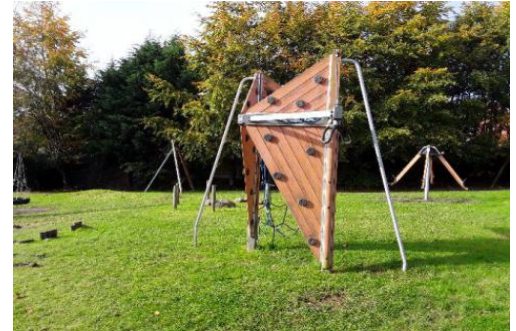
Item: Climbing Frame
Manufacturer: Lappset UK Ltd
Surface Type: Grass Matrix Tiles
Item Quantity: 1
Equipment Compliance: Yes
Surface Area Compliance: Yes

This item of equipment has a fall height in excess of 2.5m and grass mats have been installed as an impact absorbing surface; these mats rely heavily on the underlying surface to achieve their critical fall height properties. - Ensure surfacing certification is sought and consider HIC testing to ensure the surfacing is performing adequately

There is/are inserts missing - Replace missing inserts

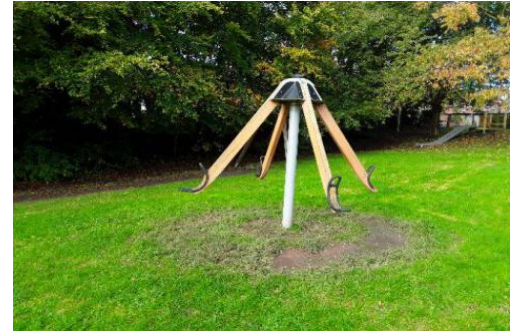
Item: Carousel
Manufacturer: Lappset UK Ltd
Surface Type: Grass Matrix Tiles
Item Quantity: 1
Equipment Compliance: Yes
Surface Area Compliance: Yes

The grass mats are silted up and the soil is compacted; this may have an effect on the impact absorbing properties of the surface - Consider HIC testing impact absorbing properties to ensure the correct surface qualities are maintained for the equipment and replace as required

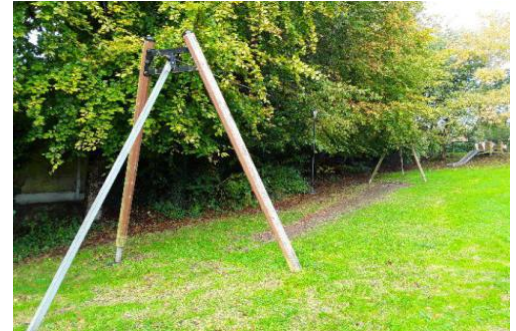
Item: Cable Runway
Manufacturer: Lappset UK Ltd
Surface Type: Grass Matrix Tiles
Item Quantity: 1
Equipment Compliance: No
Surface Area Compliance: Yes

We have completed a visual inspection of the suspension links, cable and fixing points from ground level, however it is not possible to fully inspect these areas without either hiring equipment to gain access or removing the cable and suspension and inspecting at ground level. We recommend that the main cable and fixing security is thoroughly inspected at least in accordance with the manufacturers recommendations to check for wear, damage, security or internal rusting; this will help to ensure the continued safe use of the equipment - Inspect in accordance with the manufacturers recommendations

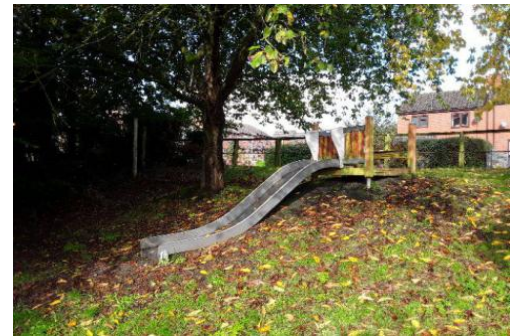
Item: Embankment Slide
Manufacturer: Lappset UK Ltd
Surface Type: Grass Matrix Tiles
Item Quantity: 1
Equipment Compliance: Yes
Surface Area Compliance: Yes

The grass mats are silted up and the soil is compacted; this may have an effect on the impact absorbing properties of the surface - Consider HIC testing impact absorbing properties to ensure the correct surface qualities are maintained for the equipment and replace as required

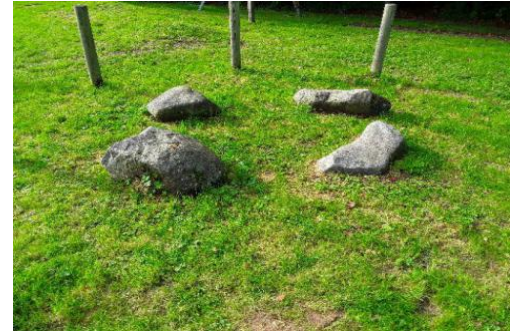
Item: Boulders
Manufacturer: Natural Feature
Surface Type: Grass
Item Quantity: 1
Equipment Compliance: N/A
Surface Area Compliance: N/A

The rocks and/or boulders have moss/algae growth apparent - Clean and maintain

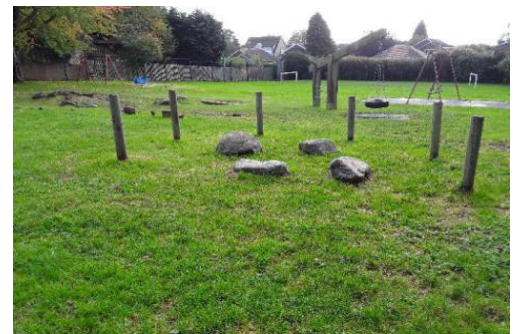
Item: Posts
Manufacturer: Owner/Operator
Surface Type: Grass
Item Quantity: 1
Equipment Compliance: N/A
Surface Area Compliance: N/A

There are areas or parts of the timber on the structure that have rotted - Replace all affected timbers

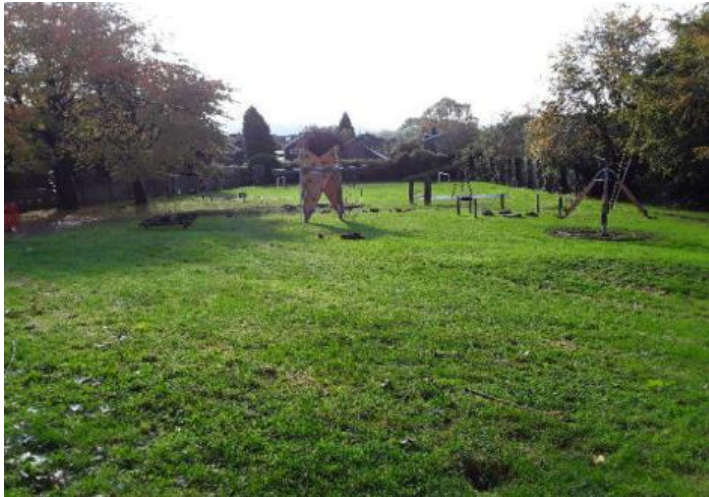
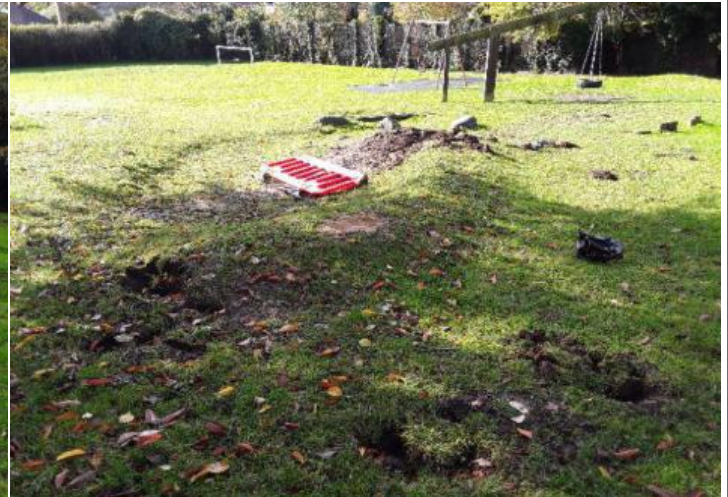
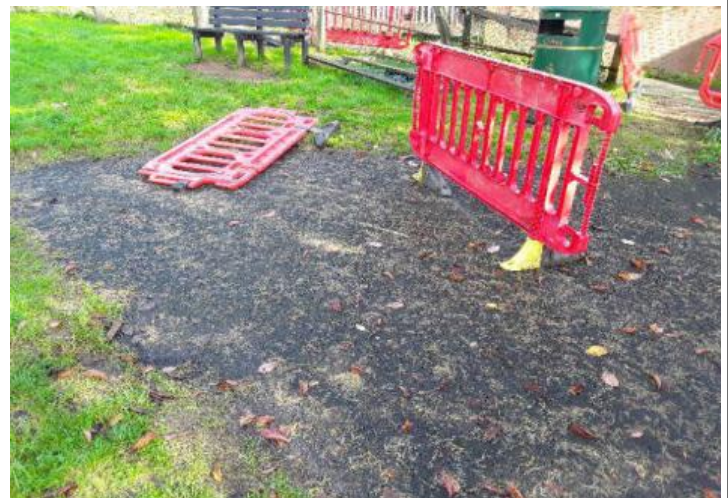
Item: Ancillary Items - Site General
Manufacturer: Owner/Operator

Finding: Maintenance work appears to be ongoing and there is unsecured temporary fencing in the play area

Action: Remove or secure

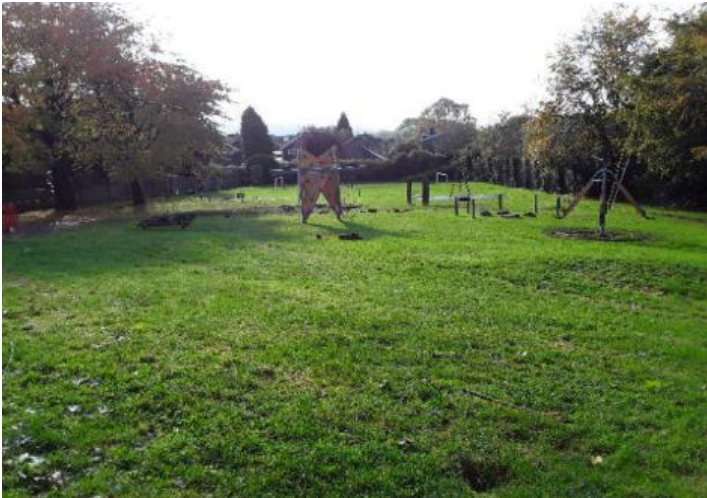
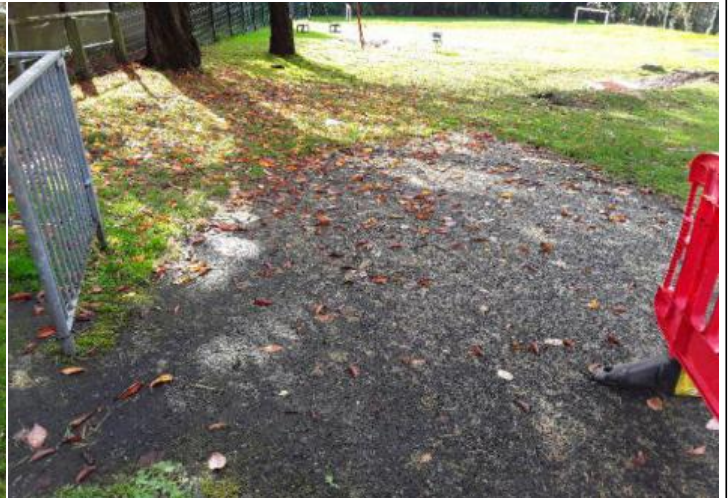
Item: Ancillary Items - Site General
Manufacturer: Owner/Operator

Finding: There is some tree debris on the surfacing

Action: Remove and maintain

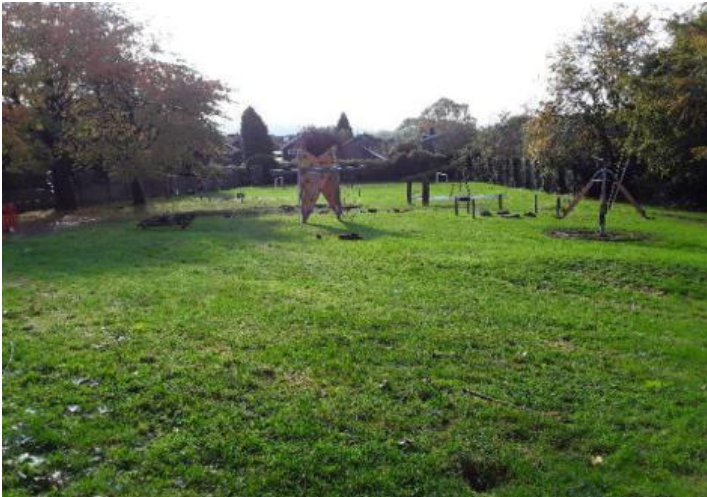
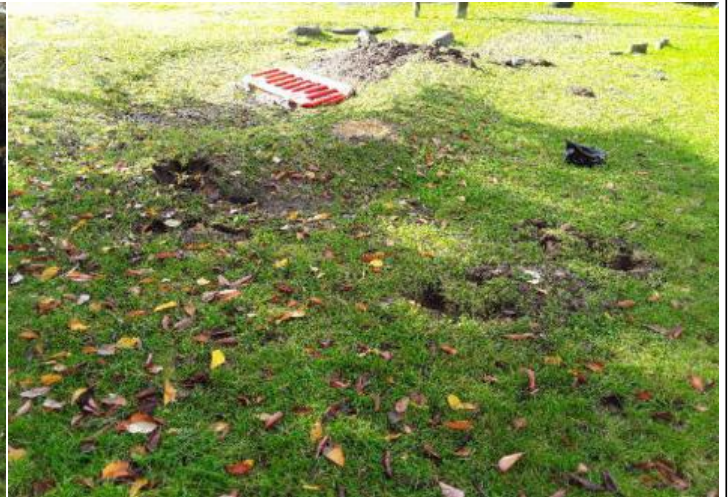
Item: Ancillary Items - Site General
Manufacturer: Owner/Operator

Finding: There are holes in surface that may have been created purposely by users.

Action: Infill to provide a sound reasonably level surface.

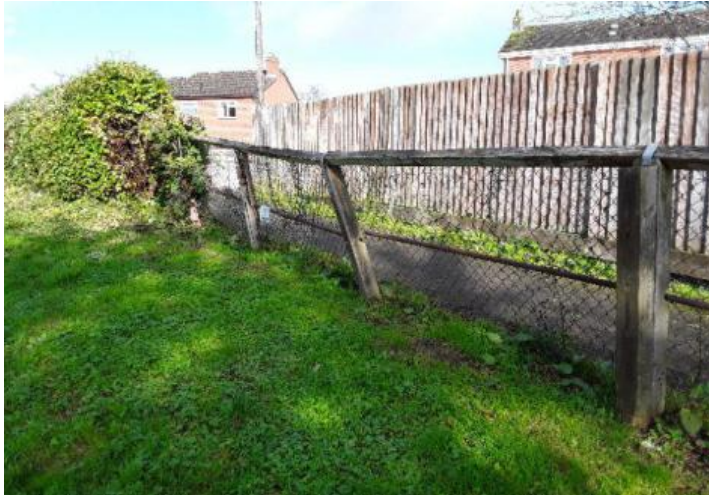
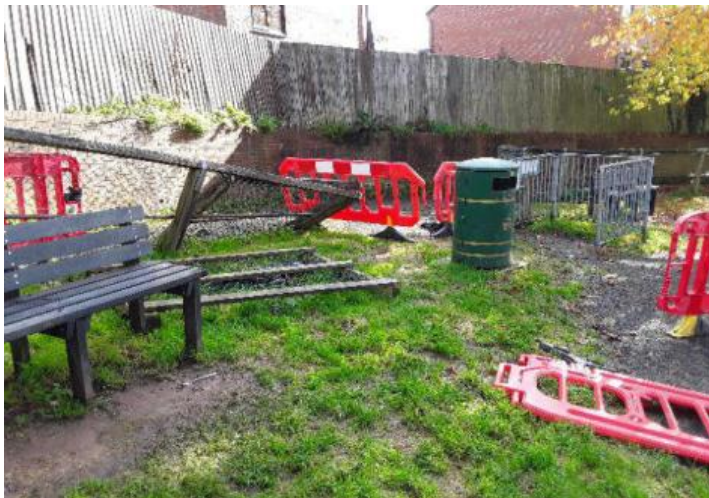
Item: Fences - Fence - Timber & Mesh Infill
Manufacturer: Not Identified

Finding: The fence has severe rot and is damaged exposing projecting fixings and there are unsecured sections of fencing within the play area

Action: Remove all damaged and rotted fencing and secure safety fencing

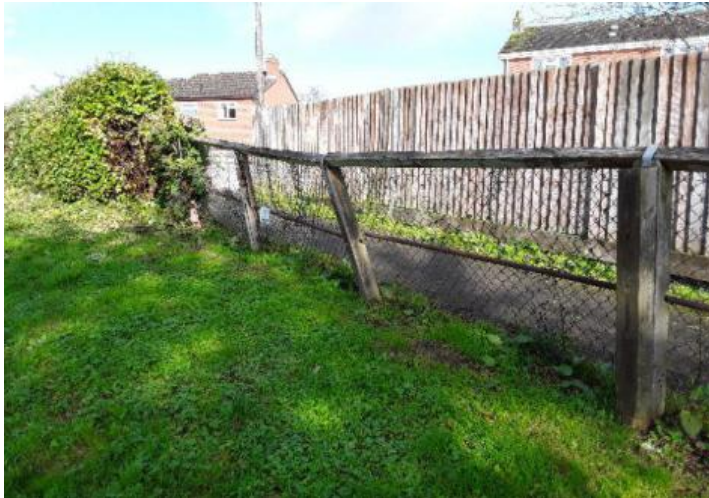
Item: Fences - Fence - Timber & Mesh Infill
Manufacturer: Not Identified

Finding: There is some strimmer / machinery damage apparent on the posts, this can penetrate the preservative applied to the timber and accelerate the rotting process

Action: Monitor for any deterioration (rot) and replace as required

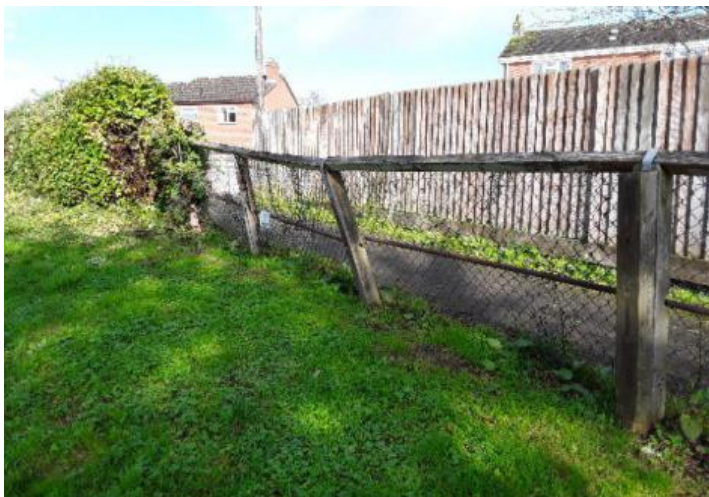
Item: Fences - Fence - Timber & Mesh Infill
Manufacturer: Not Identified

Finding: There is surface corrosion / rust present on the item

Action: Consider treating the item

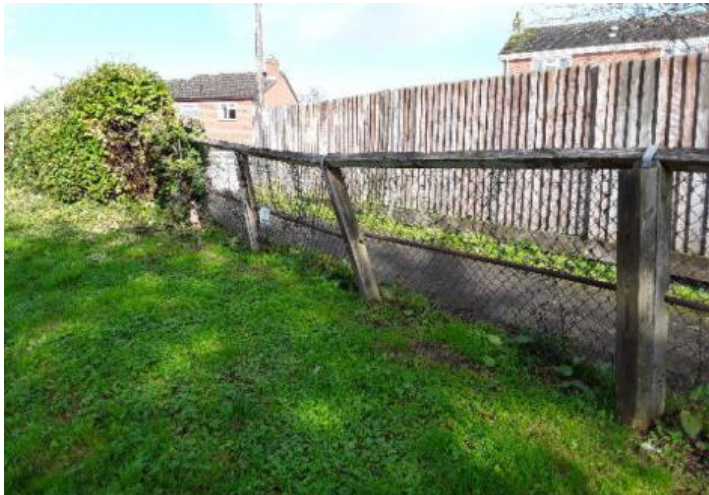
Item: Fences - Fence - Timber & Mesh Infill
Manufacturer: Not Identified

Finding: The area / equipment on site has been isolated from use however the area is still accessible and the means of isolation has either introduced additional hazards that may cause harm in the event of users accessing the area or is insufficient to stop users from accessing the equipment

Action: Provide a more suitable isolation method

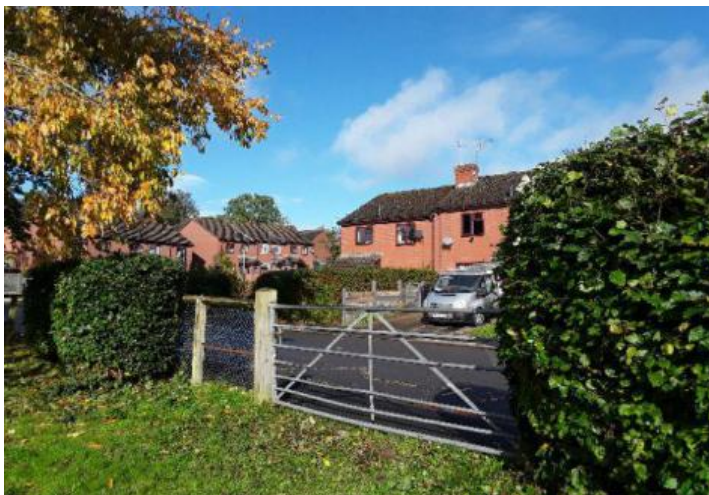
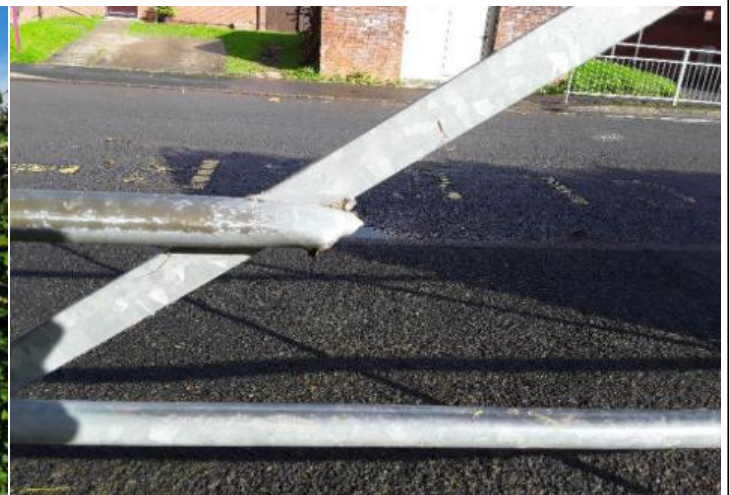
Item: Gates - Gate - Maintenance
Manufacturer: Not Identified

Finding: There is some damage to the item creating sharp edges

Action: Repair and remove all sharp edges

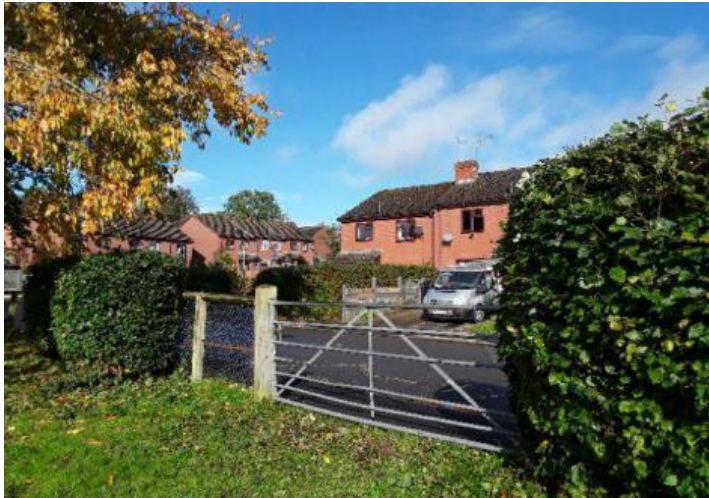
Item: Gates - Gate - Maintenance
Manufacturer: Not Identified

Finding: The weld(s) on this item have failed

Action: Repair item

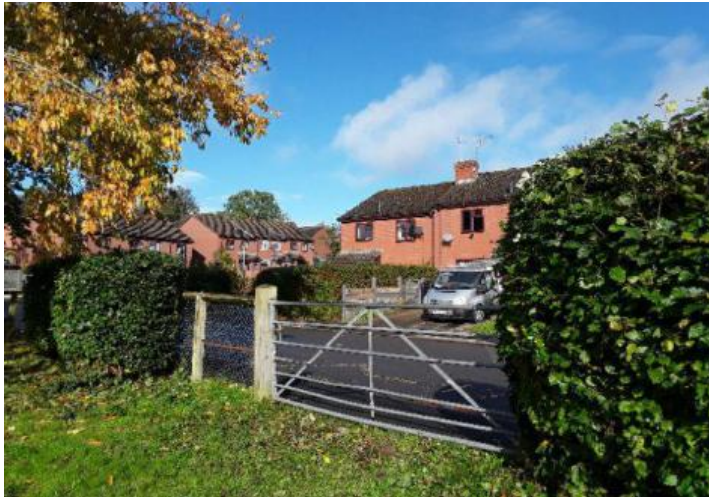
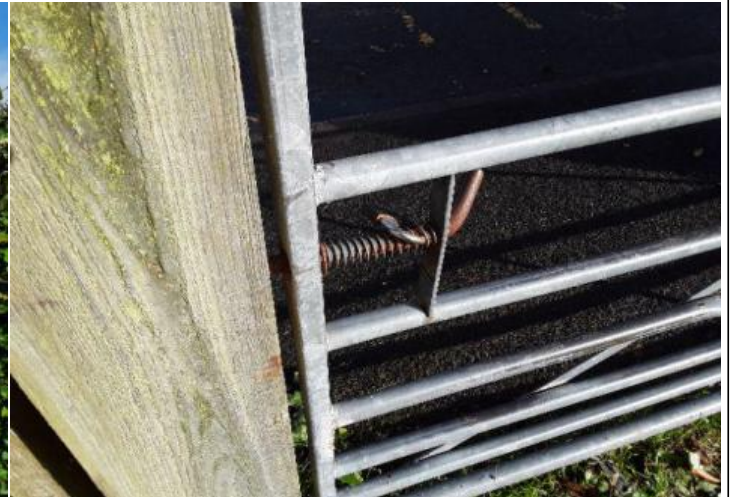
Item: Gates - Gate - Maintenance
Manufacturer: Not Identified

Finding: The maintenance gate was correctly padlocked at the time of inspection, however this means that the inspector was unable to fully assess the gate

Action: Ensure that there are 12mm gaps throughout the full range of motion on gate/s and between leaves where relevant

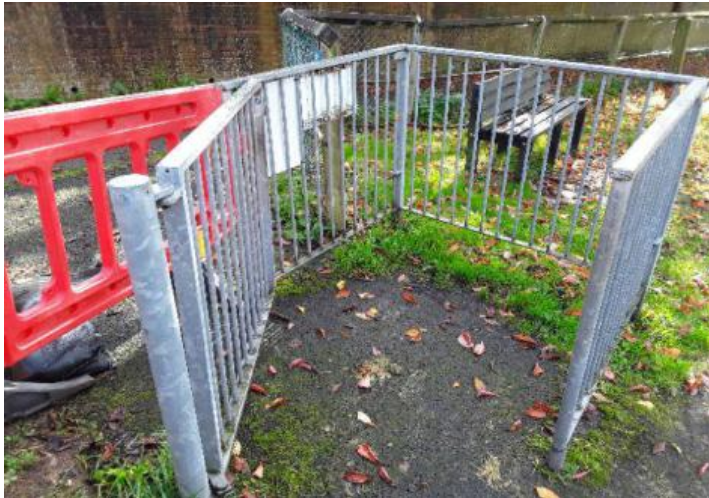
Item: Gates - Kissing Gate
Manufacturer: GL Jones

Finding: There is algae, silt or moss growth on the surface resulting in slippery conditions

Action: Clean and treat appropriately

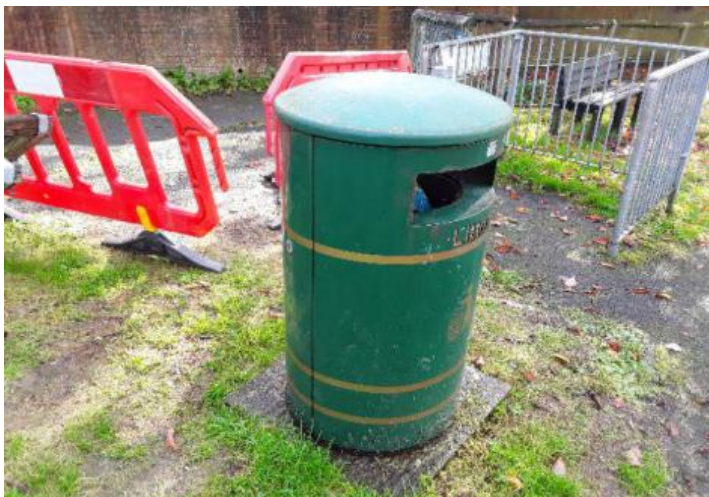
Item: Ancillary Items - Litter Bin
Manufacturer: Broxap

Finding: The paintwork on this item has been damaged or worn exposing the metal underneath which is rusting / corroding

Action: Treat affected areas and repaint

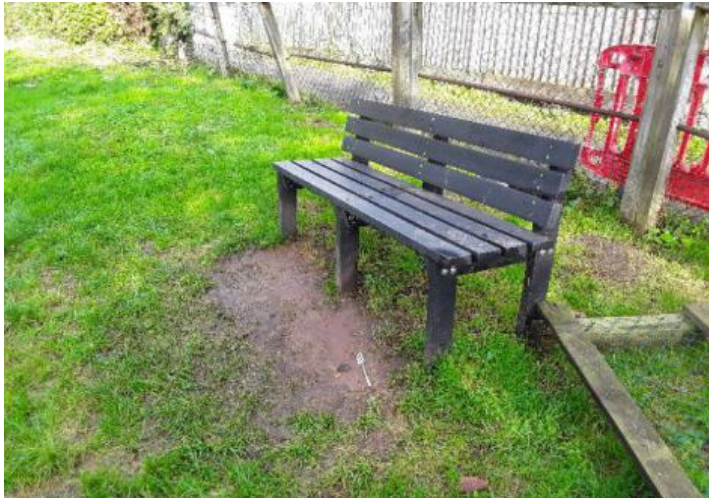
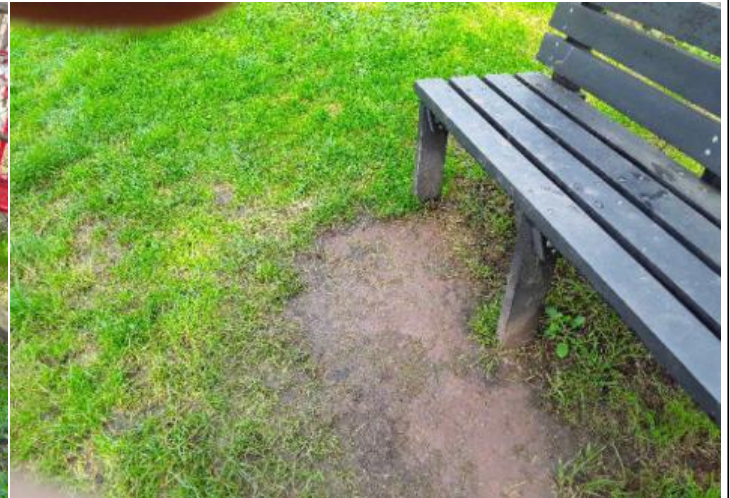
Item: Ancillary Items - Bench
Manufacturer: Not Identified

Finding: The area around the item has eroded and may become slippery

Action: Reinststate eroded area

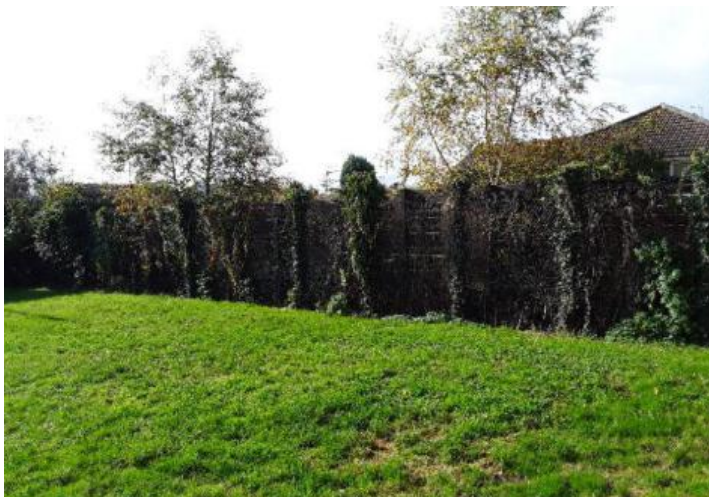
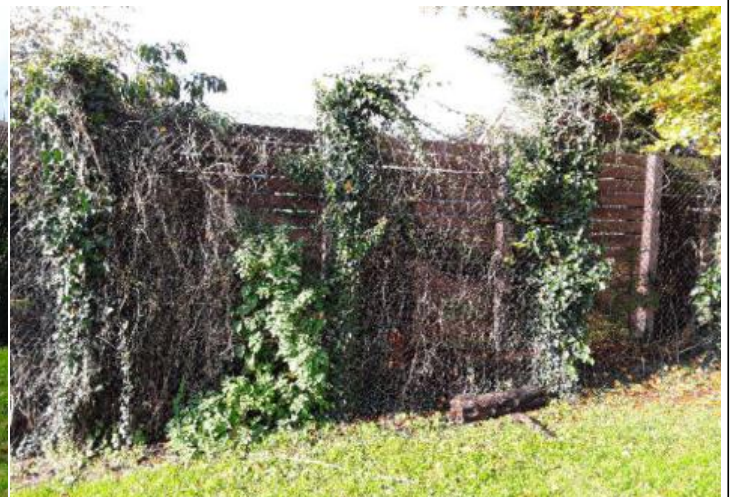
Item: Fences - Fence - Chainlink
Manufacturer: Not Identified

Finding: The adjacent foliage is overhanging

Action: Cut back and maintain

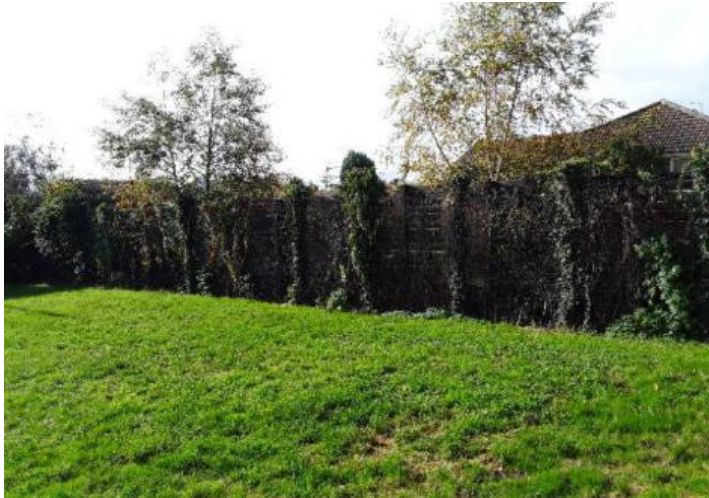
Item: Fences - Fence - Chainlink
Manufacturer: Not Identified

Finding: The fence is severely damaged in places

Action: Repair or replace all affected sections

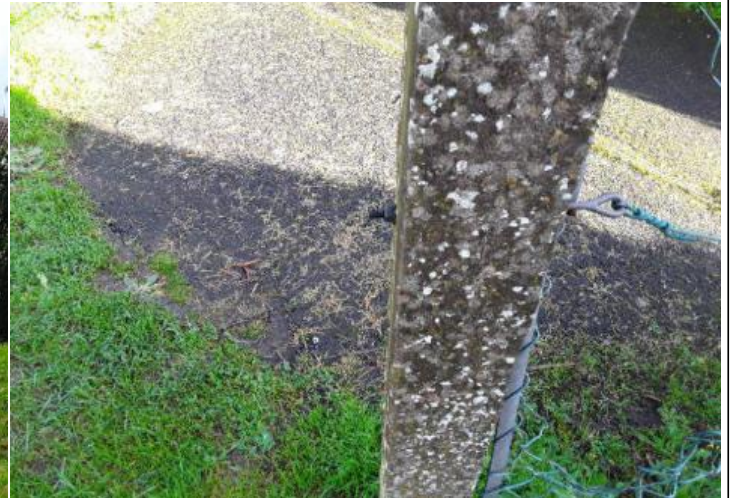
Item: Fences - Fence - Chainlink
Manufacturer: Not Identified

Finding: There are projecting bolt thread(s) present

Action: Remove excess thread length and deburr or provide cap

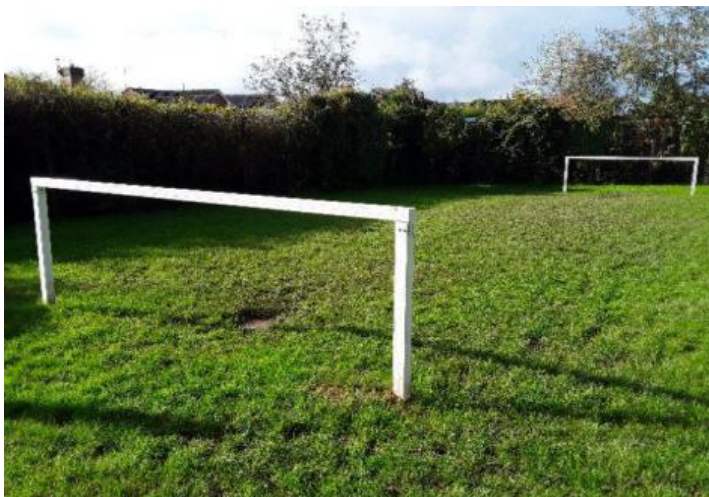
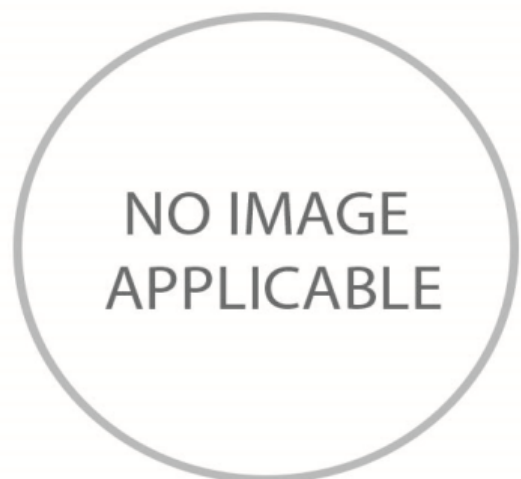
Item: Multi Use Games Area - Football Goal
Manufacturer: Not Identified

Finding: NB: We have undertaken a maintenance inspection only of the football goal(s); full load testing falls outside the scope of our inspection.

Action: Implement load testing as required

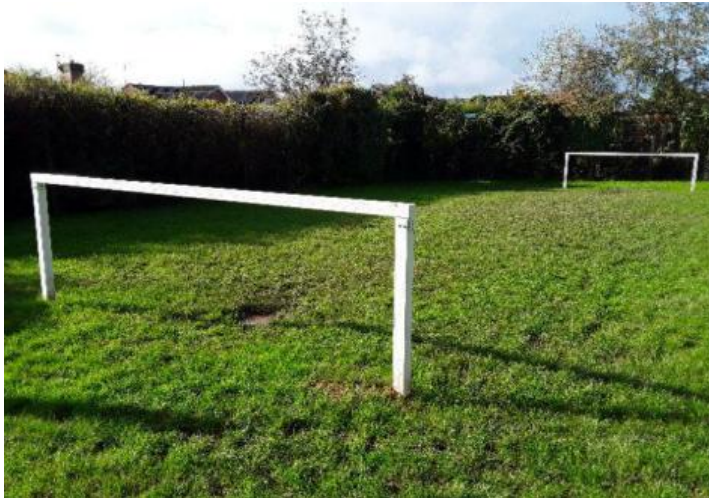
Item: Multi Use Games Area - Football Goal
Manufacturer: Not Identified

Finding: The surface has eroded in some areas and may be slippery in wet conditions
Action: Reinstate the surface

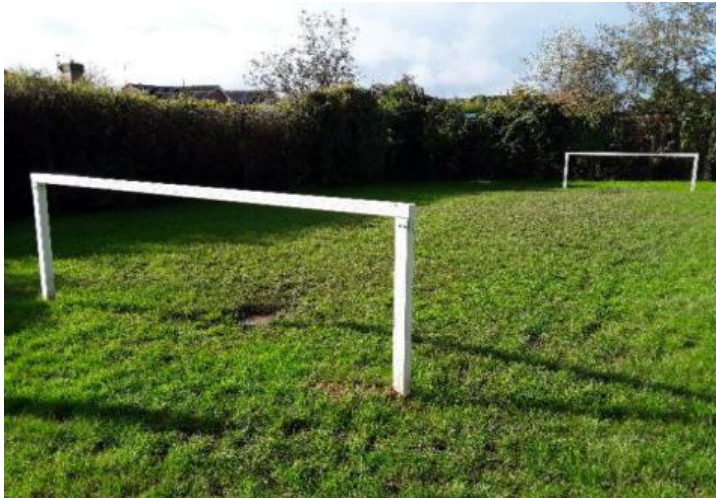
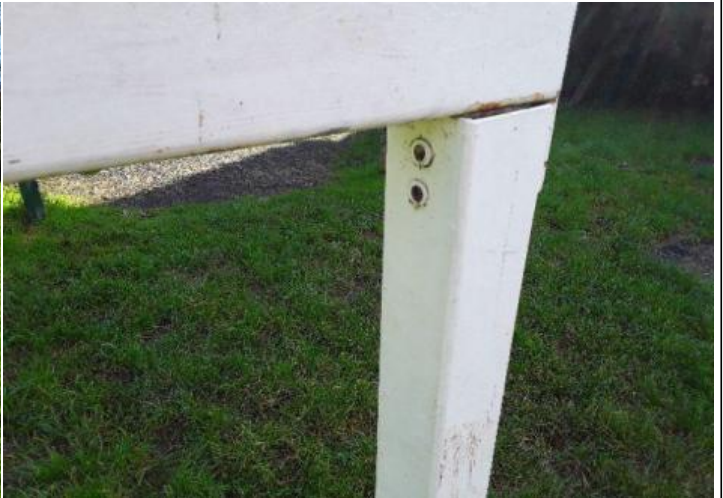
Item: Multi Use Games Area - Football Goal
Manufacturer: Not Identified

Finding: There is/are inserts missing

Action: Replace missing inserts

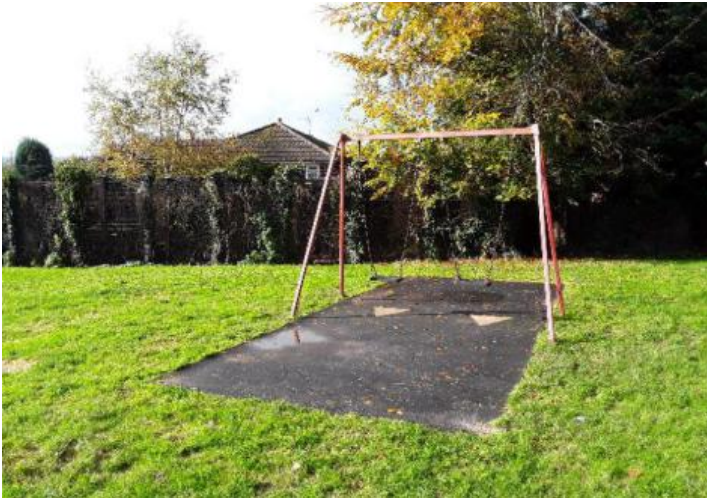
Item: Swings - 1 Bay 2 Seat (Flat)
Manufacturer: S M P (Playgrounds Ltd)

Finding: There are significant gaps (over 30mm) between the surface and the edging or between the joints in the surface; these are large enough for a small foot to enter

Action: Repair surfacing

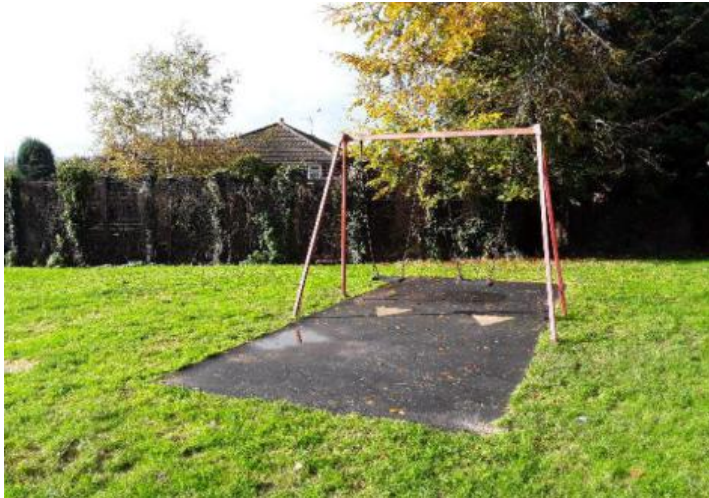
Item: Swings - 1 Bay 2 Seat (Flat)
Manufacturer: S M P (Playgrounds Ltd)

Finding: The surface has subsided in some areas

Action: Monitor for any further deterioration and repair as required

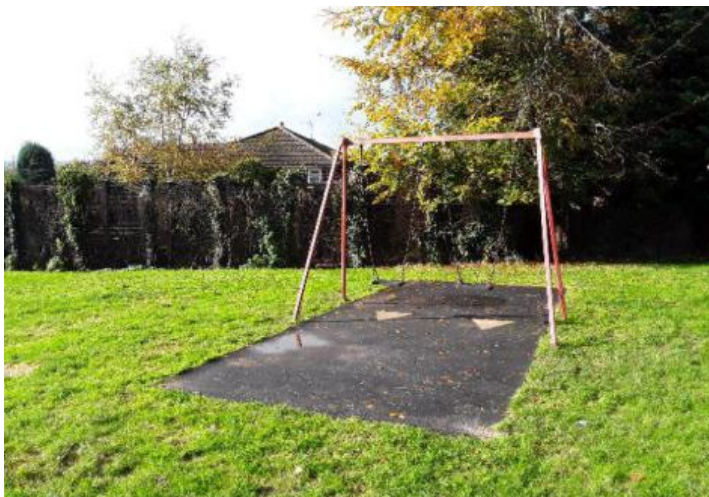
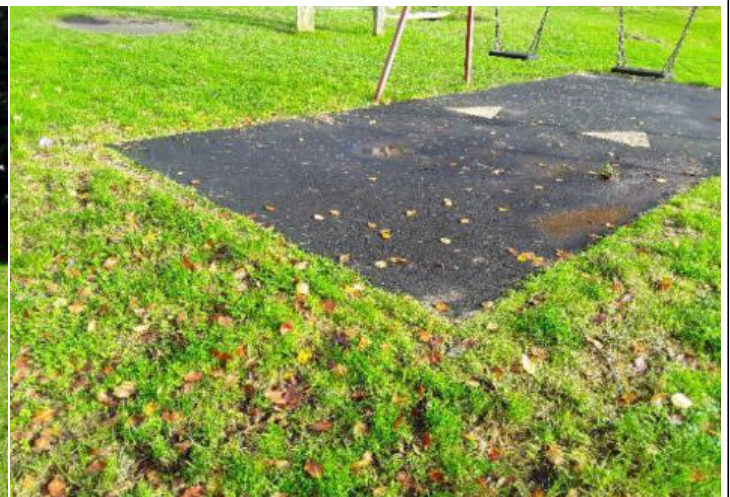
Item: Swings - 1 Bay 2 Seat (Flat)
Manufacturer: S M P (Playgrounds Ltd)

Finding: There is weed / vegetation growth on, between, or around the edges of the surfacing

Action: Remove weed / vegetation growth

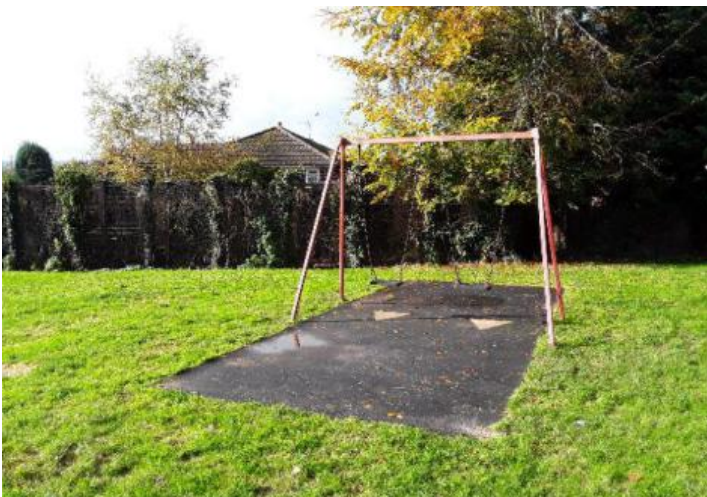
Item: Swings - 1 Bay 2 Seat (Flat)
Manufacturer: S M P (Playgrounds Ltd)

Finding: There are trip hazards at the edges of the surface
Action: Reinstate surrounding surface levels to remove the trip points

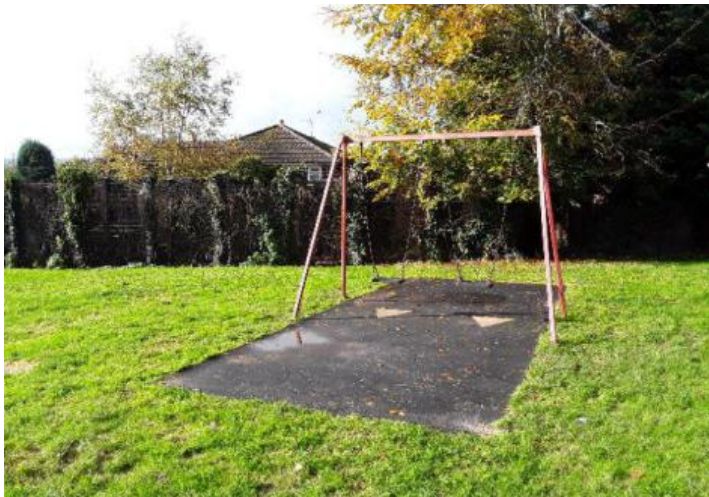
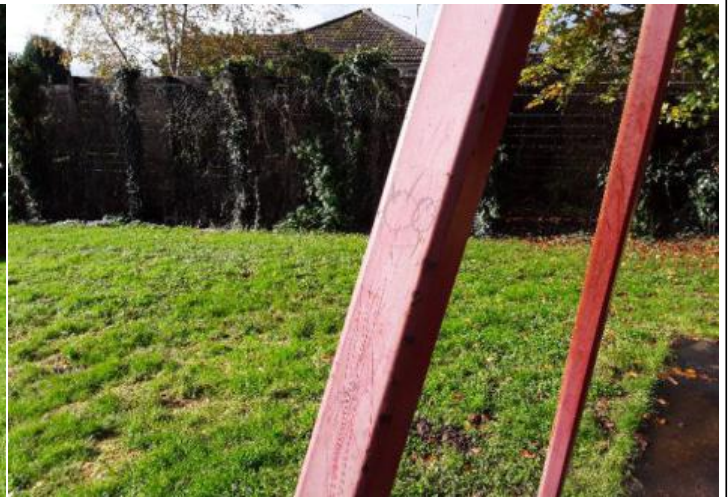
Item: Swings - 1 Bay 2 Seat (Flat)
Manufacturer: S M P (Playgrounds Ltd)

Finding: There is offensive graffiti present

Action: Remove as soon as practicable

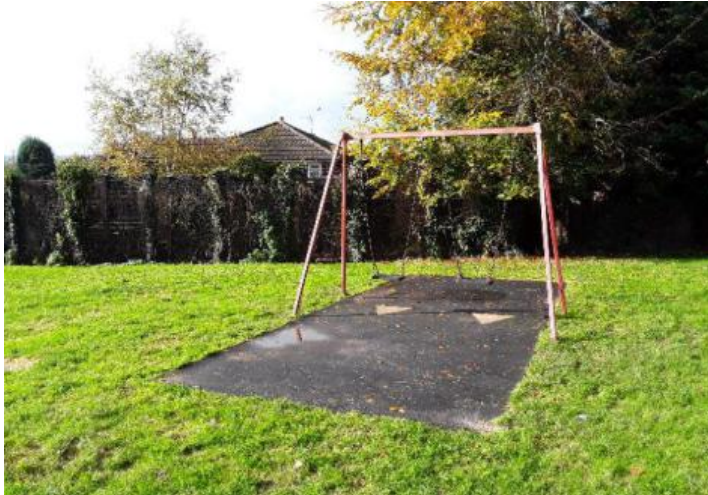
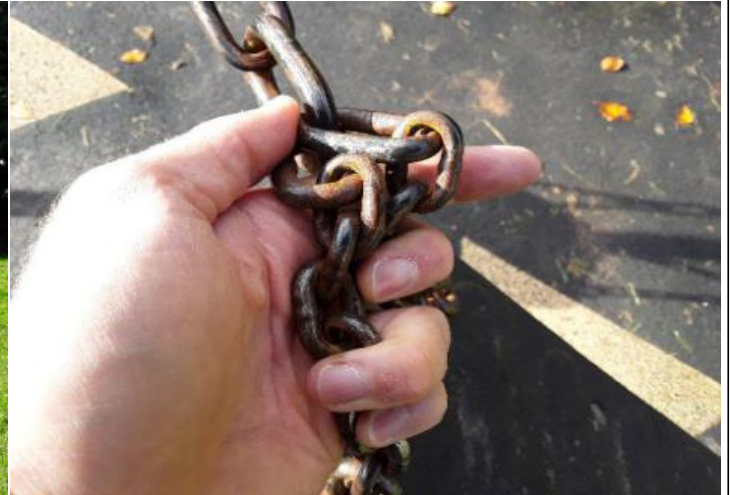
Item: Swings - 1 Bay 2 Seat (Flat)
Manufacturer: S M P (Playgrounds Ltd)

Finding: The chain links are worn in excess of 60% and require renewing

Action: Replace worn chains

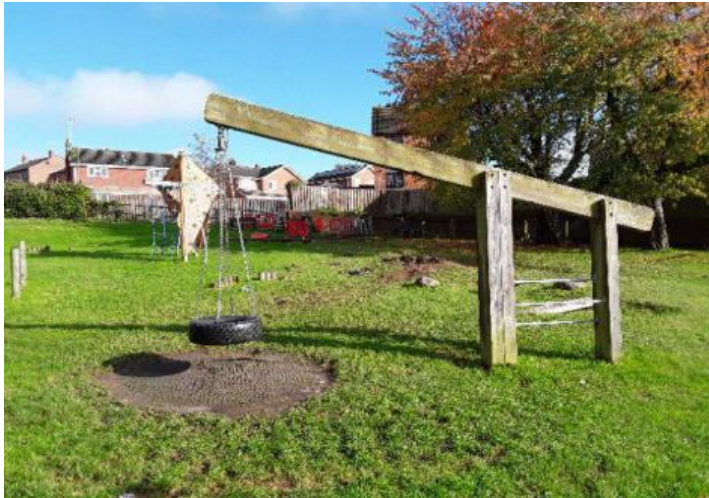
Item: Swings - Single Point Swing - Type 3
Manufacturer: Not Identified

Finding: There is/are bolt cap covers missing or damaged on the item

Action: Replace missing or damaged bolt cap covers

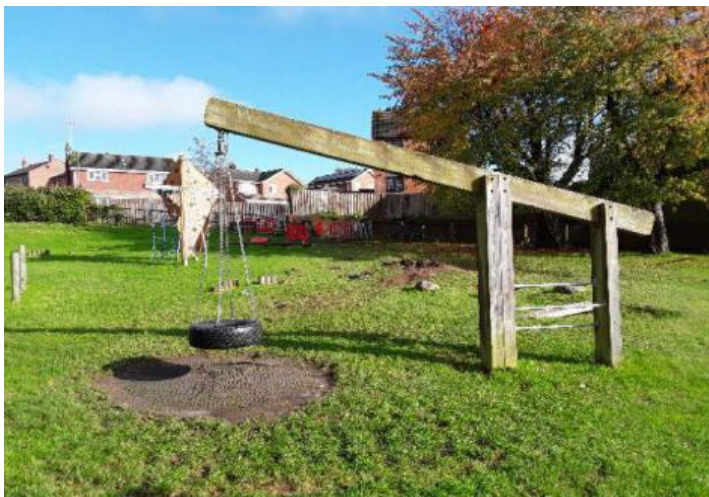
Item: Swings - Single Point Swing - Type 3
Manufacturer: Not Identified

Finding: There is some strimmer / machinery damage apparent on the posts, this can penetrate the preservative applied to the timber and accelerate the rotting process

Action: Monitor for any deterioration (rot) and replace as required
