Annual Inspection

Shropshire Council

Tollgate Road Play Area

Tollgate Road, Ludlow, SY8 1TQ

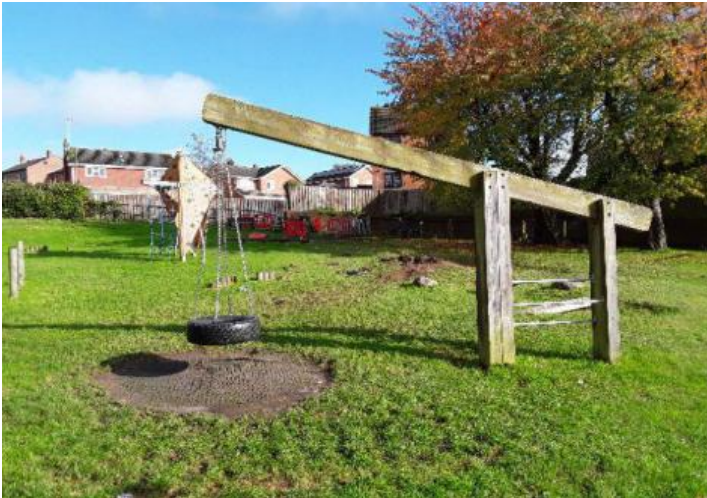
Item: Swings - Single Point Swing - Type 3
Manufacturer: Not Identified

Finding: There is some evidence of rot in the timber posts

Action: Monitor for any further deterioration and replace as required

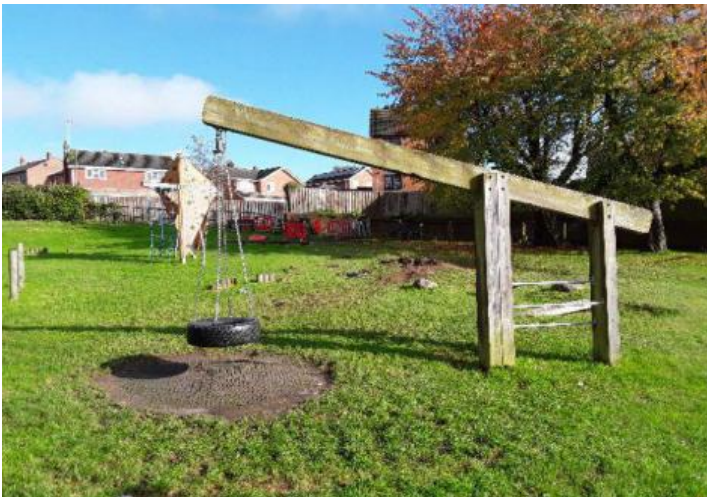
Item: Swings - Single Point Swing - Type 3
Manufacturer: Not Identified

Finding: The surfacing is severely damaged

Action: Replace damaged areas of surfacing

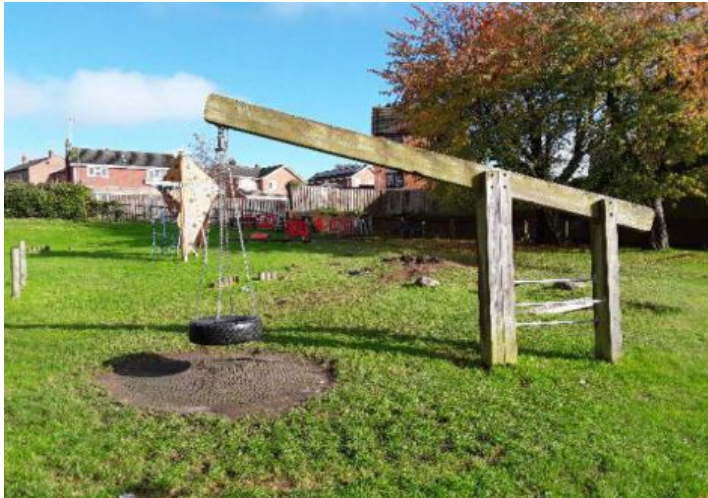
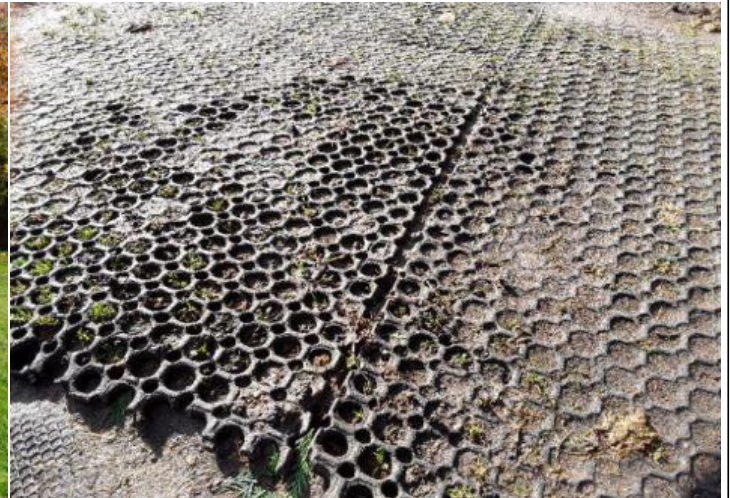
Item: Swings - Single Point Swing - Type 3
Manufacturer: Not Identified

Finding: There are gaps opening between the grass mat tiles

Action: Provide additional ties or secure / reinstate surface which are also lifting

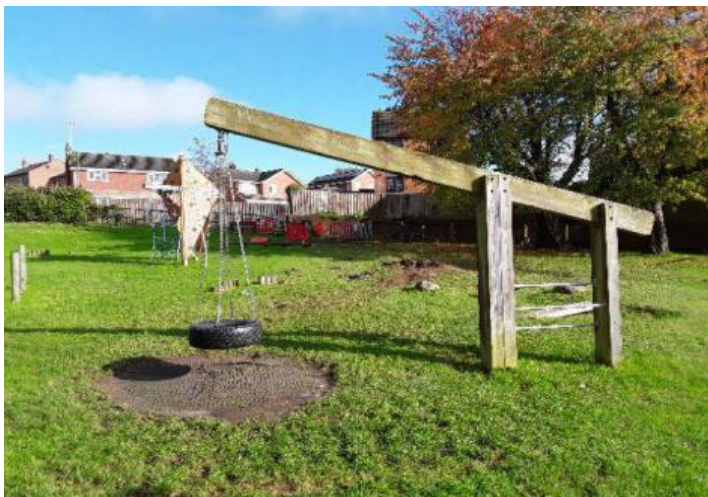
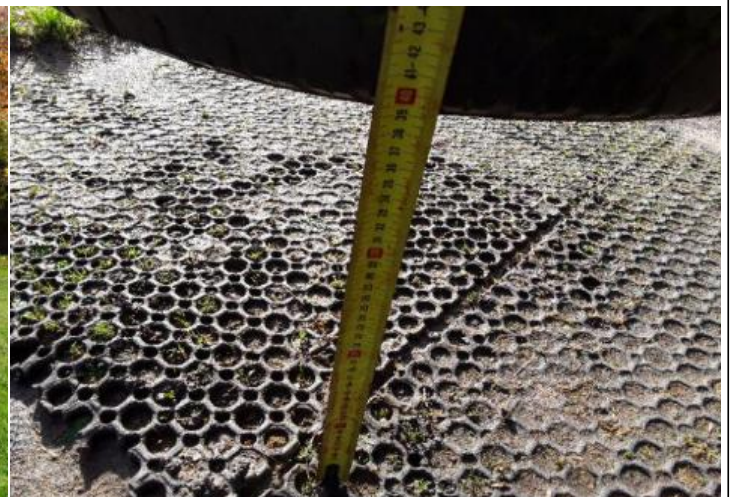
Item: Swings - Single Point Swing - Type 3
Manufacturer: Not Identified

Finding: The seat clearance from finished surface level to the underside of the seat is too low and does not meet the requirements of BS EN 1176 Part 2 (400mm minimum clearance required from rigid part of seat in most onerous position)

Action: Adjust seat clearance

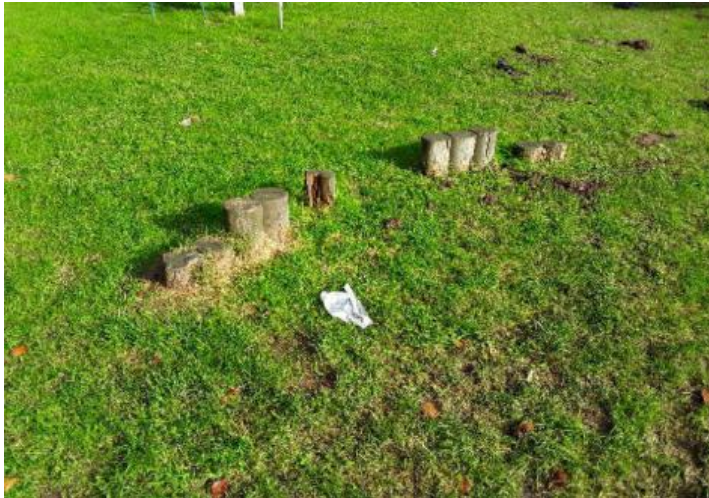
Item: Activity Equipment - Log Walk
Manufacturer: Not Identified

Finding: There are areas or parts of the timber posts that have rotted or are missing

Action: Replace all affected timbers

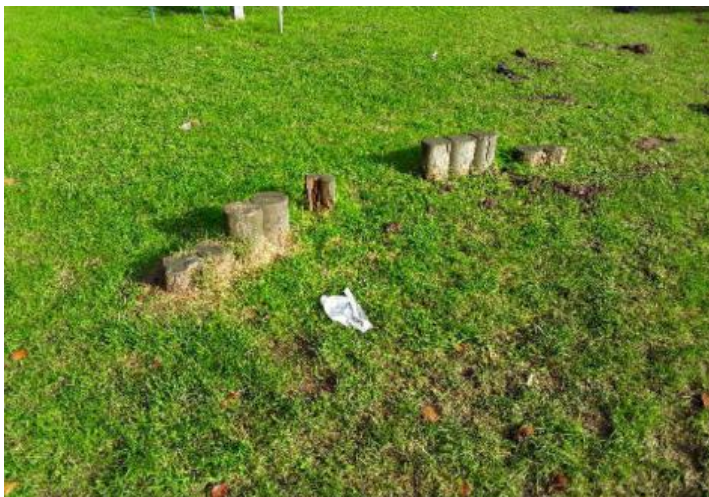
Item: Activity Equipment - Log Walk
Manufacturer: Not Identified

Finding: There is some strimmer / machinery damage apparent on the posts, this can penetrate the preservative applied to the timber and accelerate the rotting process

Action: Monitor for any deterioration (rot) and replace as required

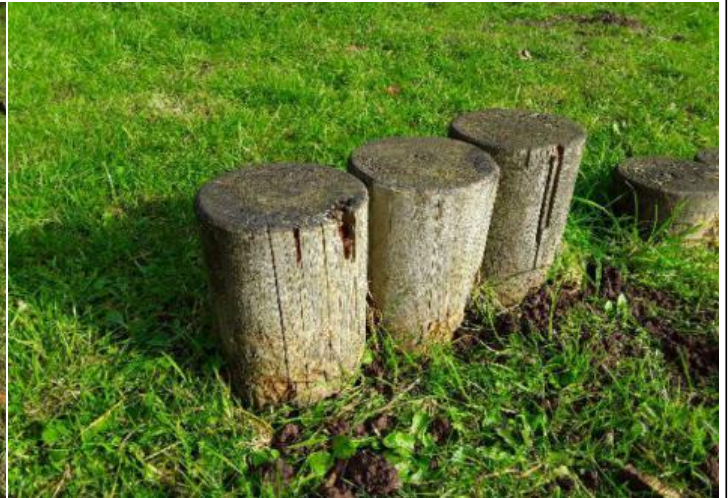
Item: Activity Equipment - Log Walk
Manufacturer: Not Identified

Finding: Parts of the timber are rough or splintered

Action: Remove all rough or sharp edges

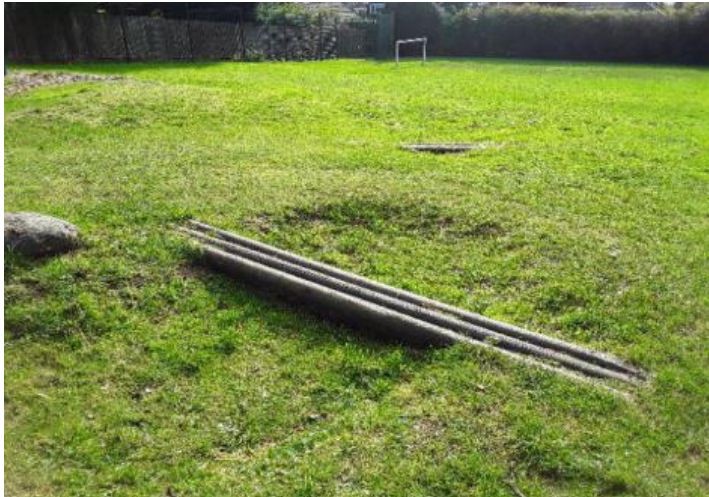
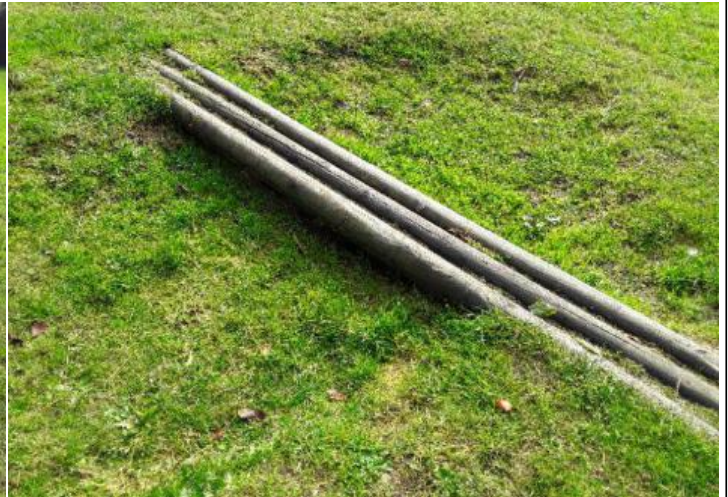
Item: Activity Equipment - Bridge
Manufacturer: Not Identified

Finding: There is algae or moss on the surface of the equipment

Action: Clean and treat appropriately

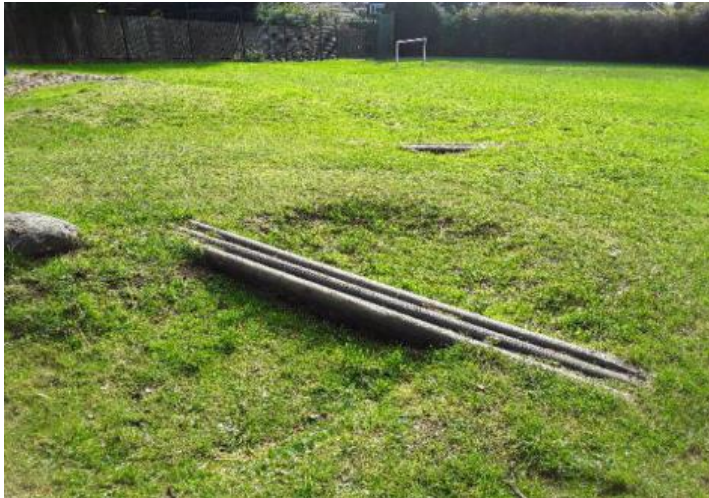
Item: Activity Equipment - Bridge
Manufacturer: Not Identified

Finding: The timber has a number of splits/shakes or air cracks and this may affect the stability or allow water ingress which will accelerate the rotting process

Action: Monitor to ensure the splits do not cross through fixing points of the structure and/or cause any instability

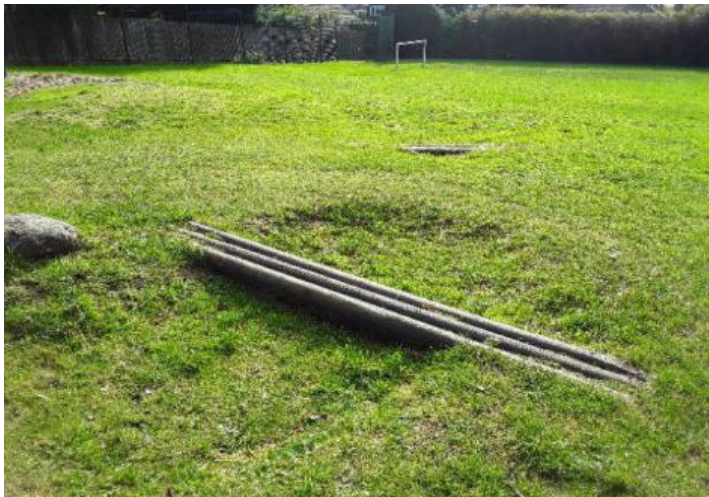
Item: Activity Equipment - Bridge
Manufacturer: Not Identified

Finding: There are areas or parts of the timber on the structure that have rotted

Action: Replace all affected timbers

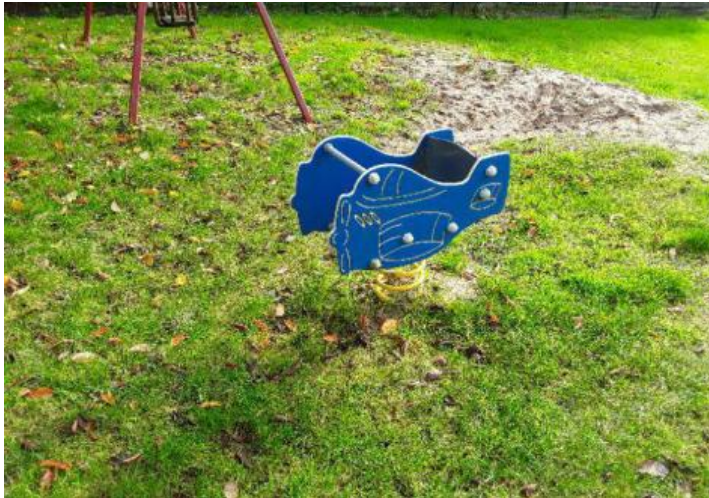
Item: Rocking Equipment - Spring Aeroplane
Manufacturer: Fahr Industries

Finding: The paintwork on the spring has been damaged or worn exposing the metal underneath which is rusting
Action: Treat any rusting components and repaint

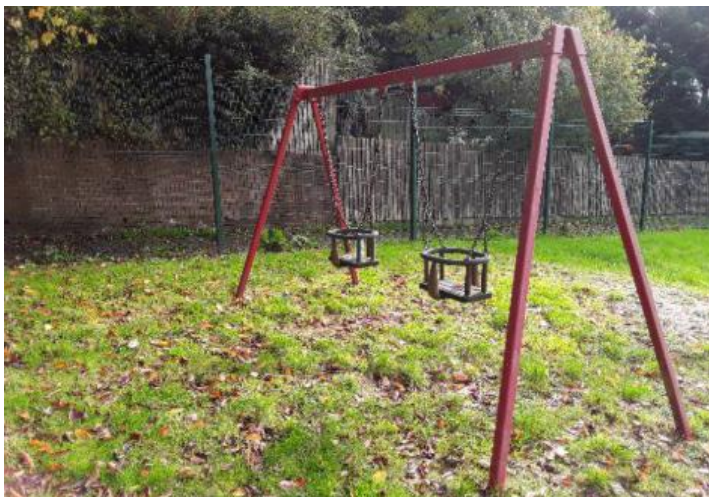
Item: Swings - 1 Bay 2 Seat (Cradle)
Manufacturer: S M P (Playgrounds Ltd)

Risk Level: L - Low Risk
Surface: Sand

Finding: There is some notable evidence of chain wear
Action: Monitor for any further deterioration and replace when 40% worn

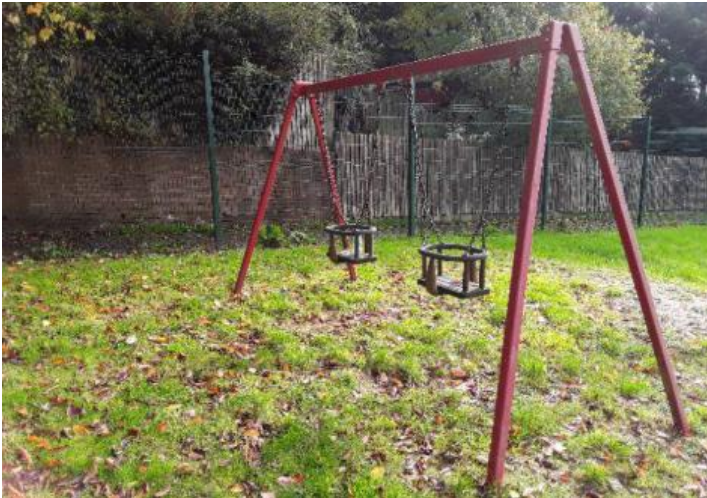
Item: Swings - 1 Bay 2 Seat (Cradle)
Manufacturer: S M P (Playgrounds Ltd)

Risk Level: L - Low Risk
Surface: Sand

Finding: There is some wear to the shackles

Action: Monitor for any further deterioration and replace when 40% worn

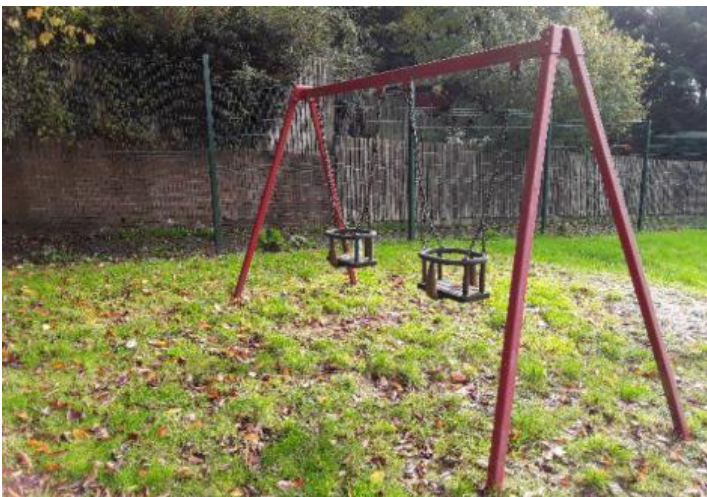
Item: Swings - 1 Bay 2 Seat (Cradle)
Manufacturer: S M P (Playgrounds Ltd)

Risk Level: V - Very Low Risk
Surface: Sand

Finding: The bushes are showing signs of wear

Action: Monitor for any further deterioration and replace as required

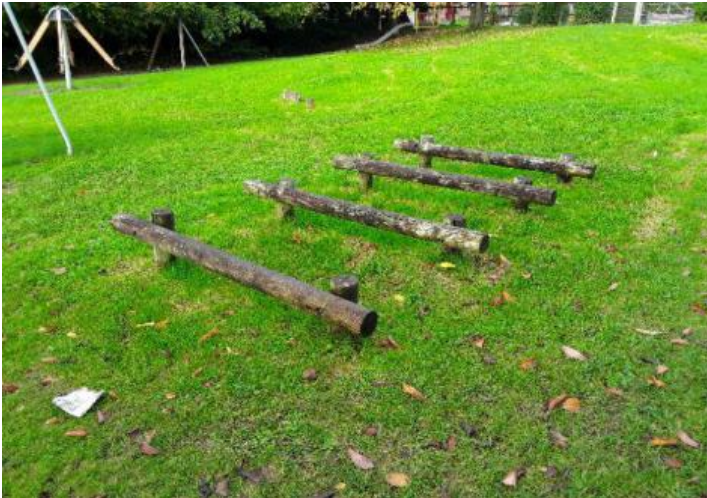
Item: Activity Equipment - Leap Frog
Manufacturer: Not Identified

Risk Level: V - Very Low Risk
Surface: Grass

Finding: There is/are bolt cap covers missing or damaged on the item

Action: Replace missing or damaged bolt cap covers

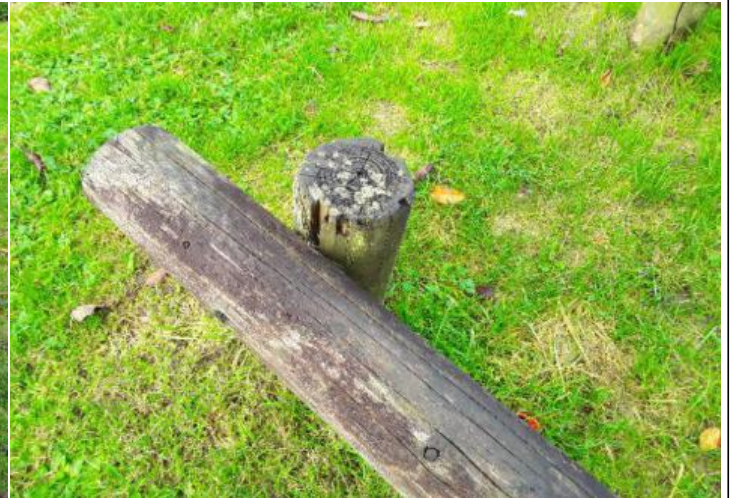
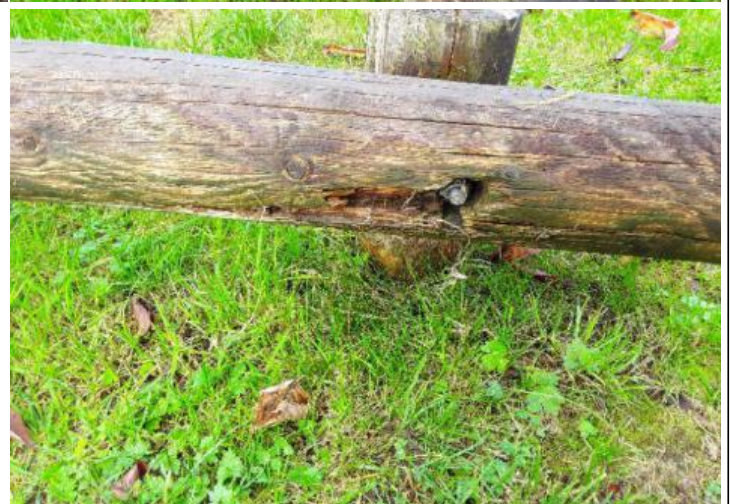
Item: Activity Equipment - Leap Frog
Manufacturer: Not Identified

Risk Level: L - Low Risk
Surface: Grass

Finding: Parts of the timber are rough or splintered

Action: Remove all rough or sharp edges

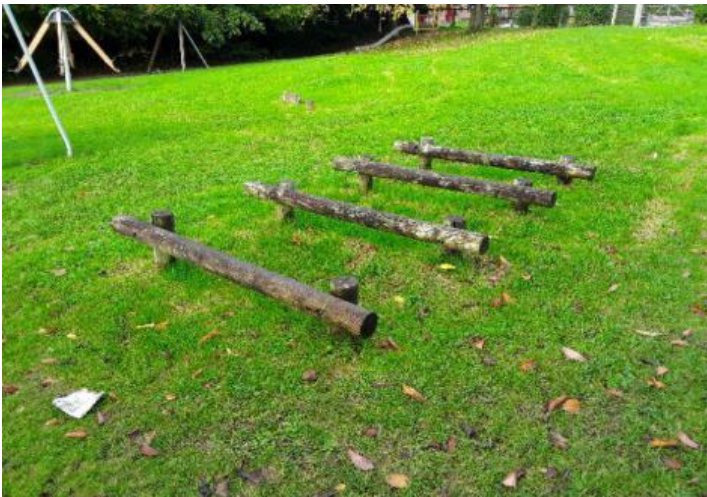
Item: Activity Equipment - Leap Frog
Manufacturer: Not Identified

Risk Level: L - Low Risk
Surface: Grass

Finding: There is some evidence of rot in the timber posts
Action: Monitor for any further deterioration and replace as required

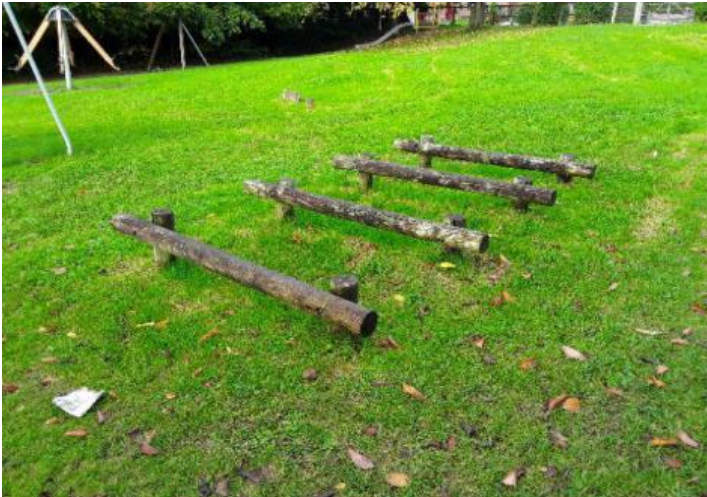
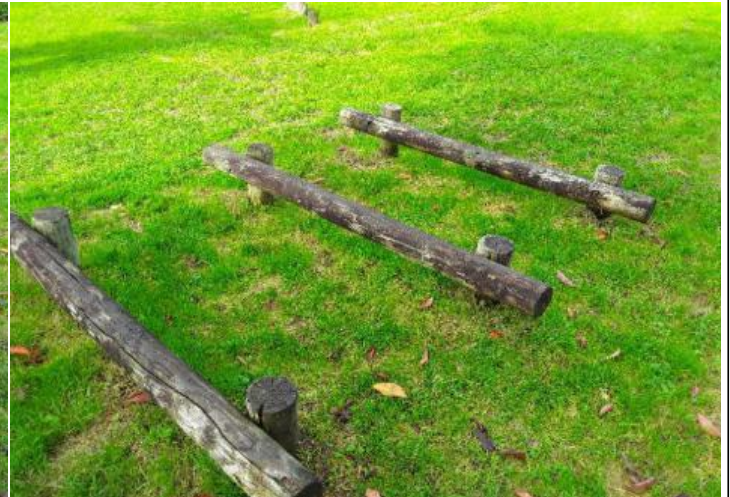
Item: Activity Equipment - Leap Frog
Manufacturer: Not Identified

Risk Level: L - Low Risk
Surface: Grass

Finding: There is algae or moss on the surface of the equipment

Action: Clean and treat appropriately

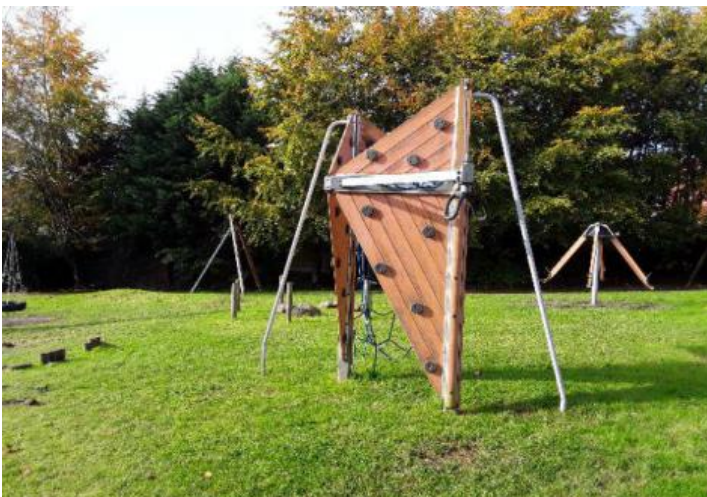
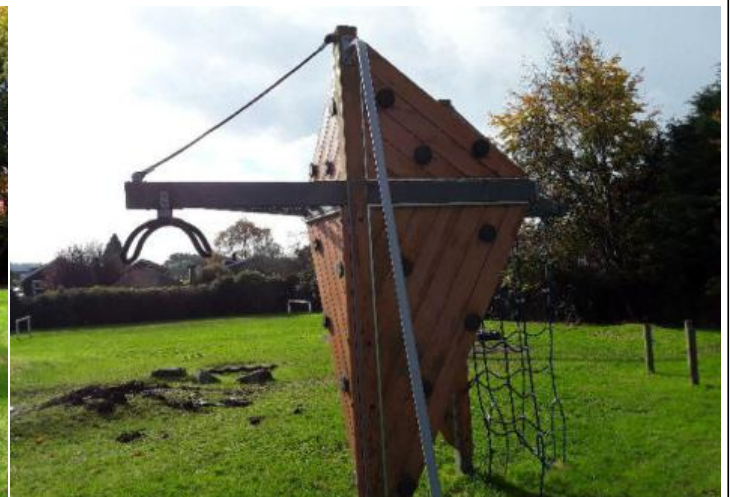
Item: Activity Equipment - Climbing Frame
Manufacturer: Lappset UK Ltd

Risk Level: L - Low Risk
Surface: Grass Matrix Tiles

Finding: This item of equipment has a fall height in excess of 2.5m and grass mats have been installed as an impact absorbing surface; these mats rely heavily on the underlying surface to achieve their critical fall height properties.

Action: Ensure surfacing certification is sought and consider HIC testing to ensure the surfacing is performing adequately

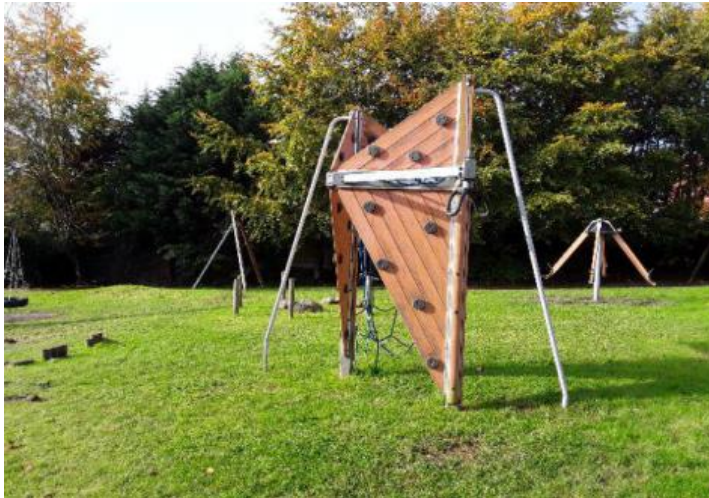
Item: Activity Equipment - Climbing Frame
Manufacturer: Lappset UK Ltd

Risk Level: V - Very Low Risk
Surface: Grass Matrix Tiles

Finding: There is/are inserts missing

Action: Replace missing inserts

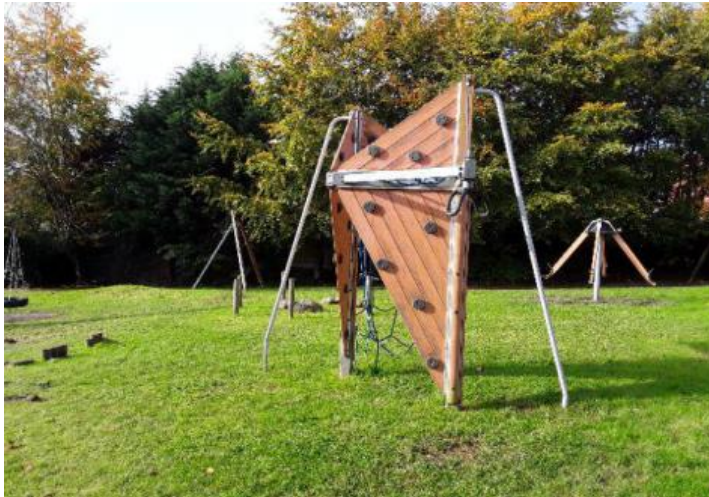
Item: Activity Equipment - Climbing Frame
Manufacturer: Lappset UK Ltd

Risk Level: L - Low Risk
Surface: Grass Matrix Tiles

Finding: There is some damage to the item

Action: Monitor for any further deterioration and repair as required

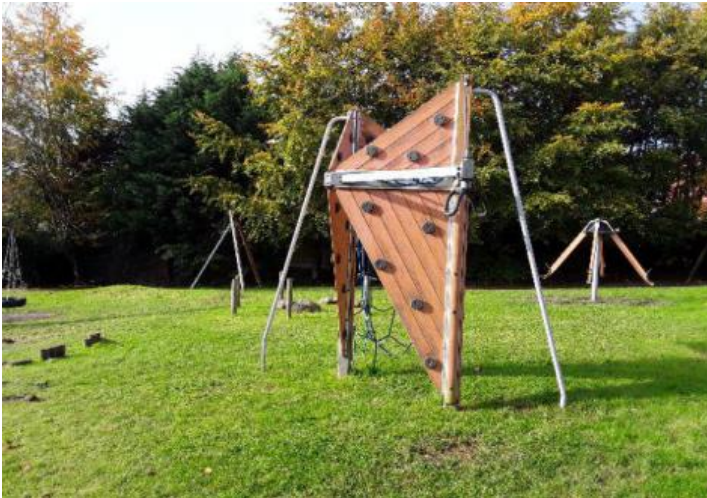
Item: Activity Equipment - Climbing Frame
Manufacturer: Lappset UK Ltd

Risk Level: L - Low Risk
Surface: Grass Matrix Tiles

Finding: There is some damage to the pole

Action: Monitor for any further deterioration and repair as required

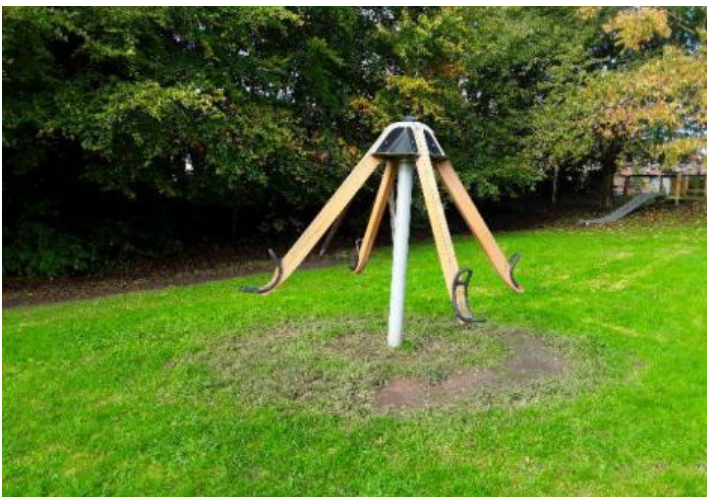
Item: Rotor Play - Carousel
Manufacturer: Lappset UK Ltd

Risk Level: L - Low Risk
Surface: Grass Matrix Tiles

Finding: The grass mats are silted up and the soil is compacted; this may have an effect on the impact absorbing properties of the surface

Action: Consider HIC testing impact absorbing properties to ensure the correct surface qualities are maintained for the equipment and replace as required

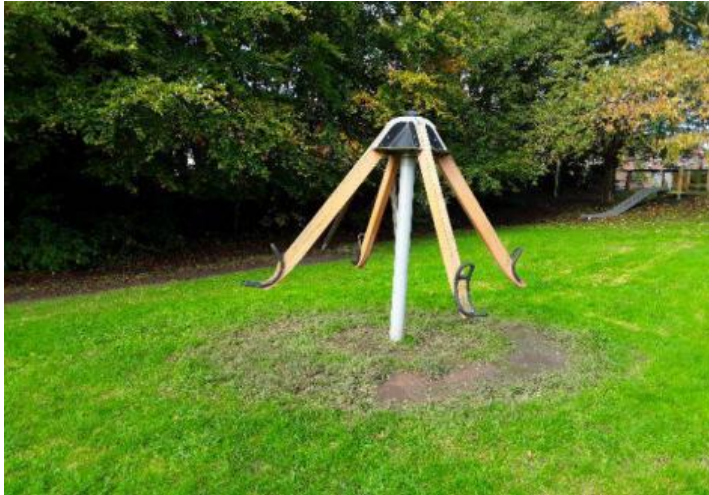
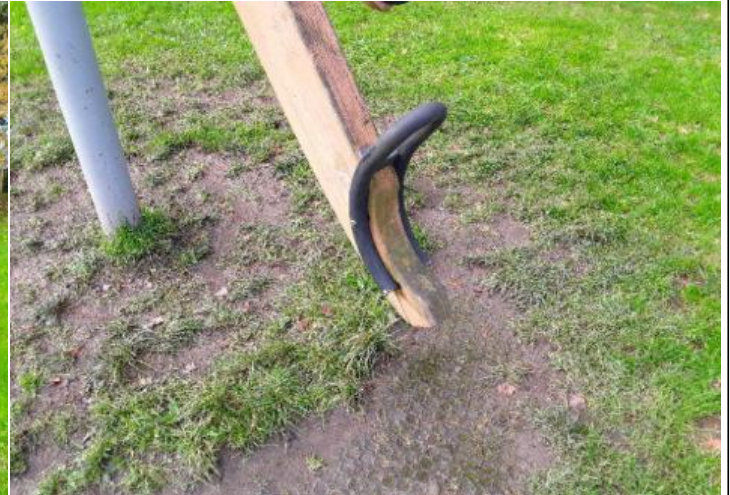
Item: Rotor Play - Carousel
Manufacturer: Lappset UK Ltd

Risk Level: M - Moderate Risk
Surface: Grass Matrix Tiles

Finding: The seat is severely damaged and requires replacing

Action: Replace damaged seat

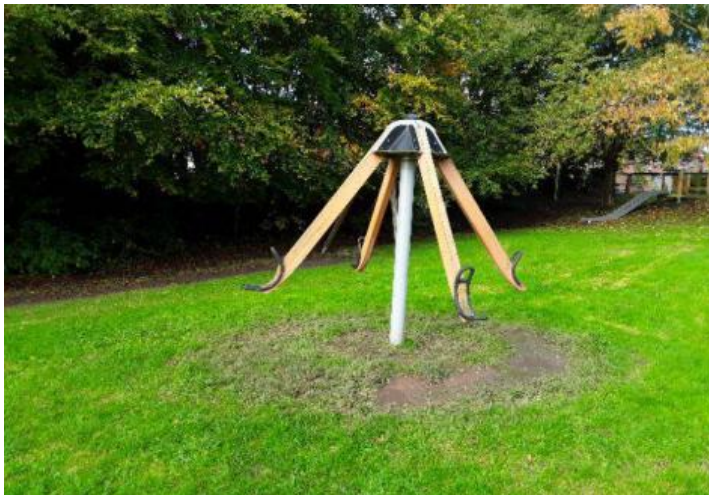
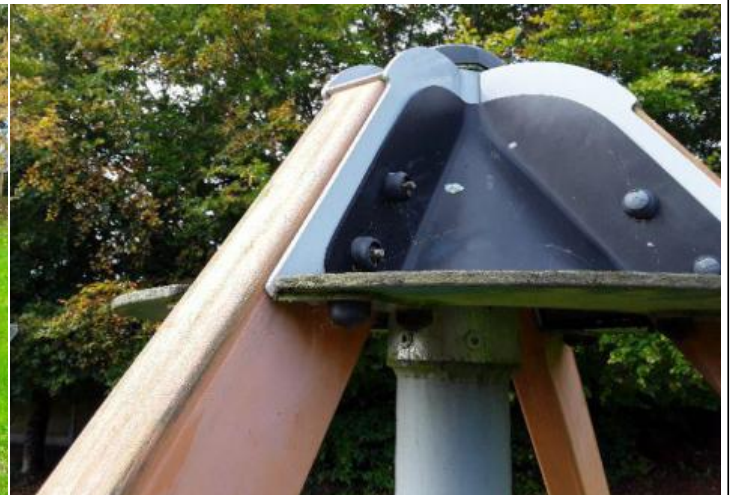
Item: Rotor Play - Carousel
Manufacturer: Lappset UK Ltd

Risk Level: V - Very Low Risk
Surface: Grass Matrix Tiles

Finding: There is/are bolt cap covers missing or damaged on the item

Action: Replace missing or damaged bolt cap covers

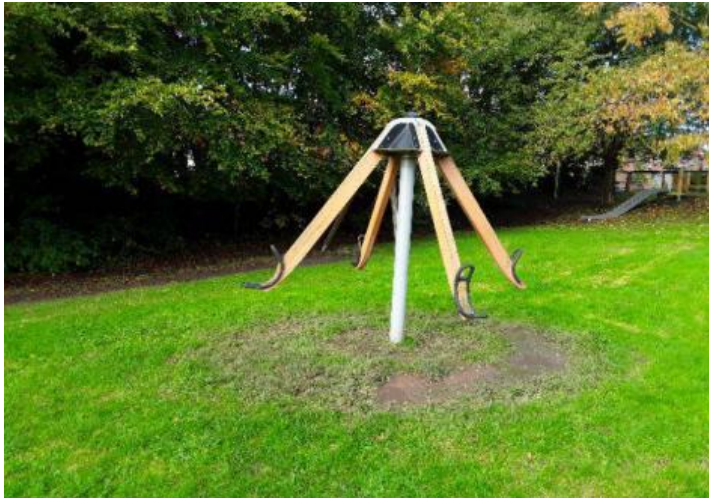
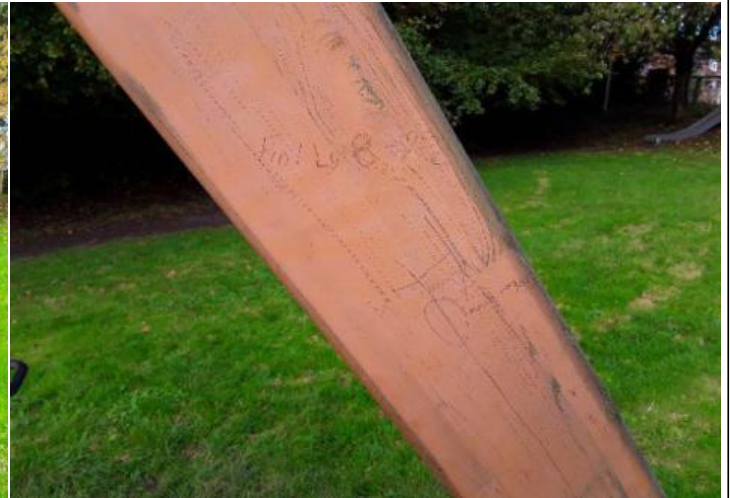
Item: Rotor Play - Carousel
Manufacturer: Lappset UK Ltd

Risk Level: N - Risk Assessment not Undertaken
Surface: Grass Matrix Tiles

Finding: There is offensive graffiti present

Action: Remove as soon as practicable

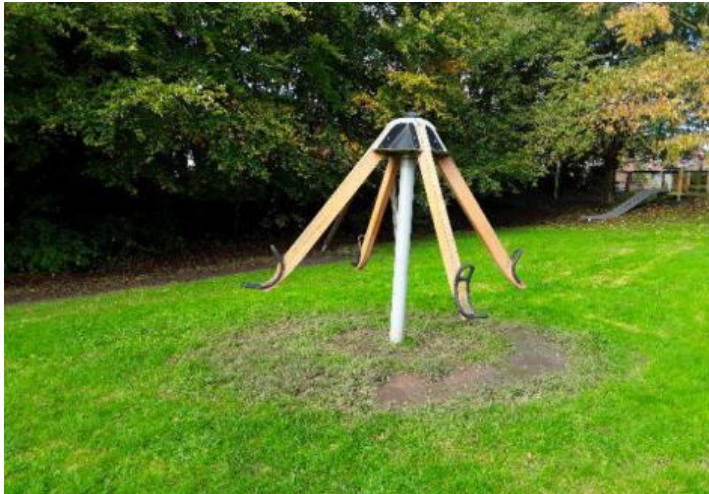
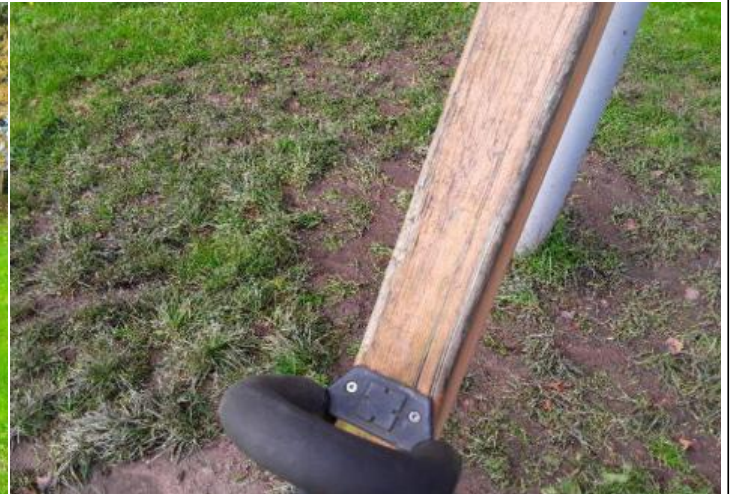
Item: Rotor Play - Carousel
Manufacturer: Lappset UK Ltd

Risk Level: L - Low Risk
Surface: Grass Matrix Tiles

Finding: Parts of the timber are rough or splintered

Action: Remove all rough or sharp edges

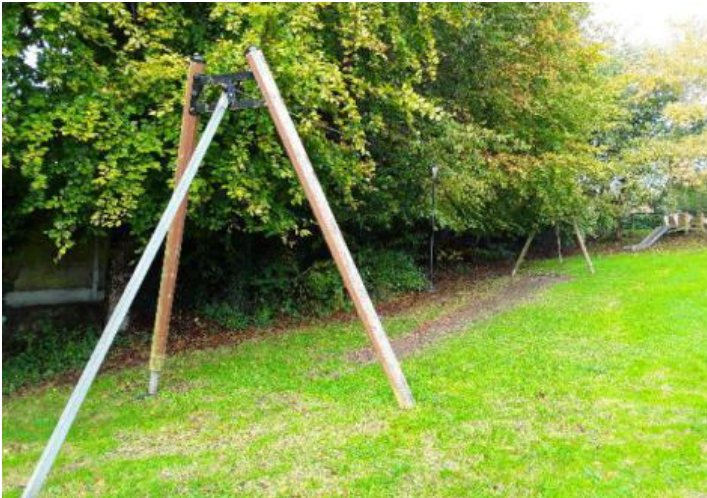
Item: Other - Cable Runway
Manufacturer: Lappset UK Ltd

Risk Level: N - Risk Assessment not Undertaken
Surface: Grass Matrix Tiles

Finding: We have completed a visual inspection of the suspension links, cable and fixing points from ground level, however it is not possible to fully inspect these areas without either hiring equipment to gain access or removing the cable and suspension and inspecting at ground level. We recommend that the main cable and fixing security is thoroughly inspected at least in accordance with the manufacturers recommendations to check for wear, damage, security or internal rusting; this will help to ensure the continued safe use of the equipment

Action: Inspect in accordance with the manufacturers recommendations

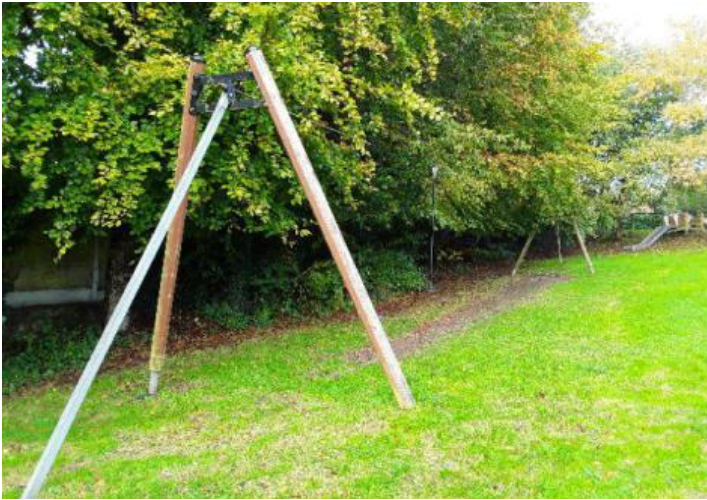
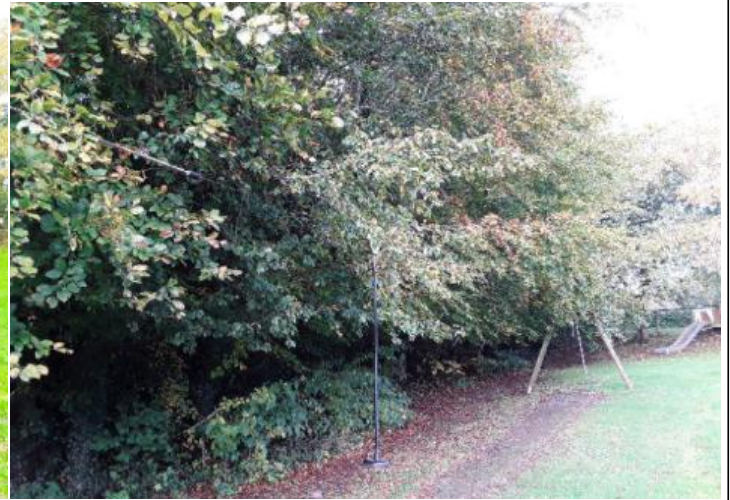
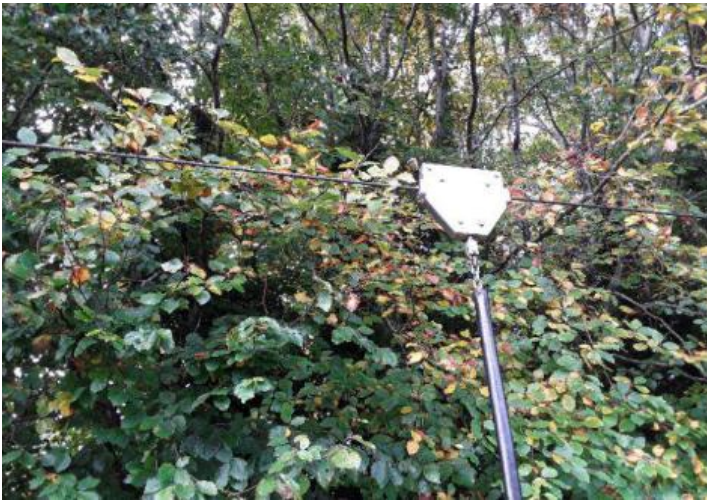
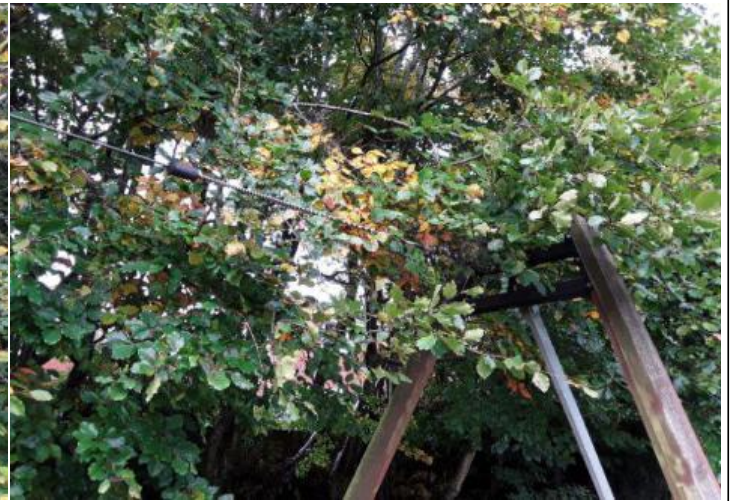
Item: Other - Cable Runway
Manufacturer: Lappset UK Ltd

Risk Level: L - Low Risk
Surface: Grass Matrix Tiles

Finding: The tree canopy overhangs the equipment and is less than 2.0m away and the cable is not obstruction free

Action: Lift tree canopy to ensure a minimum clearance of 2.0m from the equipment

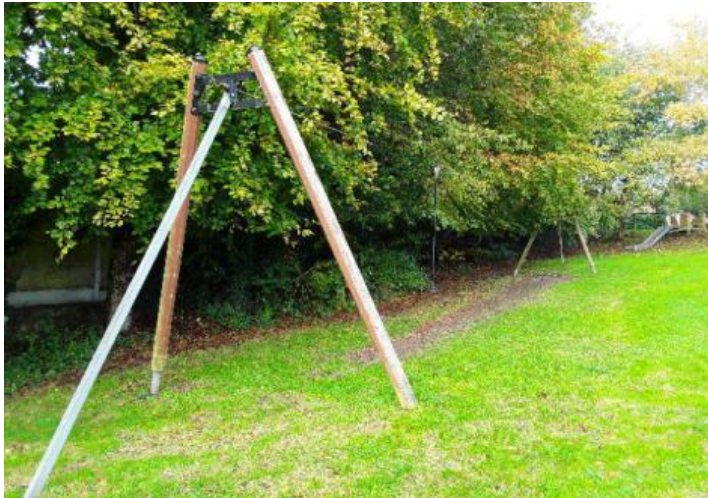
Item: Other - Cable Runway
Manufacturer: Lappset UK Ltd

Risk Level: L - Low Risk
Surface: Grass Matrix Tiles

Finding: There is some strimmer / machinery damage apparent on the posts, this can penetrate the preservative applied to the timber and accelerate the rotting process

Action: Monitor for any deterioration (rot) and replace as required

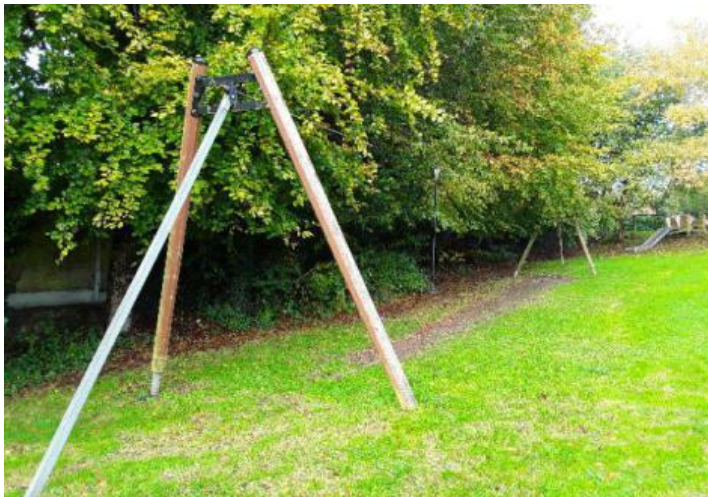
Item: Other - Cable Runway
Manufacturer: Lappset UK Ltd

Risk Level: L - Low Risk
Surface: Grass Matrix Tiles

Finding: The grass mats are silted up and the soil is compacted; this may have an effect on the impact absorbing properties of the surface

Action: Consider HIC testing impact absorbing properties to ensure the correct surface qualities are maintained for the equipment and replace as required

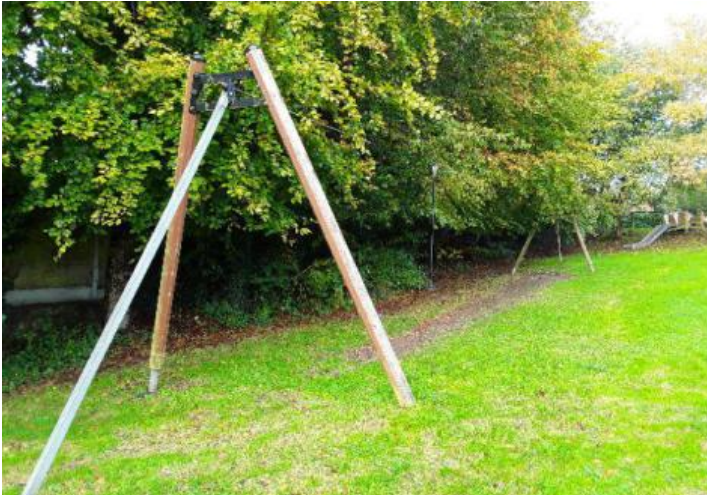
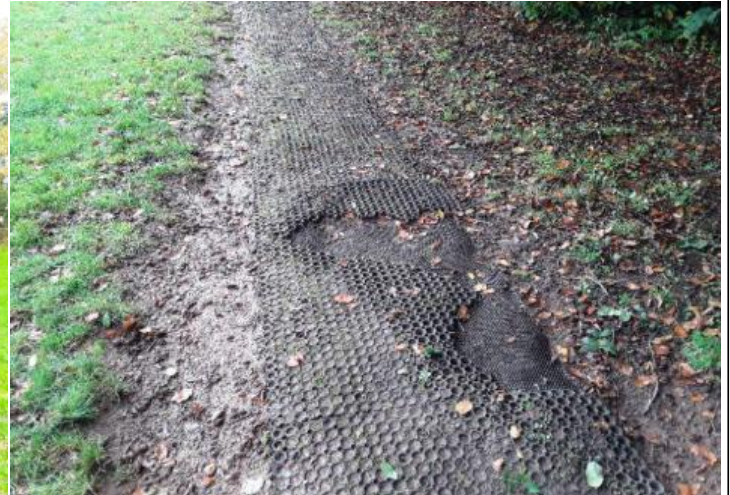
Item: Other - Cable Runway
Manufacturer: Lappset UK Ltd

Risk Level: M - Moderate Risk
Surface: Grass Matrix Tiles

Finding: The surfacing is severely damaged

Action: Replace damaged areas of surfacing

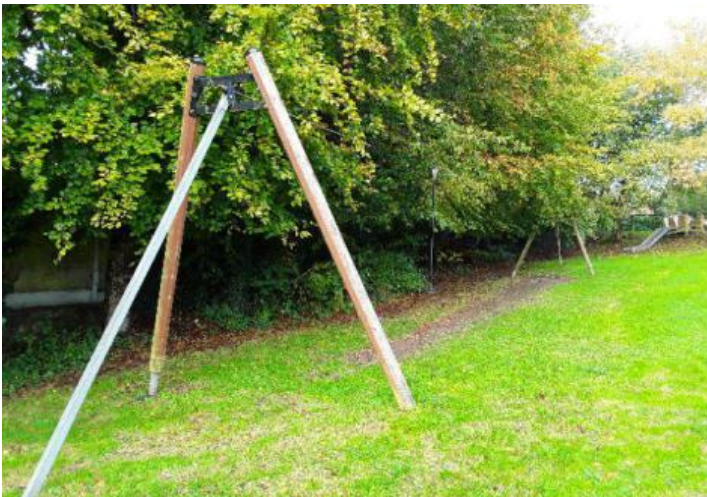
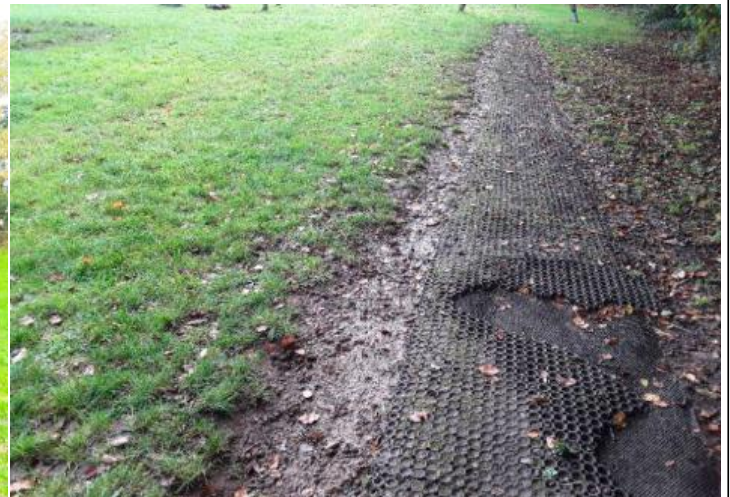
Item: Other - Cable Runway
Manufacturer: Lappset UK Ltd

Risk Level: L - Low Risk
Surface: Grass Matrix Tiles

Finding: The grass has eroded within the impact area of the equipment and may not provide the necessary impact attenuating properties for the equipment fall height; the surface may also be slippery in wet weather

Action: Reinstate the grass or provide an all weather surface

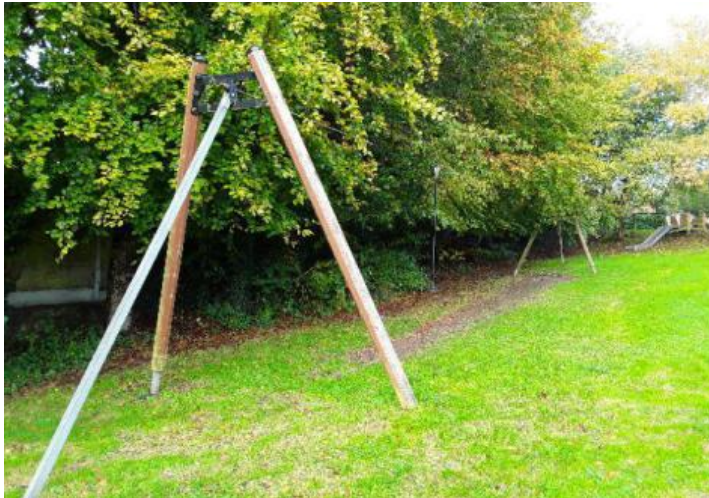
Item: Other - Cable Runway
Manufacturer: Lappset UK Ltd

Risk Level: L - Low Risk
Surface: Grass Matrix Tiles

Finding: The dampening spring or tyre is damaged or broken on the item

Action: Replace spring or tyre

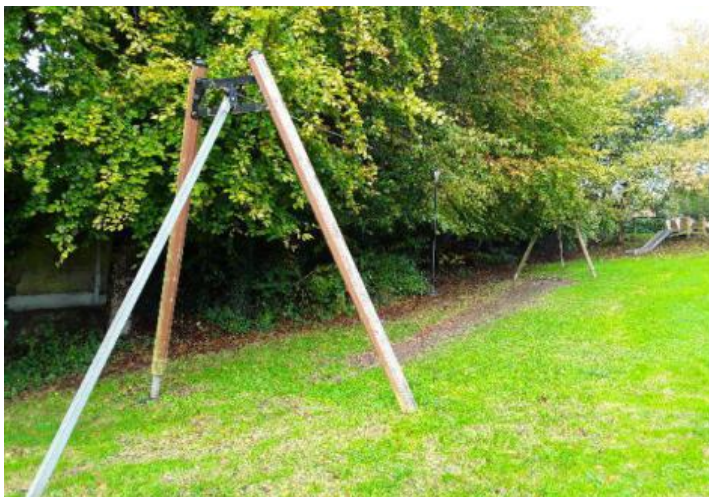
Item: Other - Cable Runway
Manufacturer: Lappset UK Ltd

Risk Level: L - Low Risk
Surface: Grass Matrix Tiles

Finding: The fixings are corroding

Action: Monitor for any further deterioration and replace as required

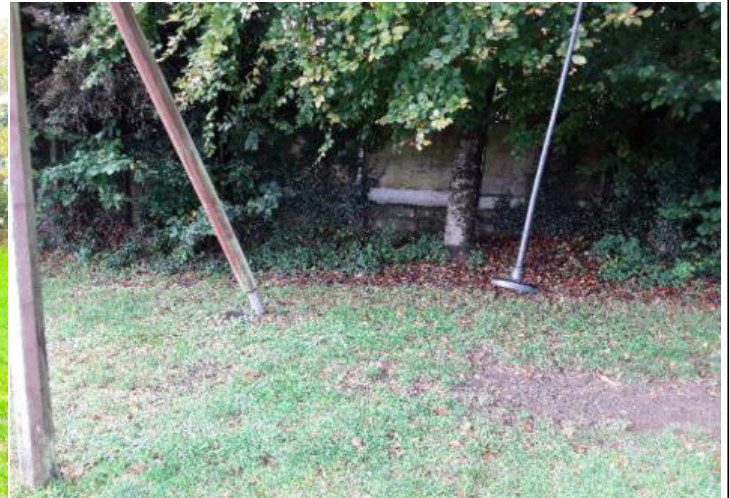
Item: Other - Cable Runway
Manufacturer: Lappset UK Ltd

Risk Level: L - Low Risk
Surface: Grass Matrix Tiles

Finding: The seat is less than 2.0 metres from the post when extended at 45 degrees at the end of the area of travel and does not meet the requirements of BS EN 1176 Part 4

Action: Adjust the cable stop position to ensure the minimum distance is maintained

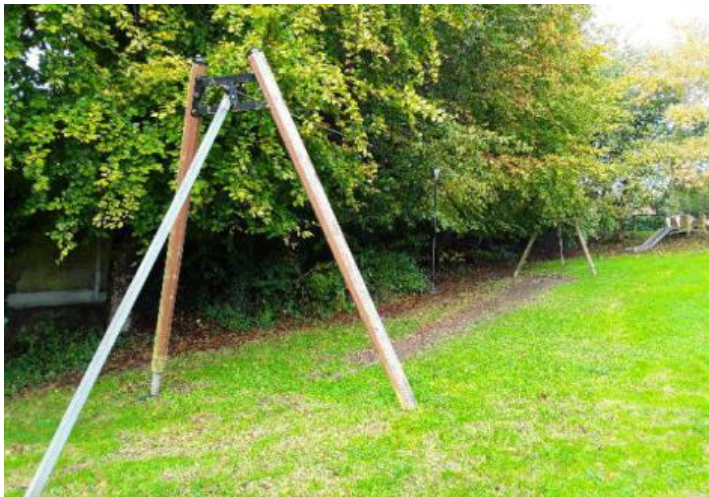
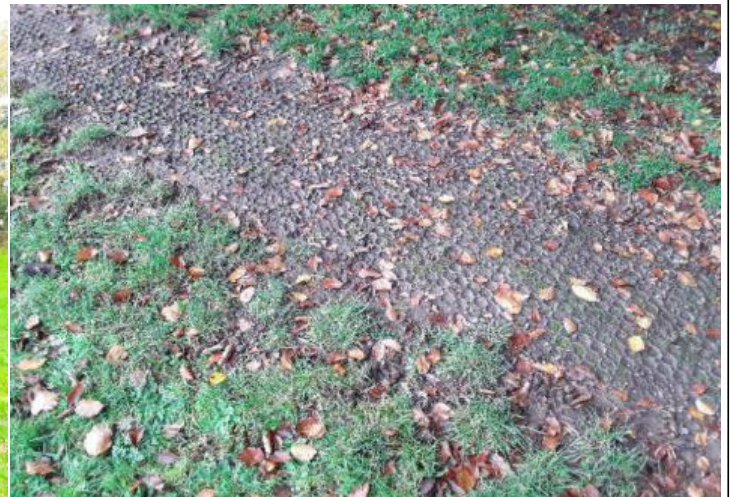
Item: Other - Cable Runway
Manufacturer: Lappset UK Ltd

Risk Level: V - Very Low Risk
Surface: Grass Matrix Tiles

Finding: Fixing Pins have been installed in the impact areas of the grass mats

Action: Remove pins from impact areas

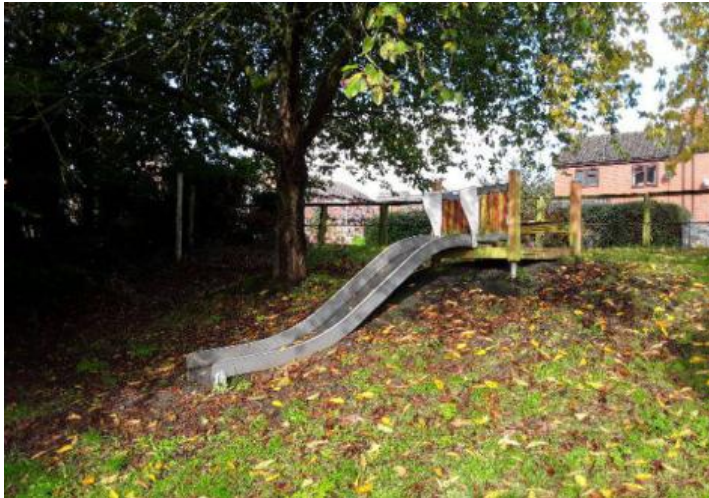
Item: Other - Embankment Slide
Manufacturer: Lappset UK Ltd

Risk Level: L - Low Risk
Surface: Grass Matrix Tiles

Finding: The grass mats are silted up and the soil is compacted; this may have an effect on the impact absorbing properties of the surface

Action: Consider HIC testing impact absorbing properties to ensure the correct surface qualities are maintained for the equipment and replace as required

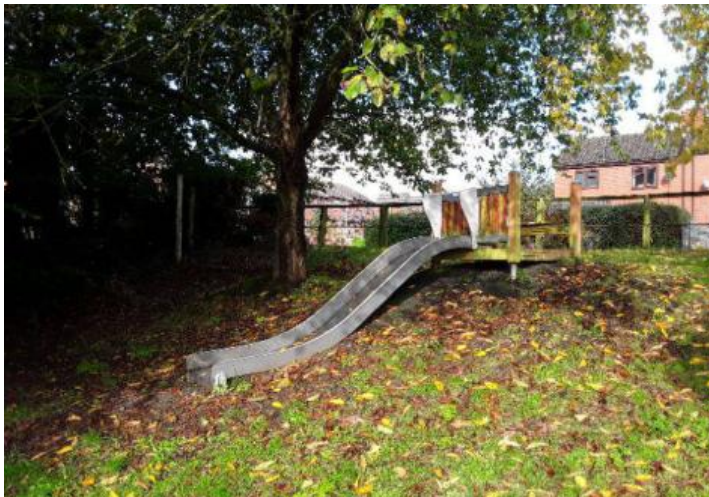
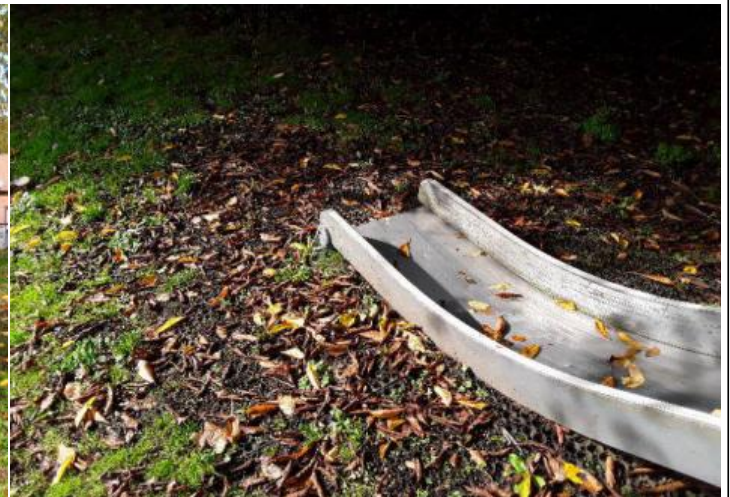
Item: Other - Embankment Slide
Manufacturer: Lappset UK Ltd

Risk Level: L - Low Risk
Surface: Grass Matrix Tiles

Finding: There is some tree debris on the surfacing

Action: Remove and maintain
