Annual Inspection

Shropshire Council

Tollgate Road Play Area

Tollgate Road, Ludlow, SY8 1TQ

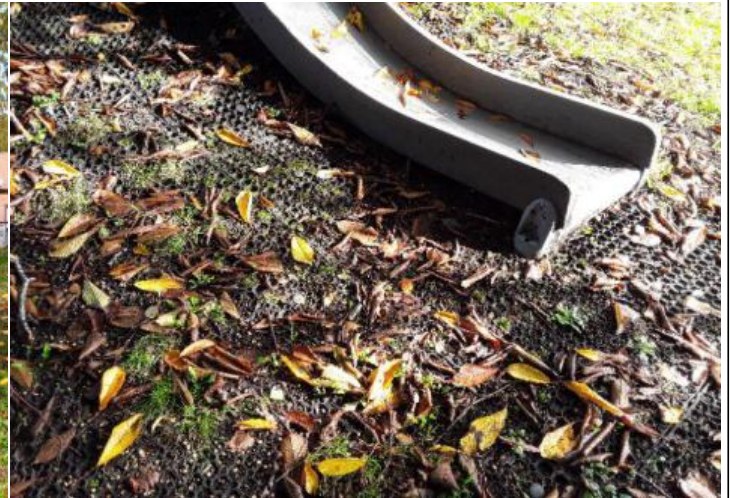
Item: Other - Embankment Slide
Manufacturer: Lappset UK Ltd

Risk Level: V - Very Low Risk
Surface: Grass Matrix Tiles

Finding: Fixing Pins have been installed in the impact areas of the grass mats **Action:** Remove pins from impact areas

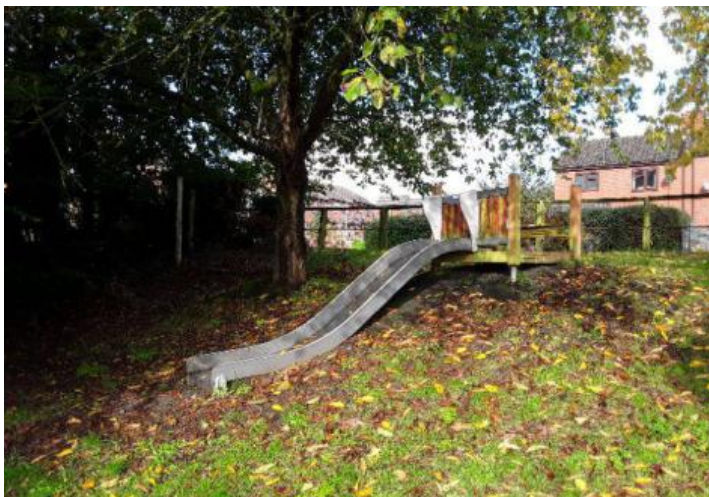
i 8 - Low Risk (Finding 4)

Item: Other - Embankment Slide
Manufacturer: Lappset UK Ltd

Risk Level: L - Low Risk
Surface: Grass Matrix Tiles

Finding: There is moderate damage to the surface **Action:** Replace the damaged areas of surfacing

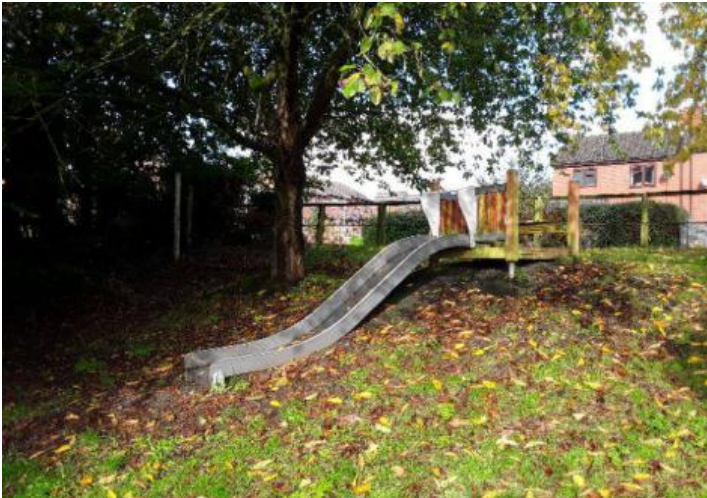
i 4 - Very Low Risk (Finding 5)

Item: Other - Embankment Slide
Manufacturer: Lappset UK Ltd

Risk Level: V - Very Low Risk
Surface: Grass Matrix Tiles

Finding: There are a number of dents in the slide surface

Action: Monitor for any further deterioration and repair as required

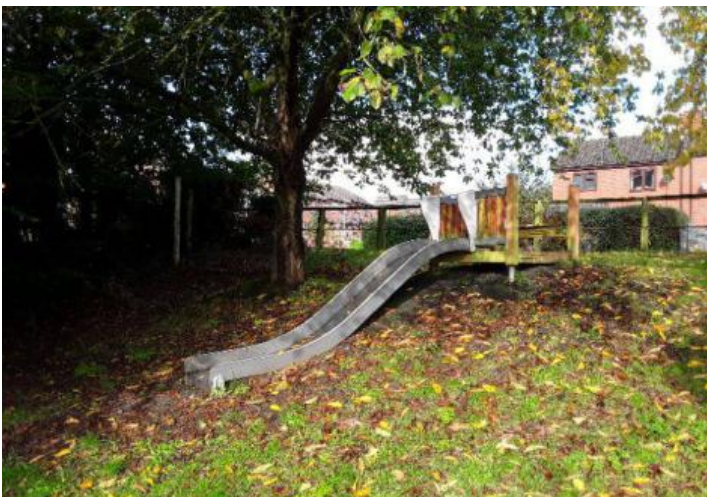
Item: Other - Embankment Slide
Manufacturer: Lappset UK Ltd

Risk Level: L - Low Risk
Surface: Grass Matrix Tiles

Finding: The side of the slide is damaged

Action: Monitor for any further deterioration and repair as required

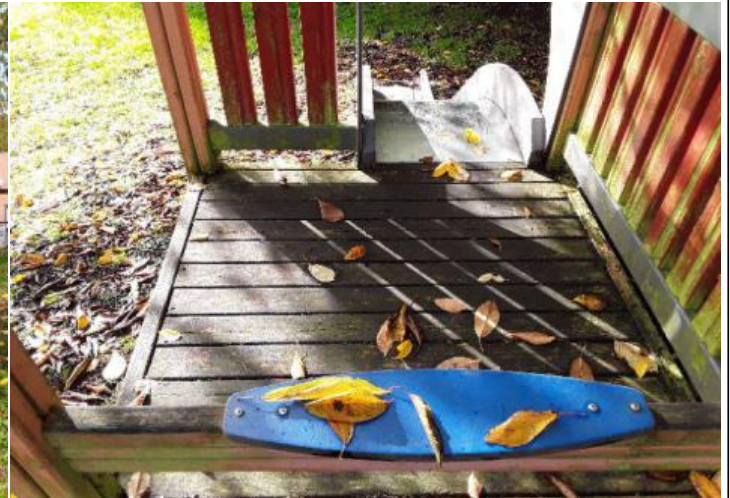
Item: Other - Embankment Slide
Manufacturer: Lappset UK Ltd

Risk Level: L - Low Risk
Surface: Grass Matrix Tiles

Finding: There is algae or moss on the surface of the equipment

Action: Clean and treat appropriately

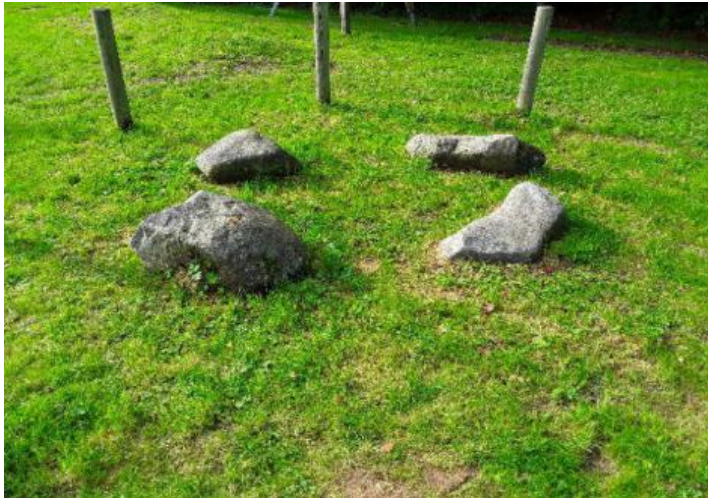
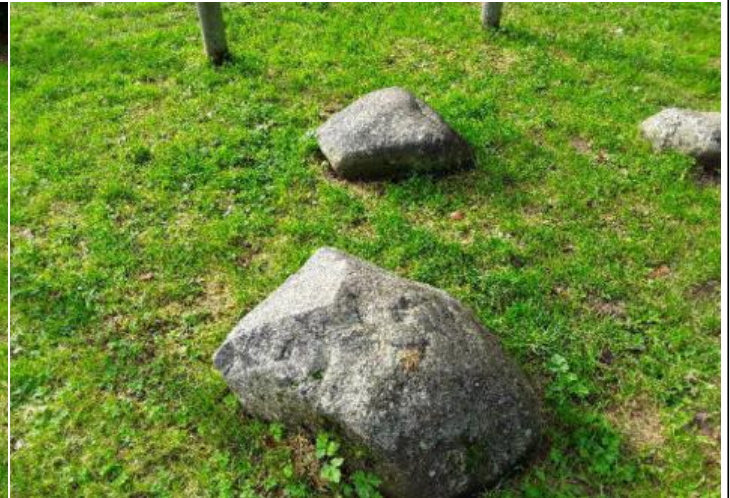
Item: Other - Boulders
Manufacturer: Natural Feature

Risk Level: L - Low Risk
Surface: Grass

Finding: The rocks and/or boulders have moss/algae growth apparent

Action: Clean and maintain

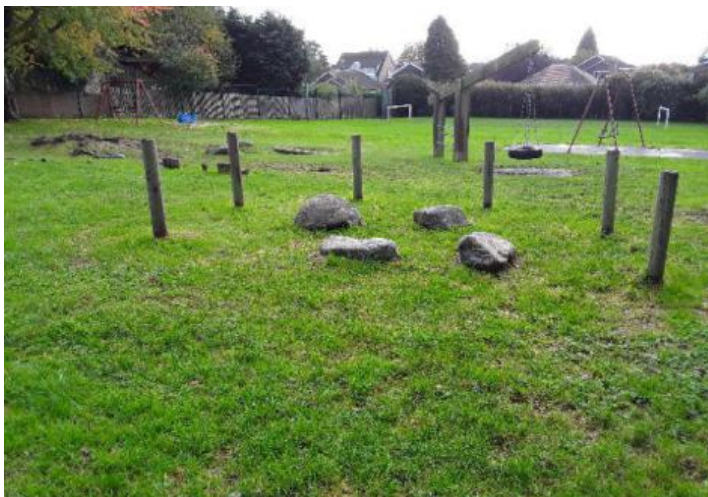
Item: Gates - Posts
Manufacturer: Owner/Operator

Risk Level: L - Low Risk
Surface: Grass

Finding: There are areas or parts of the timber on the structure that have rotted

Action: Replace all affected timbers

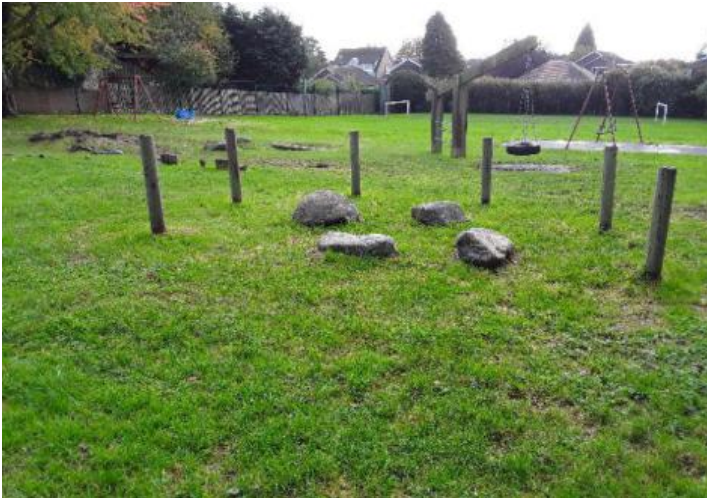
Item: Gates - Posts
Manufacturer: Owner/Operator

Risk Level: L - Low Risk
Surface: Grass

Finding: There is some strimmer / machinery damage apparent on the posts, this can penetrate the preservative applied to the timber and accelerate the rotting process

Action: Monitor for any deterioration (rot) and replace as required

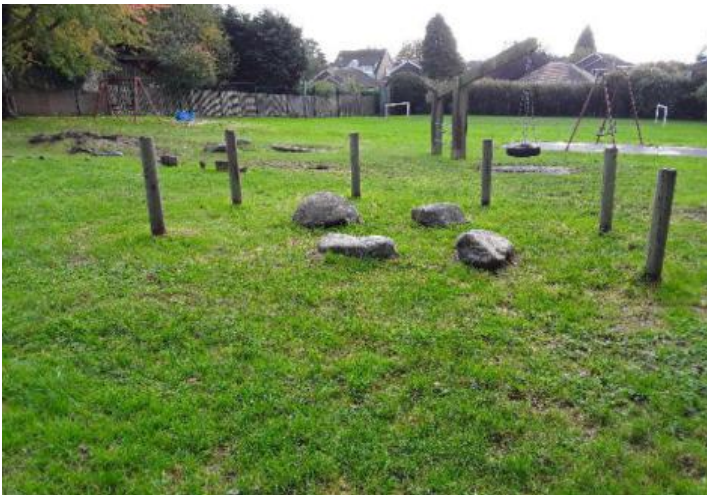
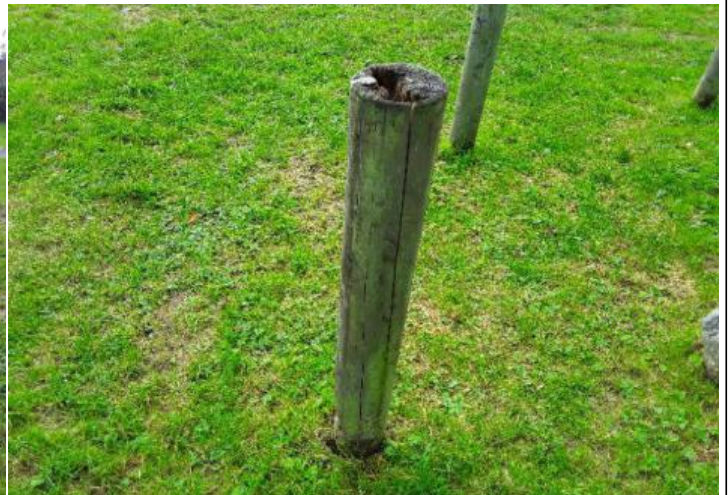
Item: Gates - Posts
Manufacturer: Owner/Operator

Risk Level: L - Low Risk
Surface: Grass

Finding: The timber has a number of splits/shakes or air cracks and this may affect the stability or allow water ingress which will accelerate the rotting process

Action: Monitor to ensure the splits do not cross through fixing points of the structure and/or cause any instability

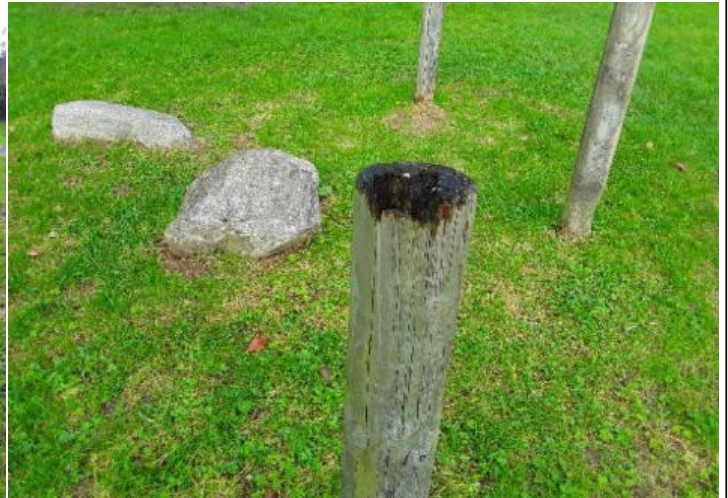
Item: Gates - Posts
Manufacturer: Owner/Operator

Risk Level: L - Low Risk
Surface: Grass

Finding: Parts of the timber are rough or splintered

Action: Remove all rough or sharp edges

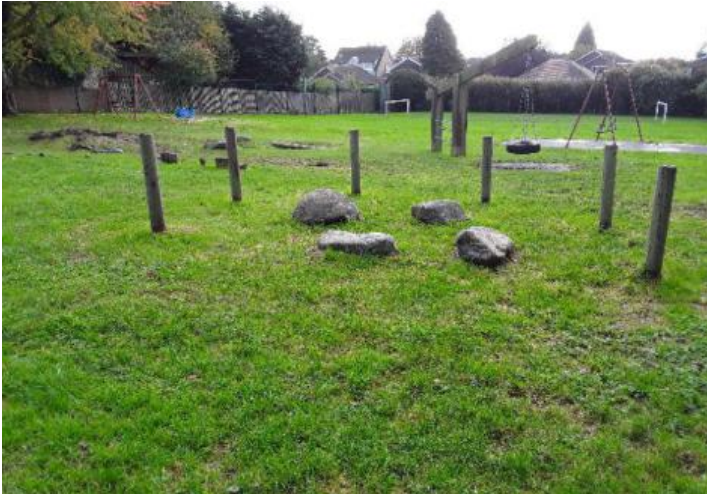
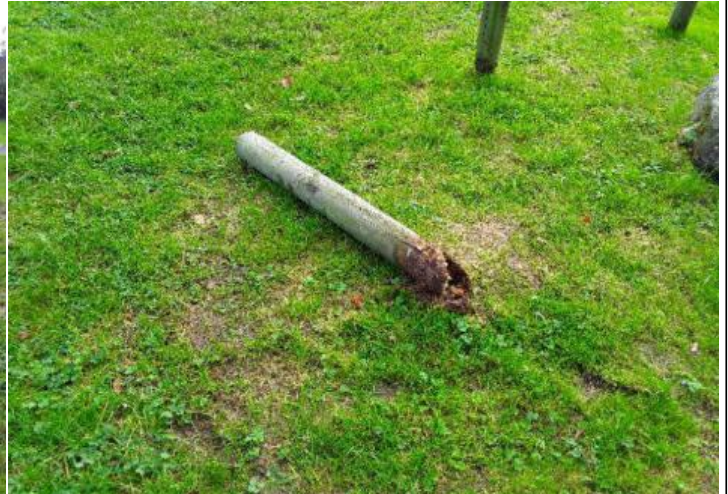
Item: Gates - Posts
Manufacturer: Owner/Operator

Risk Level: M - Moderate Risk
Surface: Grass

Finding: There are areas or parts of the timber post that have rotted and failed under testing

Action: Replace all affected timbers and remove damaged timber from site
