T21023/23/001

STRUCTURAL INSPECTION

**Whitchurch Civic Centre
High Street
Whitchurch
Shropshire
SY13 1AX**

Shropshire Council

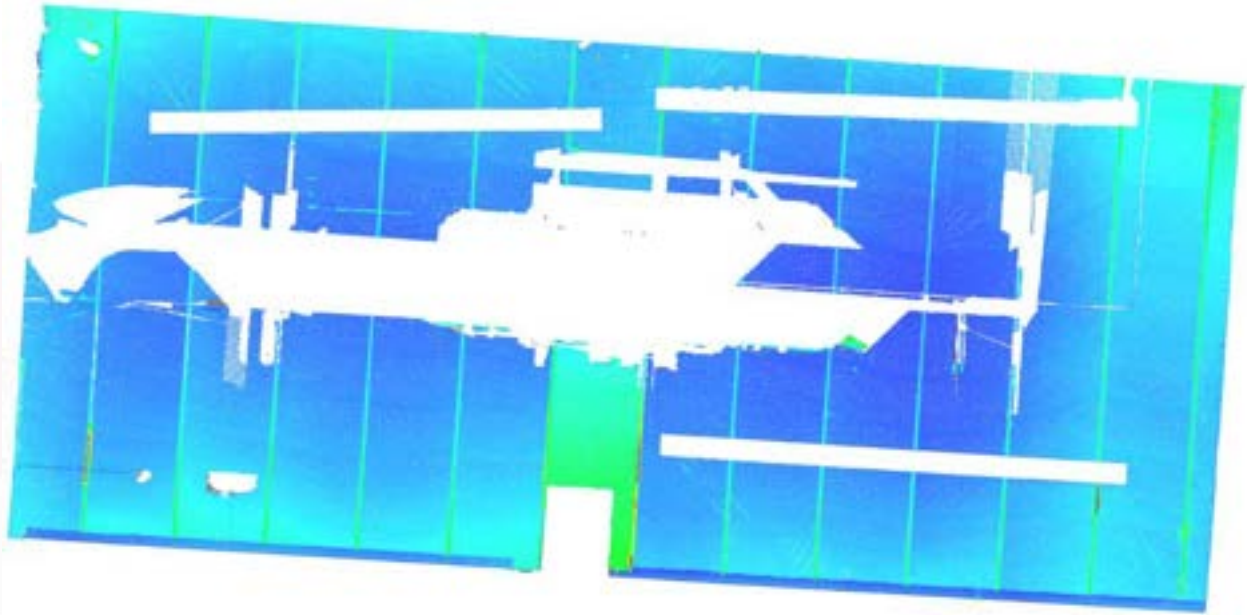
Figure 6 deviation from plane in garage.

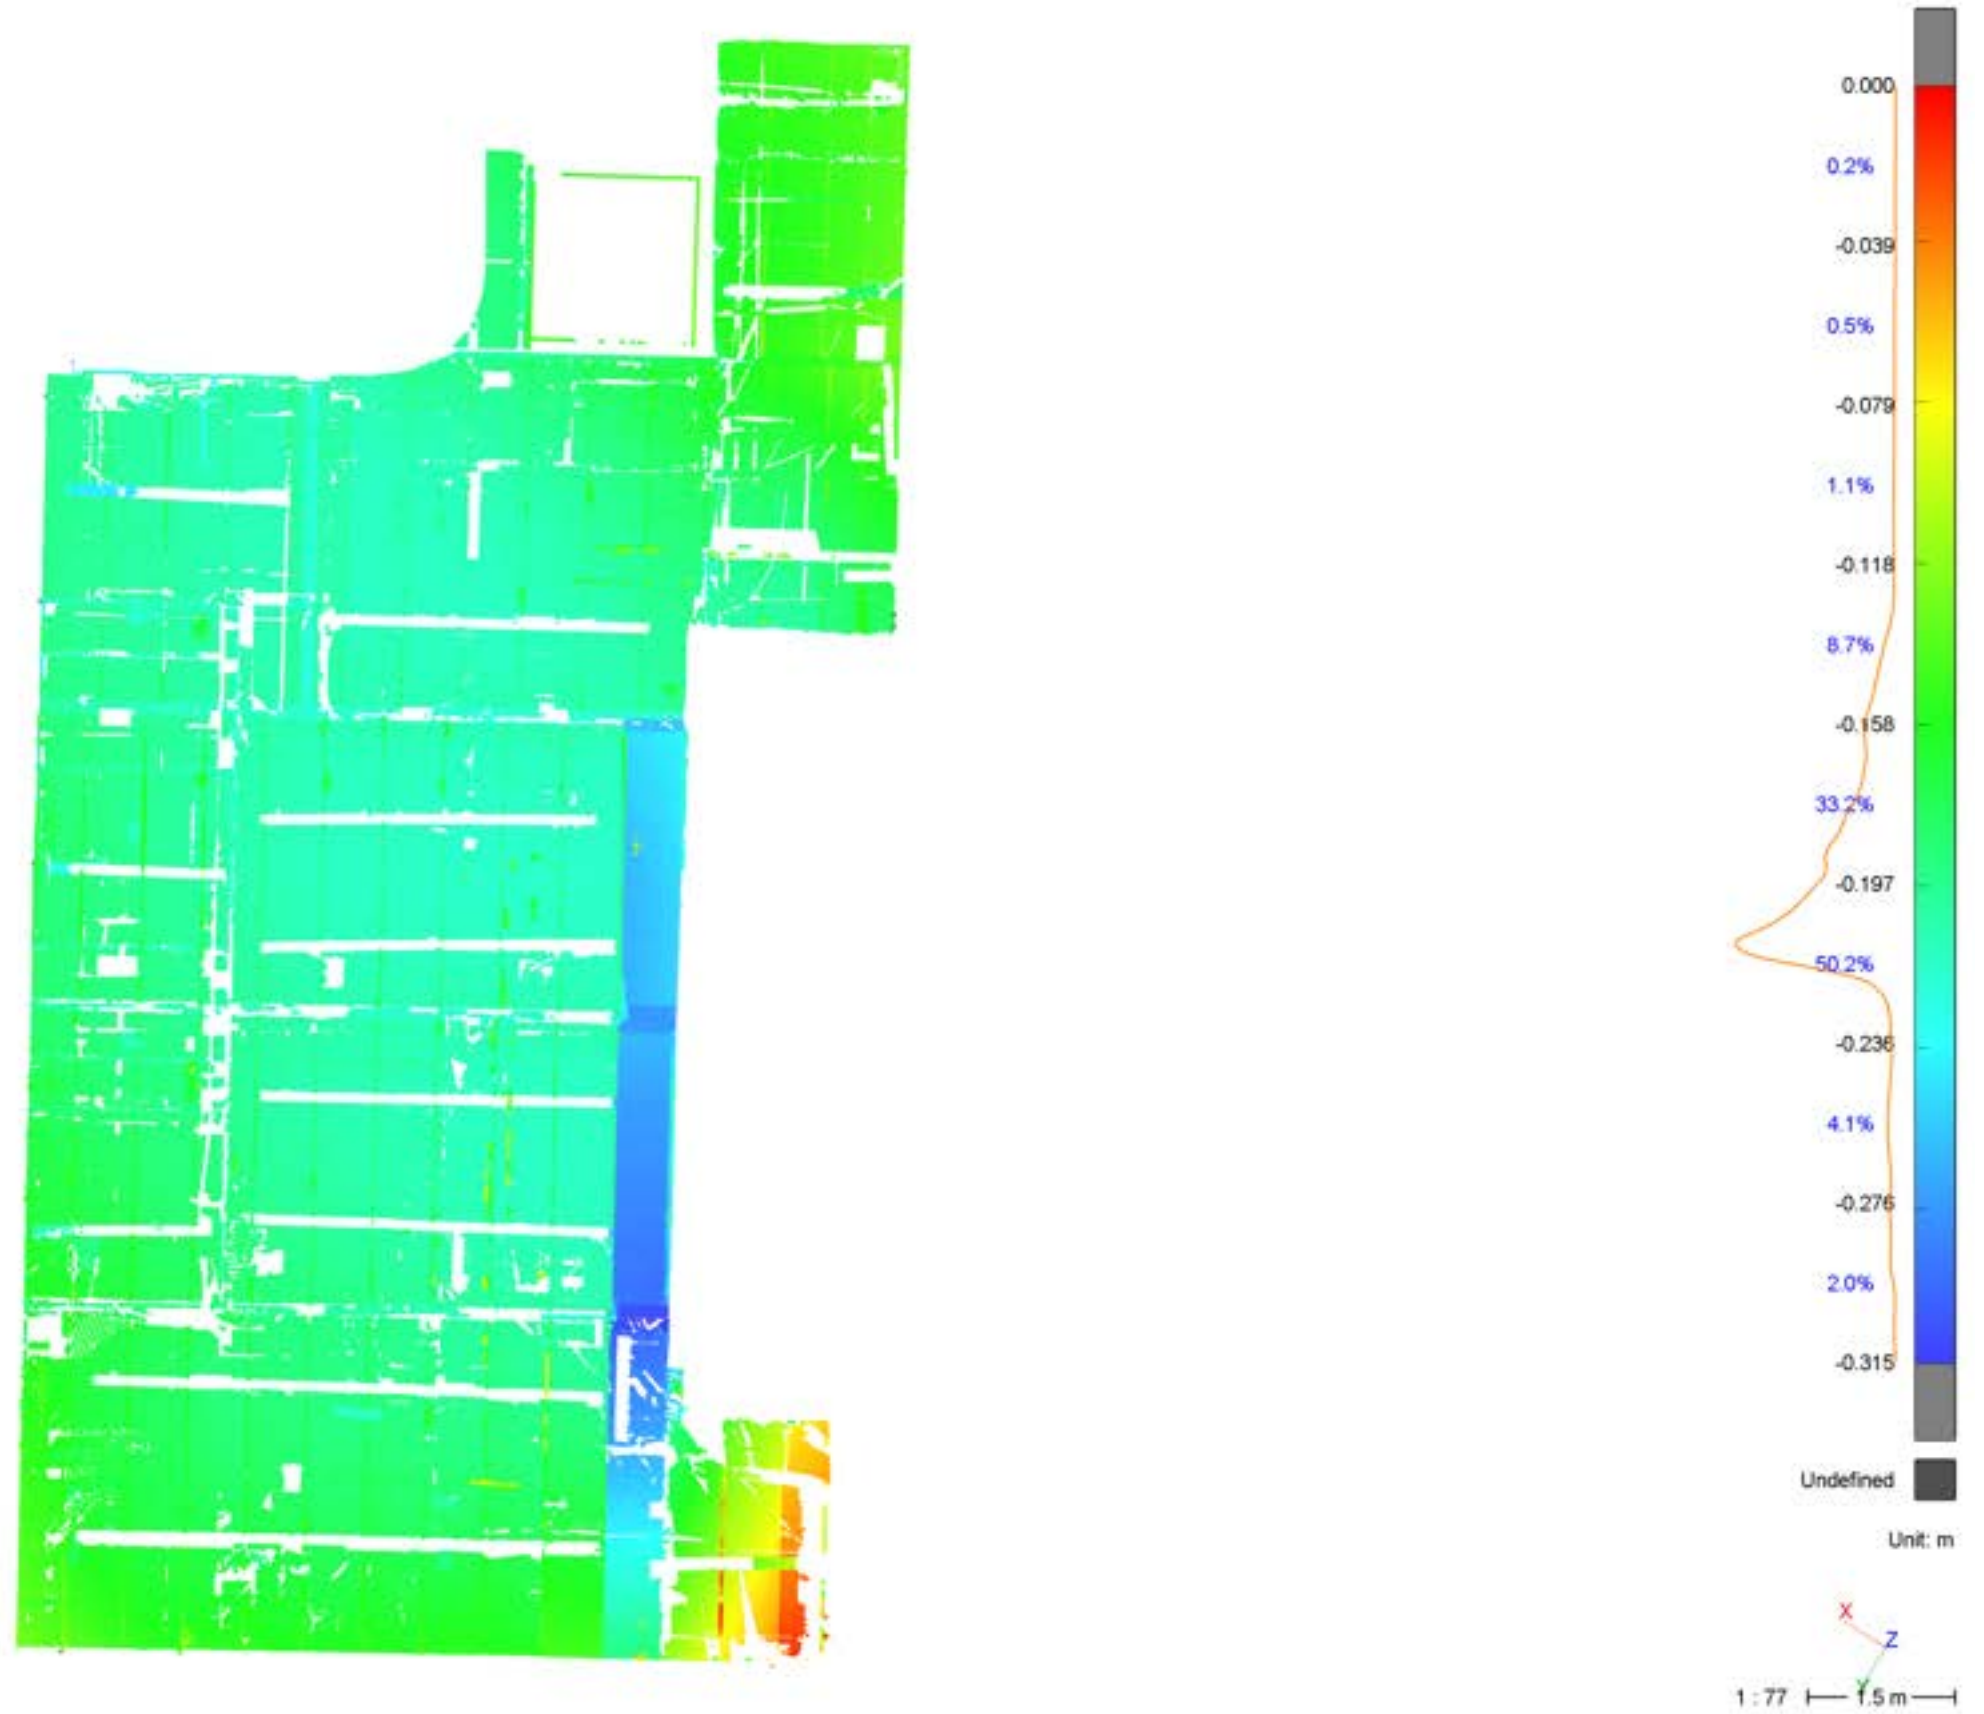
Deviation From Plane - Ground Floor, Library

The imaging shows that there is a general fall from the external wall towards the library. This also shows that there are large deviations between panels of 20mm. There is greater deflection in the RAAC panels either side of the roof lights. The lower area is coloured green, it is in these areas that the RAAC panels have longitudinal cracking to the sides of the roof light.
