Whitchurch Swimming Centre

Building Surveyor's Inspection Report

Shropshire Council

9th April 2021

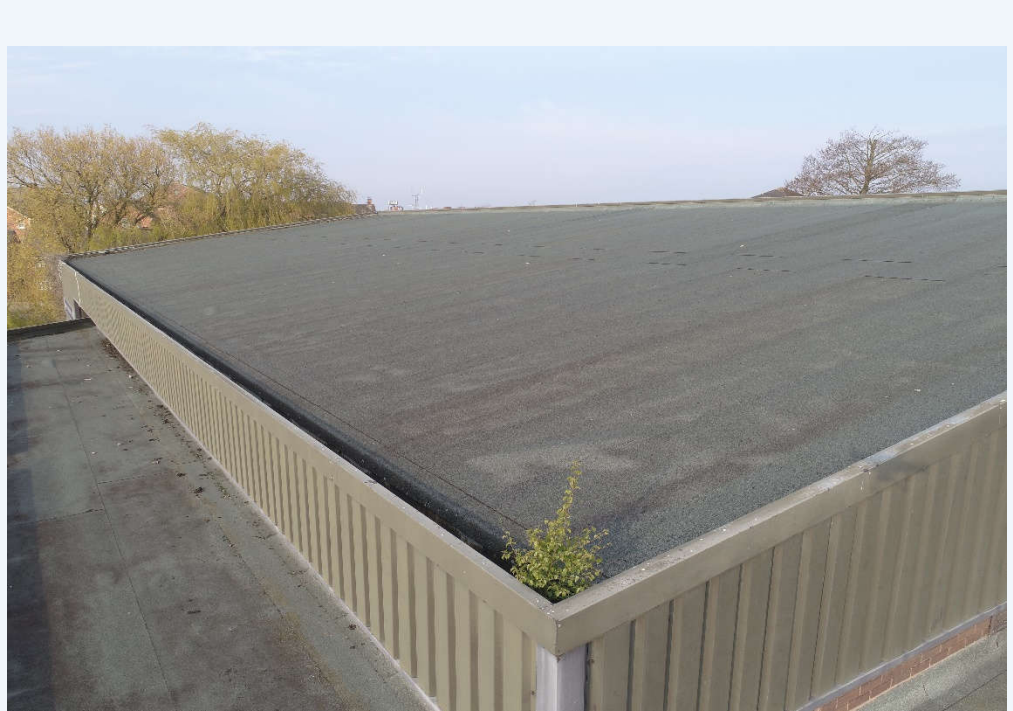
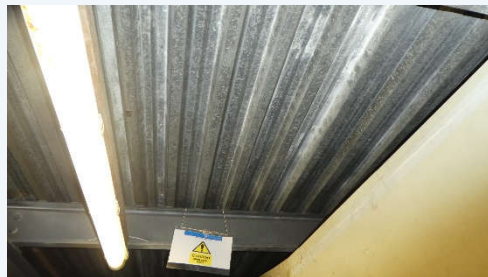
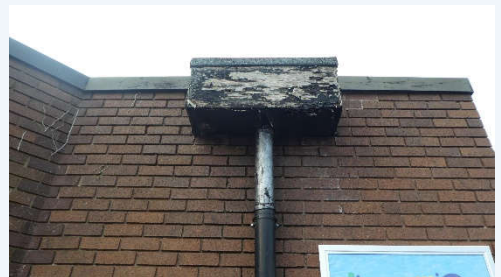
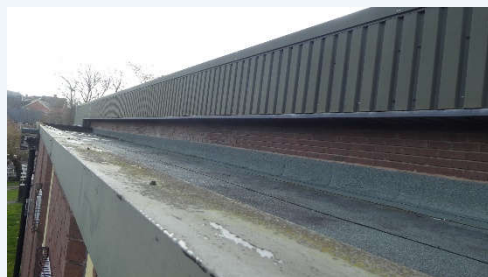
8.1 Roofs and Rainwater Disposal

i)	Further investigation to woodwool slab and thermal imaging survey recommended.	Medium
ii)	Historic leaking and stains evident to metal profiled roof.	Low
iii)	Roof covering replacement required in both the medium and long term.	Medium
iv)	Corrosion and delamination of metal parapet capping's.	Medium
v)	Rainwater hoppers failed and system should be cleaned throughout.	Low
vi)	Temporary repairs evident to SVP / pipework penetrations.	Low
vii)	Access for cleaning and maintenance difficult.	Low

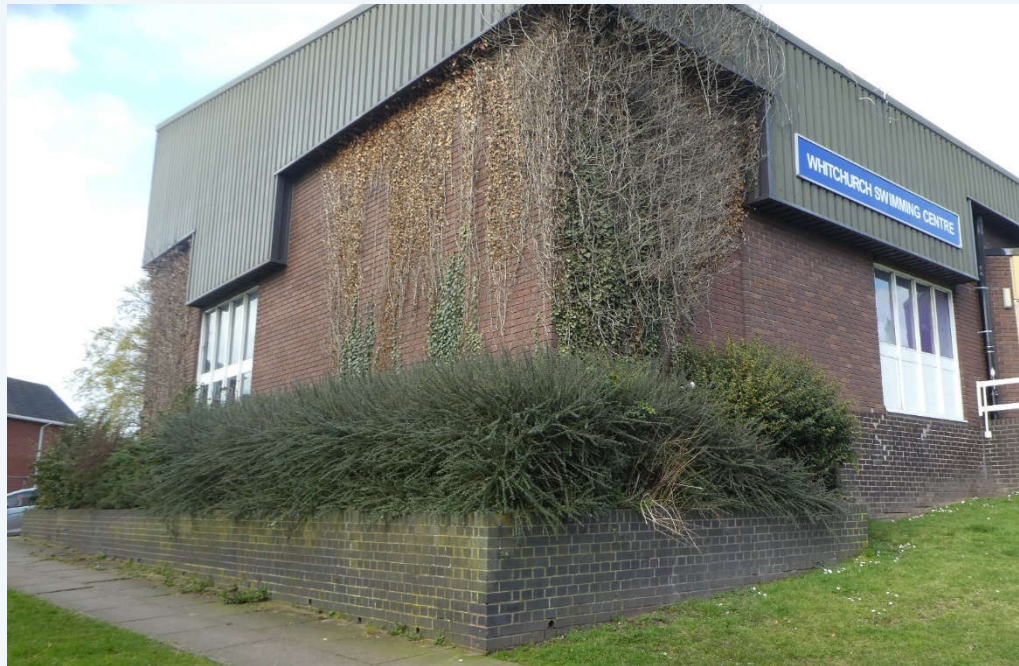
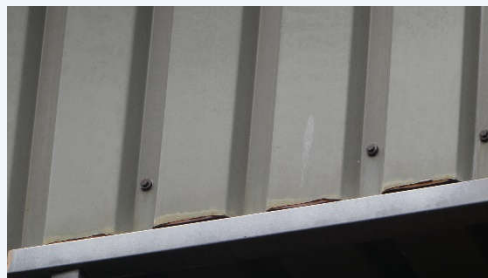
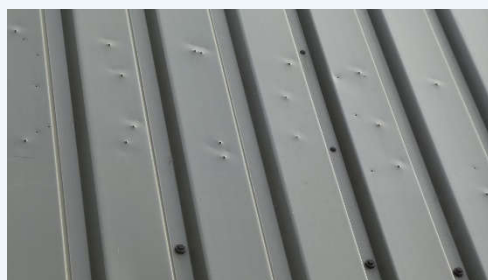
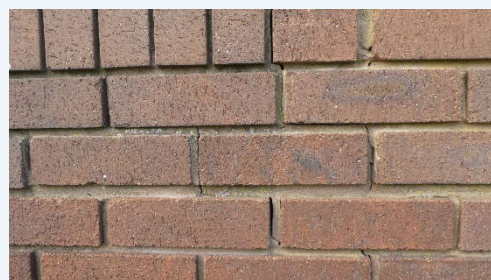
8.2 Walls

i)	Movement is evident within the structure at the change of level position and across a specific section of the building line.	High
ii)	Cracking to the brickwork façade is apparent and should be repaired in conjunction with investigations at point (i).	Medium
iii)	Mortar is weak and eroded and requires repointing throughout.	Medium
iv)	Wall climbing vegetation should be removed.	Medium
v)	Metal cladding panels where suffering severe delamination and mechanical damage require replacing.	Medium
vi)	Metal cladding panels require recoating throughout (unless being replaced).	Medium
vii)	Staining and vandalism to brickwork requires cleaning down.	Low
viii)	Expansion joints should be renewed.	Low

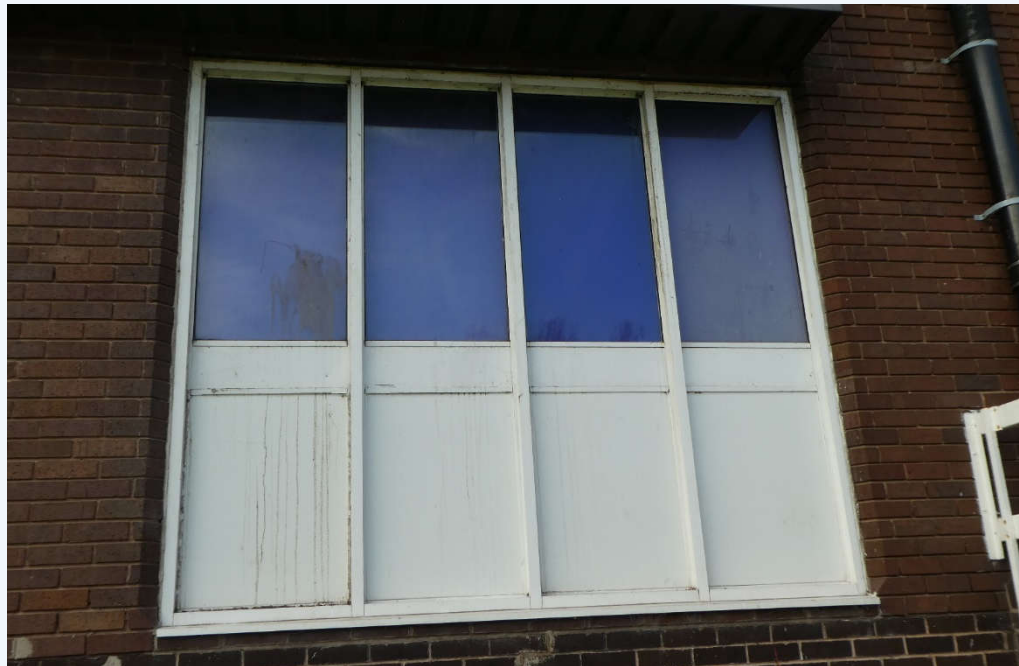
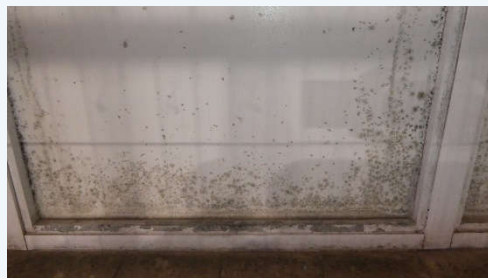
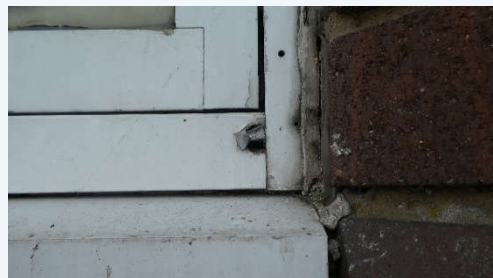
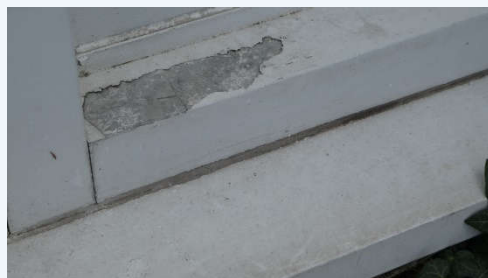
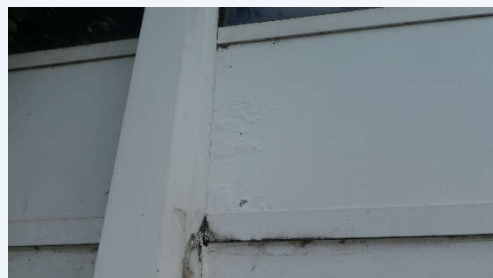
8.3 Windows

Opening mechanisms where tested were out of alignment and stiff to operate, requiring renewal.

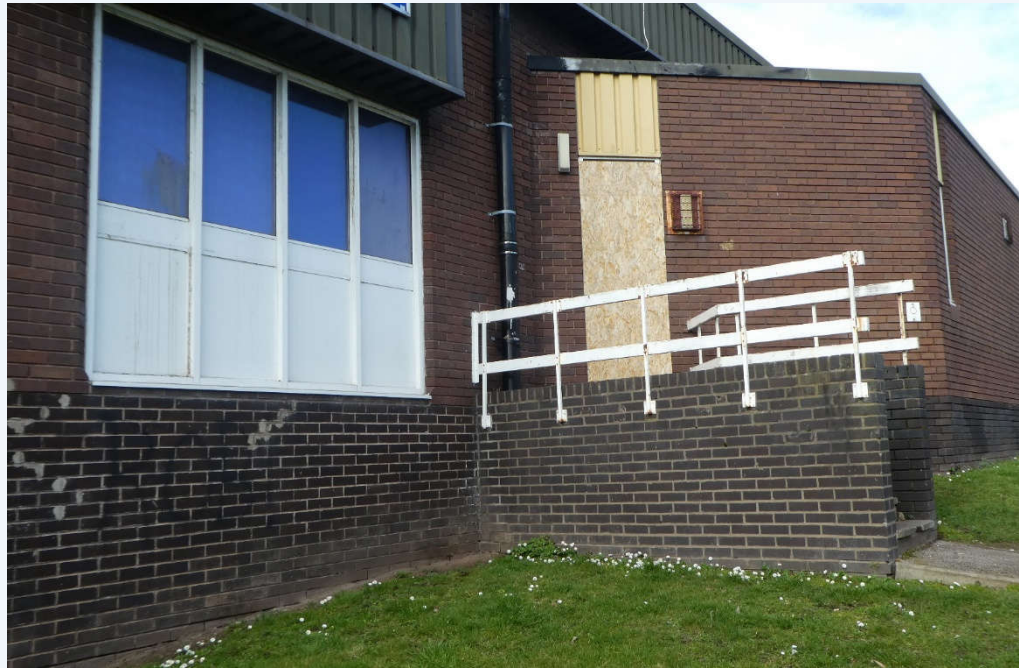
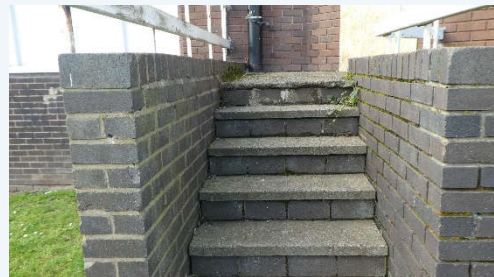
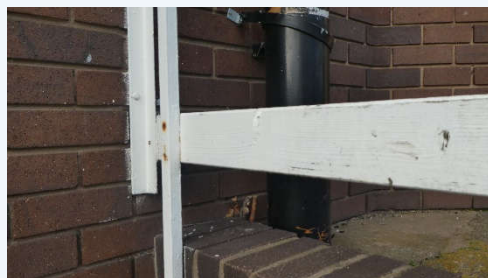
8.5 External Stairs

To the left hand corner, the roof level drainage pipework penetrates the paving to discharge into the underground drainage (assumed). The structure is original and performing as intended, however, nosing's are mechanically damaged and weathered and vegetation growth is evident. In addition, sections of brickwork are suffering from stepped cracking. Water appears to be leaking from the rainwater goods as heavy efflorescence and staining can be seen to the brickwork around the pipework penetration. The pipework will require renewal and section of the stair taken down and rebuilt.

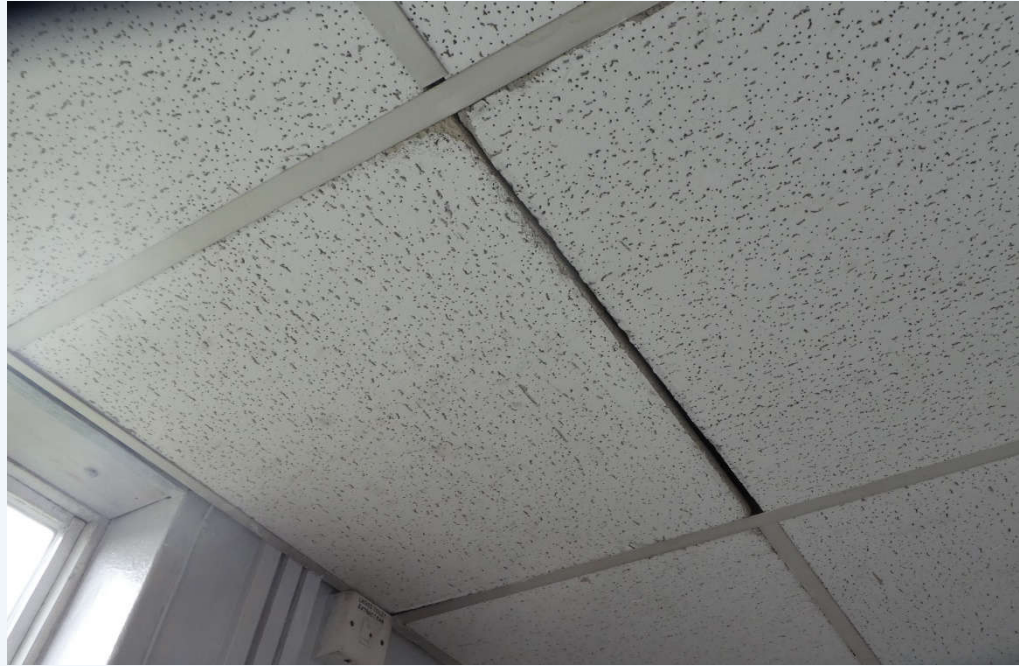
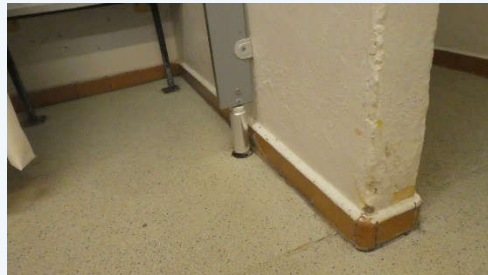
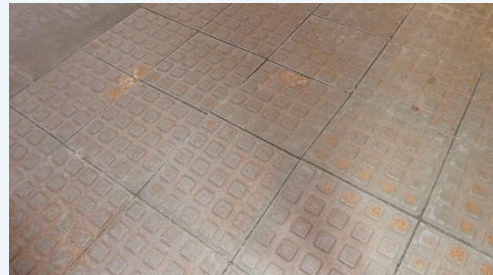
9.1 Ceilings

Aged perforated mineral suspended ceiling tiles within area 001 - 005, 007, 023, 025, 026 are damaged around perimeters, incorporate some minor staining from service pipework, some damaged / split tiles and 2x sections of exposed "T" frame missing.

Smooth and sealed humidity resistant suspended ceiling tiles in exposed metal grid are provided to areas 014, 017, 018, 020, 021, 022, 024. These areas are aged and suffering some surface residue staining and corrosion of the frame.

The painted / stained timber boarding laid perpendicular to timber carrier beams beneath woodwool slab / profiled mono-pitch to areas 006, 008, 009, 010 are generally in fair condition but suffering surface residue staining to the moisture laden pool areas. A minor number of sections are also split or damaged and will require renewal.

There are asbestos fibre board ceiling panels affixed beneath the concrete deck to plant room (012). Sections are damaged and it was noted in the asbestos survey report that several unsealed areas were present and that these areas required encapsulation.

Where ceiling tiles were lifted some unsealed pipework, penetrations were noted but compartmentation lines and fire strategy of the building is unknown.

Typically, all suspended ceilings are functional, but tiles are considered obsolete and will therefore require complete renewal and refresh / upgrade. Other than some isolated replacements the timber ceilings require cleaning down and redecoration only. The asbestos ceilings should be removed in their entirety by asbestos licensed contractor due to the age, location and fragility of the material.

- i) Suspended ceilings and asbestos ceilings would benefit from replacement.
- ii) Timber ceilings require works but access issues will be problematic
